HSE NEWS

MR. MUSLEH's

Learning from Incidents

Welcome to issue No. 16 of Mr. Musleh's News, the communication which provides a 'one stop shop' for you to receive learning's from incidents in PDO and the oil and gas industry.

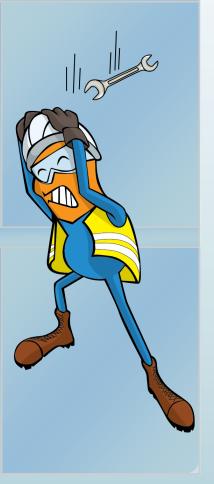
Tool falls 18m

An adjustable spanner fell from 18 meters while a third party employee was working on the tubing hanger in rotary area.
