Concurrent Operations

INCIDENT

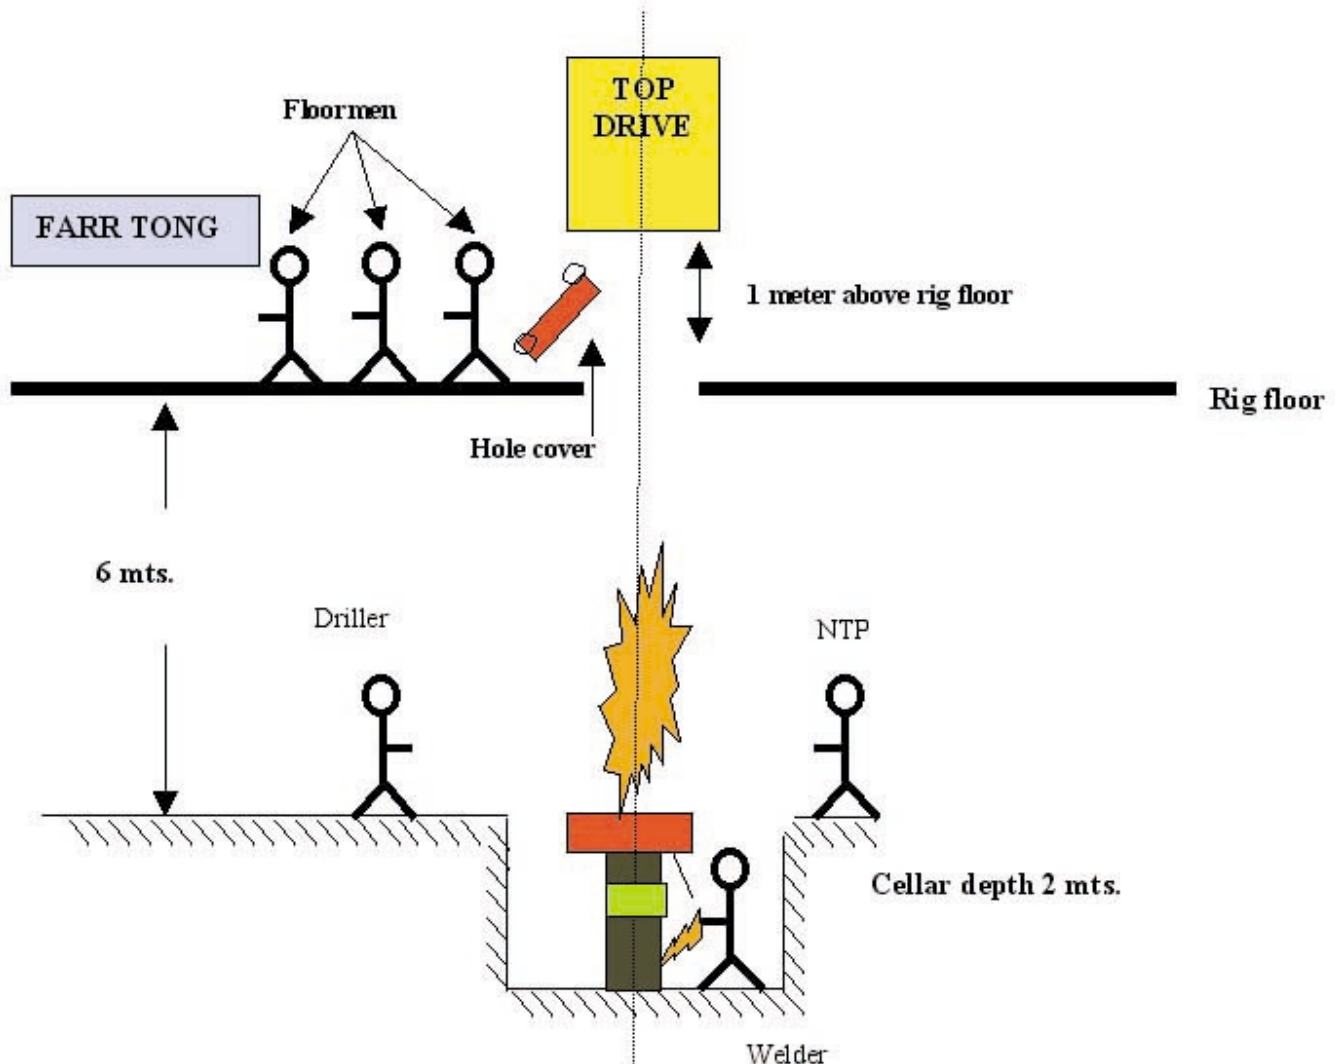
Whilst cutting conductor pipe in the bottom of cellar, a small explosion occurred inside the conductor pipe when gas ignited and blew water and vapor upwards. This caused the hole cover to be blown from the rotary table. The rotary table cover then deflected off the bottom of the top drive, grazing the leg of a floorman working on the rig floor.

- FOLLOW RULES AND PROCEDURES
- BE AWARE OF THE HAZARDS OF PERFORMING CONCURRENT OPERATIONS
