Pressure testing incident Summary

- *Pressure testing 5K choke manifold TX 54-10*
- *Choke tested inside GY base well test pressure test bay*
- *Workshop Foreman and Technician inside test bay to inspect for leaks*
- *Thermowell (3/4" NPT) failed*
- *Hit Workshop Technician in leg, resulting in serious injury to right knee*

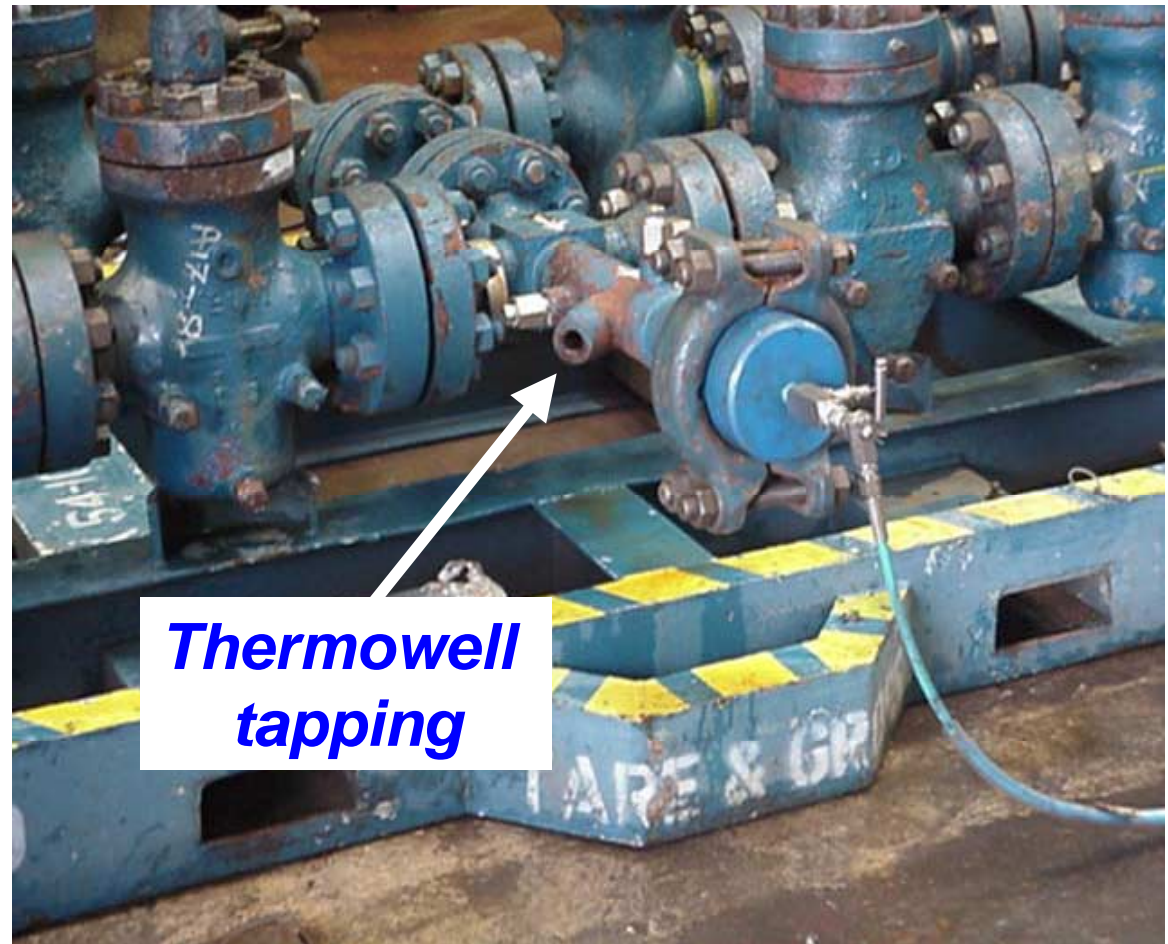
The injury was caused when the Technician was struck by a thermowell ejected from a 3/4" NPT female tapping in a 5K choke manifold during a pressure test.

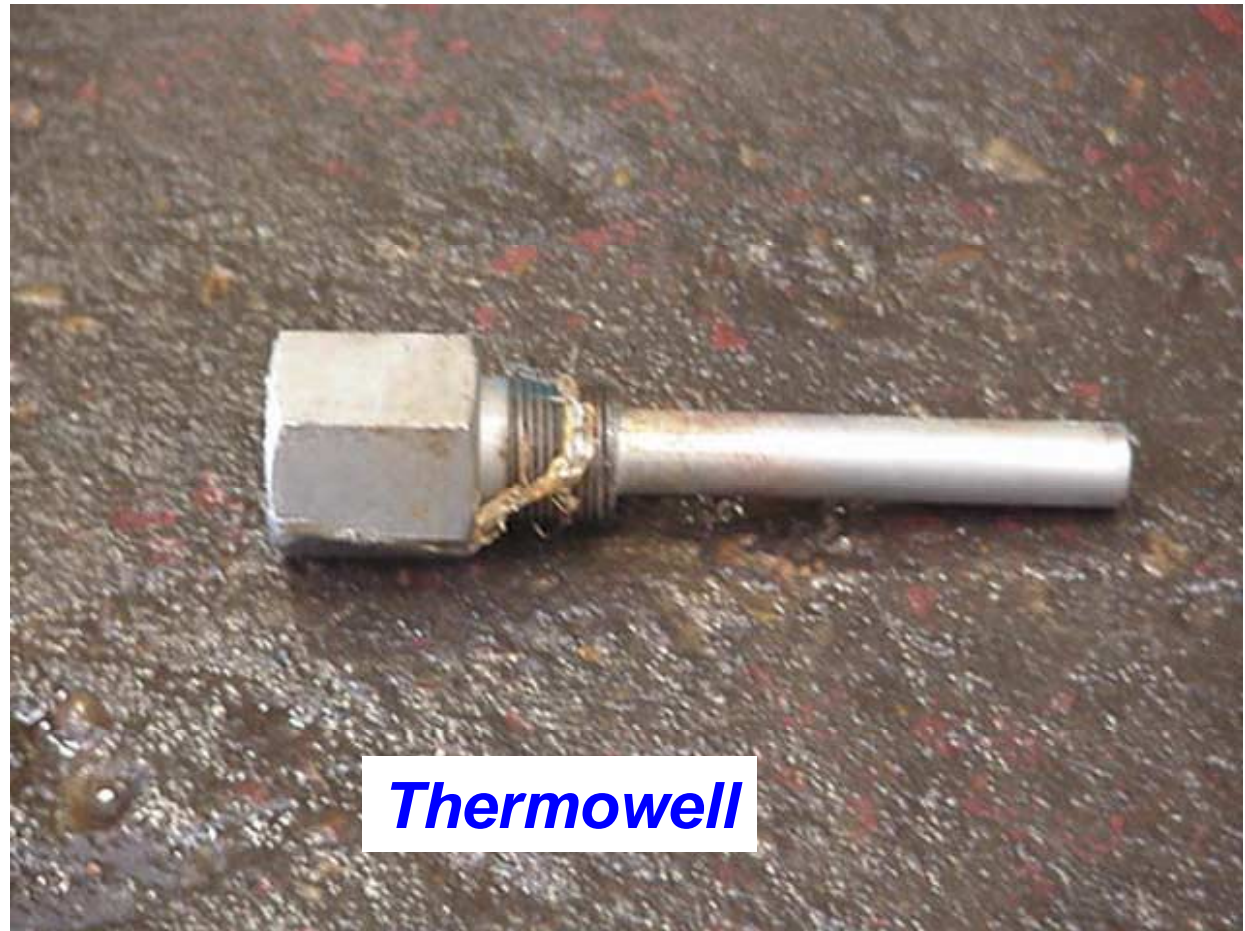
3/4" NPT Thermowell

*The thermowell is
about 9 ins long and
weighs approx 1 kg.*

*It struck the
Technician on his
knee from approx
0.5 metres.*

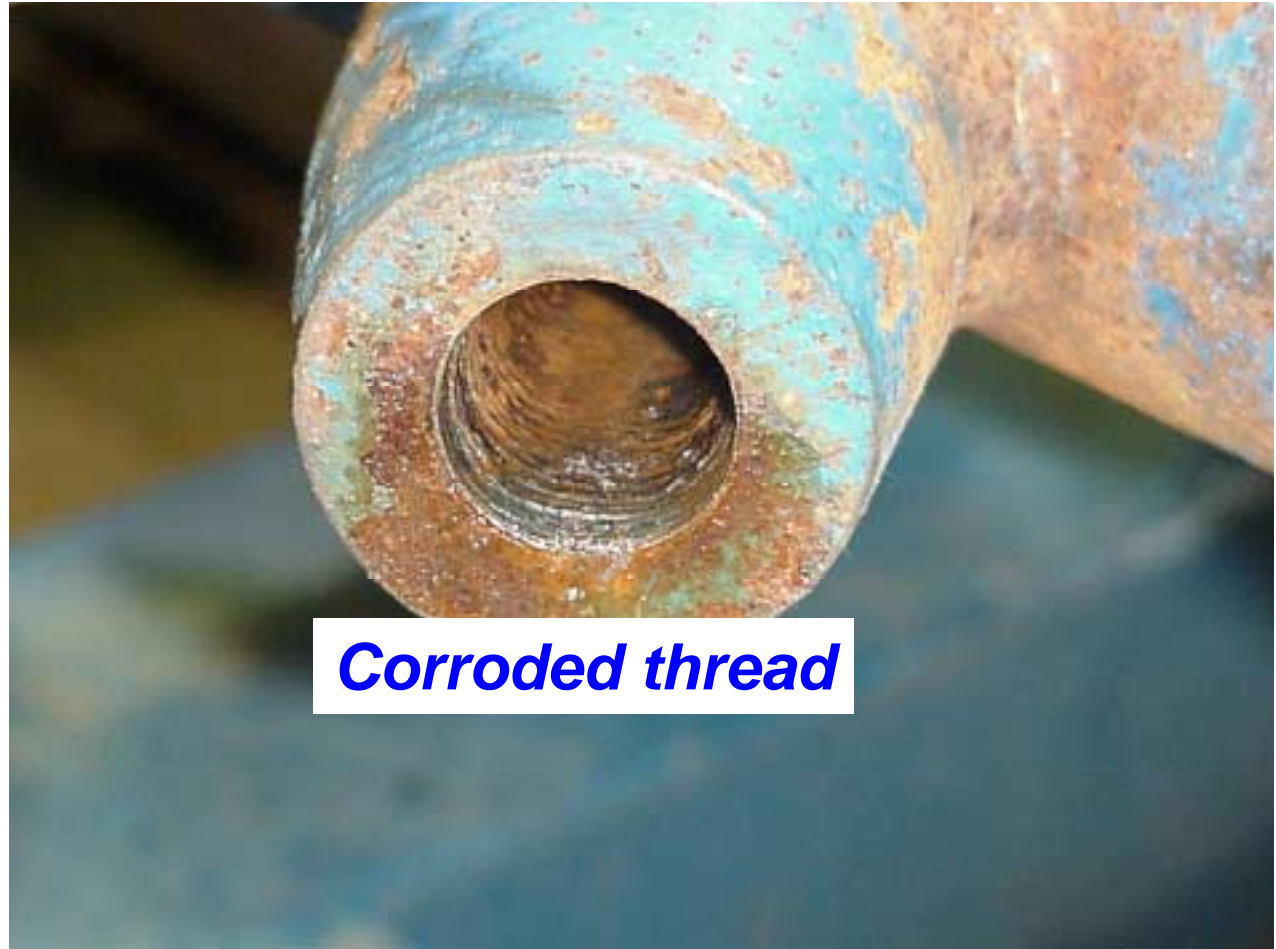
Corroded thread

Severe corrosion had affected the mechanical integrity of the female thread.

The forces generated by the 5000 psi test pressure overcame the mechanical strength of the corroded thread and caused the thermowell to be ejected.

Pressure retaining threads and tappings should have been inspected for wear and corrosion during the maintenance of the choke manifold. See the photographs and answer the question, had they been?

Calibrated thread gauges are to be used for checking the condition of the threads. The gauges were specified in the procedures but had not been used.

Dismantle and inspect ALL pressure retaining threads on Yarmouth Base equipment using calibrated thread gauges. Ensure condition of threads are established and deficient components are scrapped and replaced as required prior to any further pressure testing activity.
