#### Three High Potential Incidents involving H<sub>2</sub>S in oily water treatment occurred in 2006

# SAFETY FEEDBACK NOTICE

## HYDROGEN SULPHIDE (H<sub>2</sub>S)

**DGEP / HSE**
**Ref: 02 - 2007**
**Issued: 16/02/07**

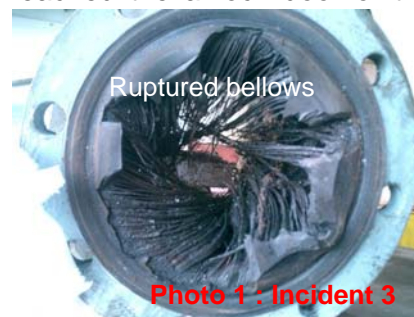
**Incident 3:** One and half months later, one of the two new bellows installed after incident 2 ruptured (see Photo 1). The operator who saw the water jet alerted the Control Room and asked for activation of ESD1. The nearest H<sub>2</sub>S detector was triggered.

- (5) **The internal lining of the new bellows installed was not suitable for the service**. Inappropriate bellows were **purchased** and **delivered**. The **material data sheet** which detailed the incompatibility of certain materials with hydrocarbon was **ignored** (Incident 3).

- (1) Revise design and operating philosophy of the oily water network downstream of the oily water tank.
- (2) Do the preventive replacement of bellows on lines containing hydrocarbon and insure of their compatibility with H<sub>2</sub>S and hydrocarbon.
- (3) Enforce correct use of airlocks and restricted access to the Control Room through field instructions.
- (4) Downgraded situation follow up at weekly meeting, under GM chairmanship.
- (5) Reinforce quality control on spare parts before shipment to site.
