Fatality Report

Fatalities on Offshore Installations - UKCS, Norway & Holland (2000-2002)

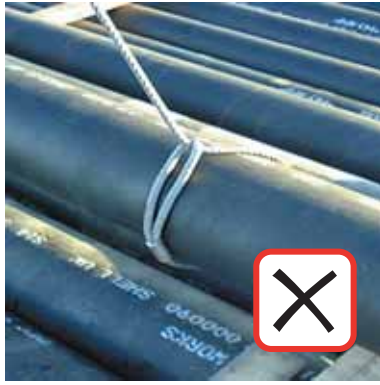
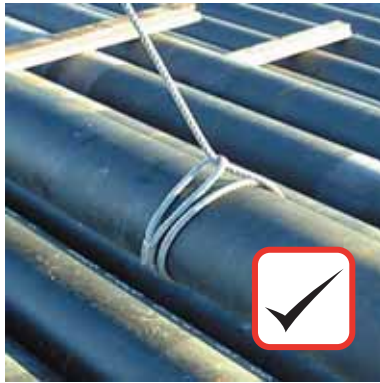
1. The lifting slings on the casing were (in this case) single wrapped rather than double wrapped.
2. Use of double-wrapped slings was the correct and accepted practice on the rig (double wrap was used at start of job).
3. Some previous joints had been lifted with single-wrapped slings. Though observed, no one said anything.
4. The crew were doing a short-shift change in order to go from night shift to day shift.

As the joint of casing was lifted, one of the slings slipped along the length, causing the joint to drop and swing. It hit the pipe deck, bounced and struck one of the crew who was not standing in a safe area as he had been on previous lifts. He was taken to hospital and died later in the day. He was found lying on a removable thread protector – perhaps he moved to a safe position and returned to retrieve this.

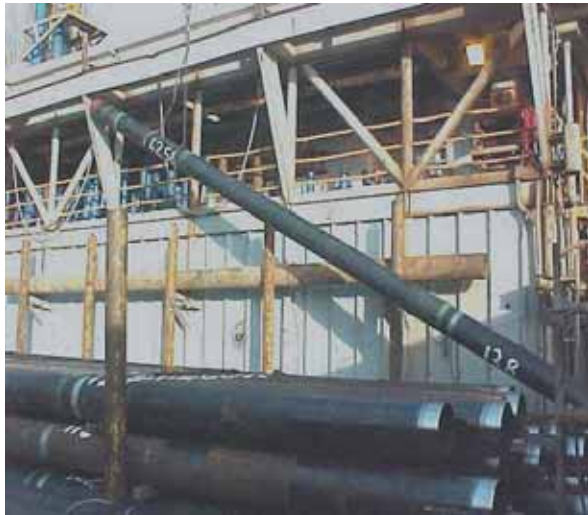
1. At 17:00hrs the Crane Operator was relieved for a meal break by the qualified Relief Crane Operator who had been acting as banksman. The operation was in daylight and the weather conditions were good.
2. A qualified roustabout on the crew took the role of banksman (all roustabouts on the crew had banksman training).
3. A toolbox talk was carried out at 12:00hrs at the beginning of the shift, but not when the Relief Crane Operator assumed operation of the crane.
4. Two crewmembers preparing to use tag lines were on the starboard side of the catwalk, inside the protection cage while the banksman was positioned on the walkway to the port side of the catwalk (not banksman's normal location).

When the Relief Crane Operator entered the crane, a bundle of 3½" drill-pipe was attached to the crane waiting to be lifted. Prior to the lift, two roustabouts positioned themselves on the starboard side of the catwalk inside the protection cage to control movements using taglines. The banksman was on the walkway to the port side of the catwalk. When the load was lowered and at chest/waist height, the aft end of the bundle swung toward the banksman striking him in the torso. The bundle of pipe came to rest on the walkway to the port side of the catwalk, and the banksman was found lying on his side against the handrail on the walkway supporting himself on his right elbow. He was attended by the medic, and (still conscious) transferred to the sick bay by stretcher, where his condition deteriorated. He lost consciousness. After 40mins, efforts at artificial resuscitation were ceased. A post mortem revealed major internal injuries consistent with being struck by a high-energy low velocity object.

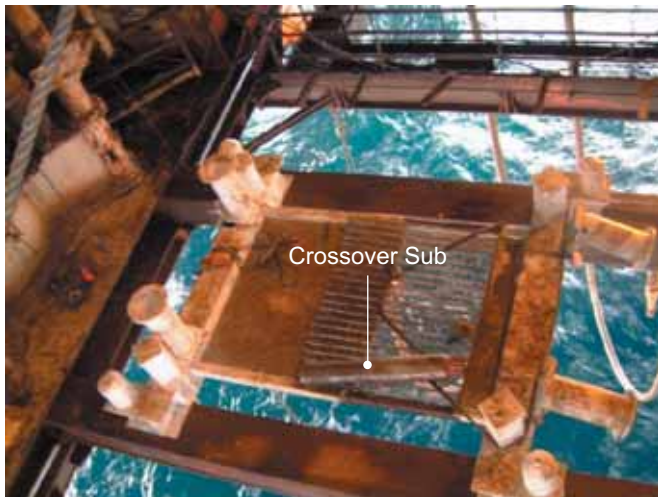
1. The mousehole opening (on the drill floor) did not have adequate dropped object protection.
2. The PTW system did not control the activity of the engineer in the moon-pool.
3. The radio communication between the drill floor and the moon-pool was inadequate.
4. The engineer was relatively senior and was treated as a 'free agent'.

Landing Frame: Showing the crossover sub lying on the grating that covers half of the landing frame.

The engineer was repairing and adjusting a landing frame in the moon-pool area. A crossover sub (large piece of pipe) weighing 191.5kg fell through an opening on the drill floor called the mousehole and hit the man standing on the landing frame 13.7m below. He suffered severe injuries and died shortly after.

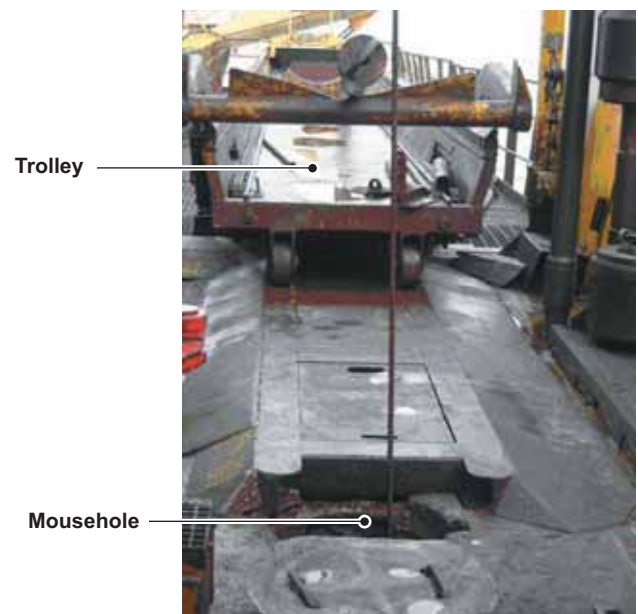
Drill floor: Showing the mousehole and the catwalk trolley.

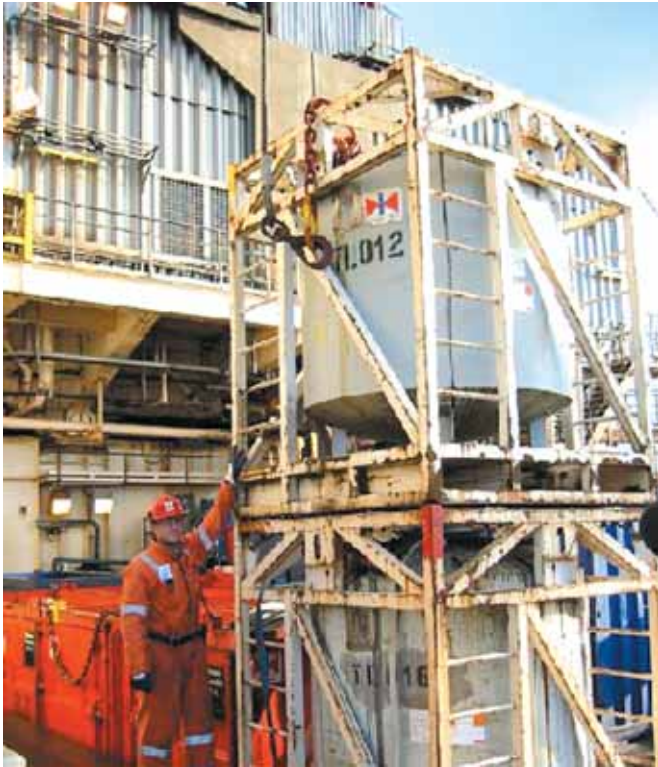
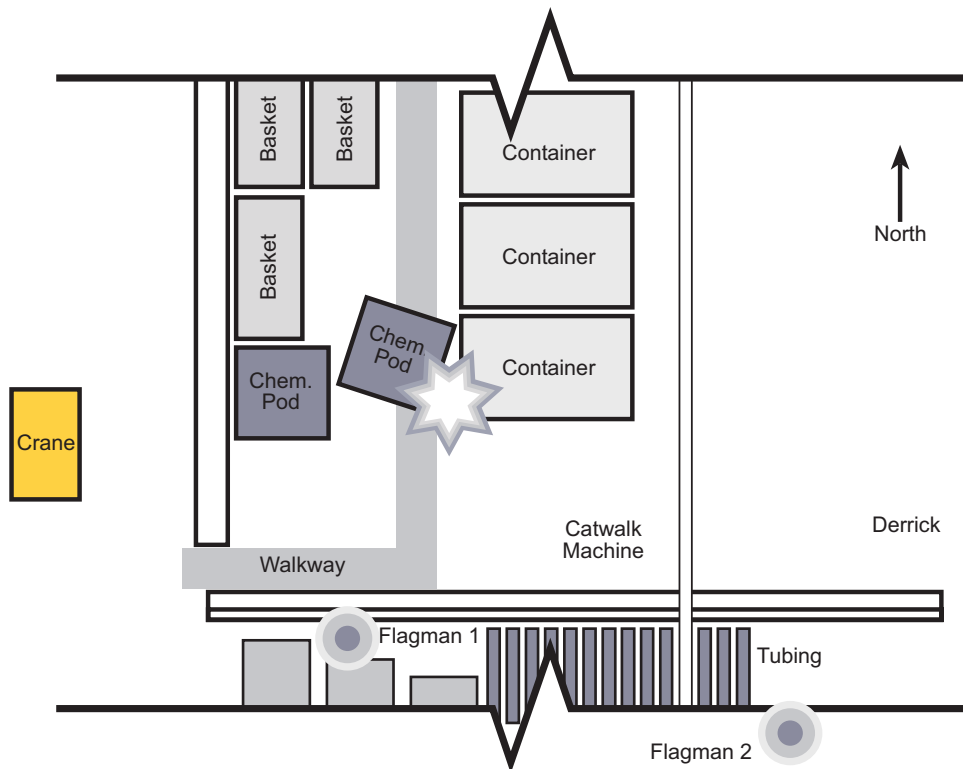
1. The aluminium ferrule on the end of the wire (part of the lifting equipment) was hung up between the tank and the frame on one side.
2. The banksman was in radio contact with the crane while standing on the ladder of the upper tank.
3. The lifting arrangement was not within reach of the deck if a tank was stacked.
4. The open-top arrangement of this type of tank allows for lifting equipment to go down between tank and frame.
5. The tank was equipped with stacking lugs
6. If the tank was lifted clear of the lugs on one side the tank is free to move sideways.

On request, the crane-driver lowered the crane pendant, which came down too far and fouled between the tank and its frame. The banksman requested the crane driver to pick up 20cm; on doing so (with the lifting gear fouled between the tank and its frame), the tank lifted on one side. It was then free to slide sideways and as it did, the banksman was trapped against a nearby container and killed.
