HSE NEWS

MR. MUSLEH'S

Learning from Incidents

Welcome to issue No. 17 of Mr. Musleh's News, the communication which provides a 'one stop shop' for you to receive learning's from incidents in PDO and the oil and gas industry.

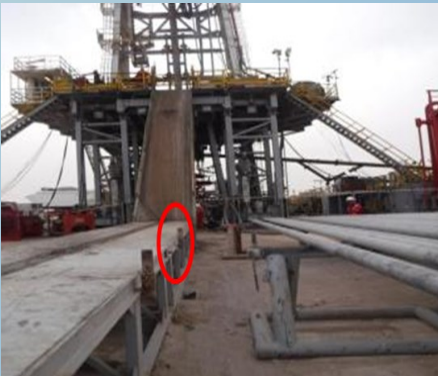
Dropped Pipe

While laying down the drill pipe, the pipe moved toward edge of catwalk, knocking the roustabout to ground and landed on his left leg.

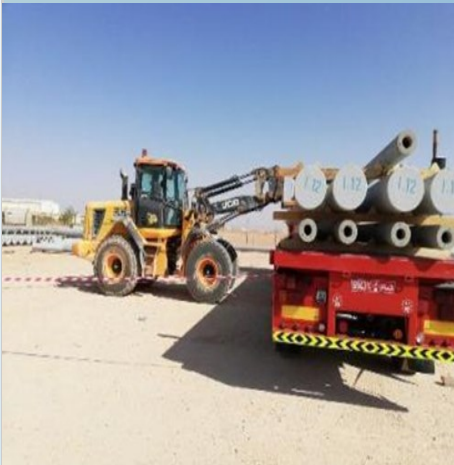
Fatality

While unloading OHL concrete poles from the trailer using a tool carrier, the pole swung and hit the right chest area of the worker who was standing between the poles resulting in crush injury.

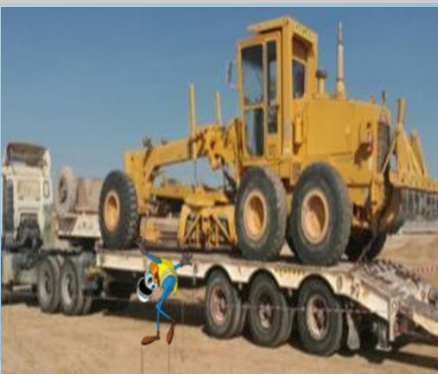
Driver falls

After checking his load security, a driver was getting down from a Low bed Trailer when he lost his balance and fell resulting in a fracture to his left wrist.

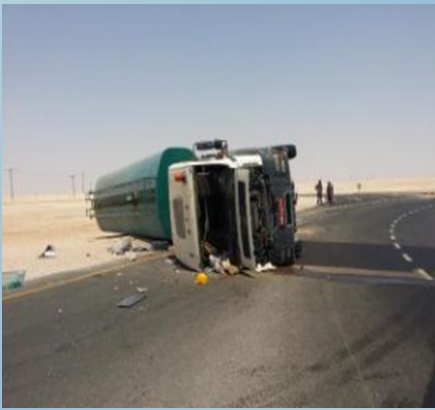
Tanker tips

While negotiating a roundabout the driver lost control of the tanker tipping over onto its right side. The helper sustained multiple soft tissues injuries and driver minor abrasions.

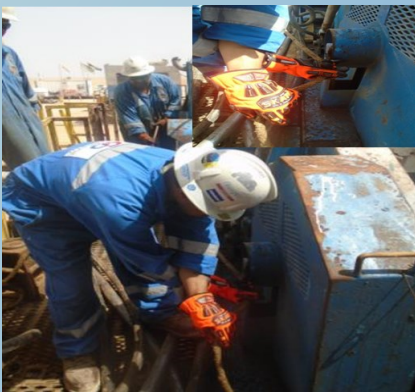
Pulling the Guy

Rig crew members were in process of Rigging up. The Driller and Derrick Man were on the rig carrier, pulling the guy lines for clearing away from the mast prior to raising the mast. Derrick man was holding a guy line near the draw works which was stuck at the Hydro-matic coupling side and at the same time it was pulled rapidly by the Driller. The sudden force resulted in hitting the right hand little finger of the Derrick man on the guard of the Hydro-matic coupling of draw-works. Derrick man was taken to the government clinic where X ray revealed fracture.

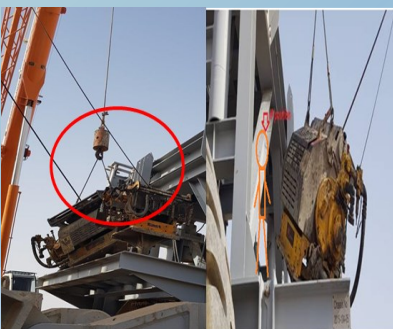
Swinging load

While mast lowering preparation, a roustabout was assigned to guide the winch and install locking pin. Assistant driller was acting as banksman in order to set the winch on its base, while doing so the utility winch imbalanced and swung, which resulted in Roustabout left arm being caught between the winch and dolly beam.

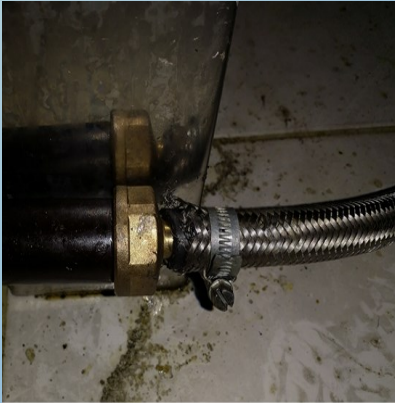
Kitchen burns

A gas supply hose connected to a kitchen burner became detached. The released gas ignited and the flames reached a Chapatti maker causing 3rd degree burns to 45% of his body.

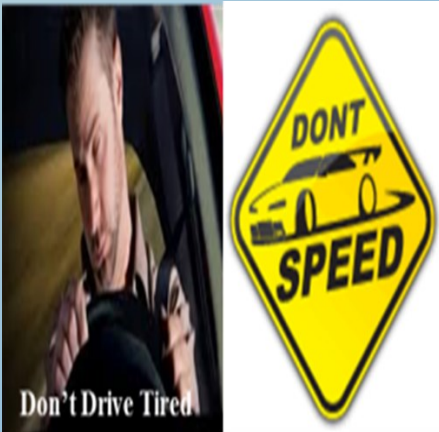
Don't loose control

A driver and one passenger travelled from Muscat to Lekhwaier to attend a meeting before continuing onwards with their journey to Yibal. At 13:39 hrs the driver lost control of the vehicle, and it was driven across the road into the oncoming lane and then onto soft terrain (sand) resulting in the rollover. Both employees received minor injuries.

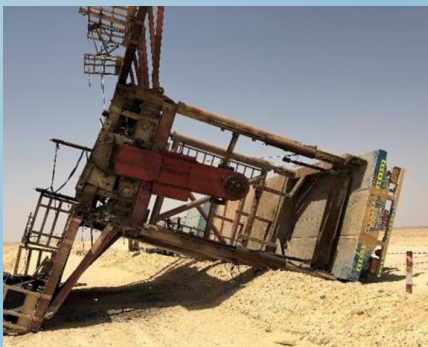
Mast tips over

During rig move operations, one of the trailers carrying rig floor substructure rolled over on the graded road between the old and new rig sites. Total distance between both rig sites is 4.5 km, during travelling the driver was maneuvering the vehicle to avoid pot holes on the road. After 1.7km from the old location the driver drove on the road left shoulder which was uneven and caused the truck to tip over due to high center of gravity.

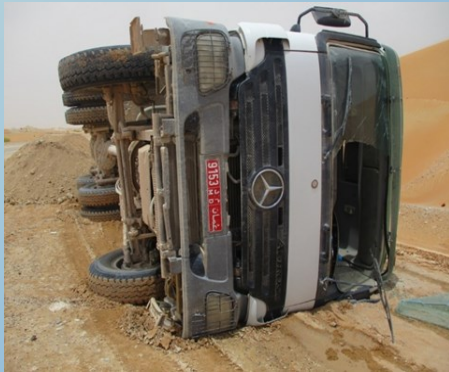
Tipper tipped over

While the tipper driver was offloading the soil in the work location for road resetting work, due to the uneven surface the tipper fall to the side.

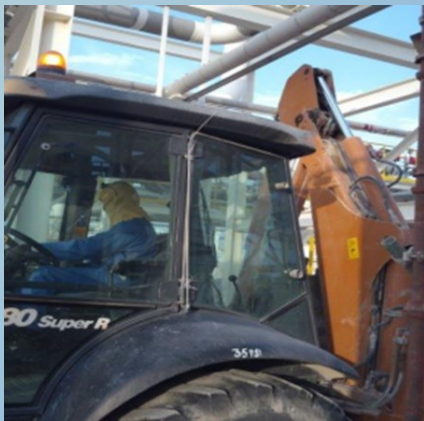
OHL strikes

A Back Hoe Loader carrying back filling material was passing underneath an over head 2-inch via Instrument air line inside a live gas plant. While passing the line the rear arm of the loader hit the line as the vehicle recoiled when the operator applied brake. Due to the impact the line detached from its threaded flange which caused trip of two running compressors in the station.

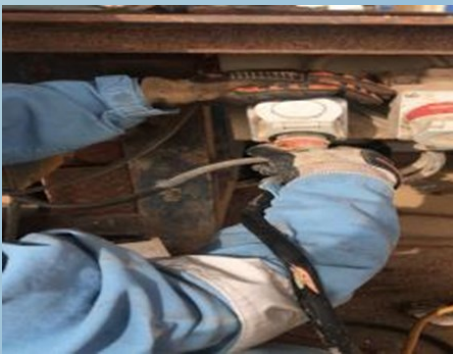
Shocker

During rig up, the night electrician connected the power cables and turned on the light switches from MCC (motor control center). While walk around the electrician noticed that the light on the water tank was not on. Upon inspection he found that the cable to the water tank was not connected. He then attempted to plug the socket and turned it (Twist Switch) to switch on the power.

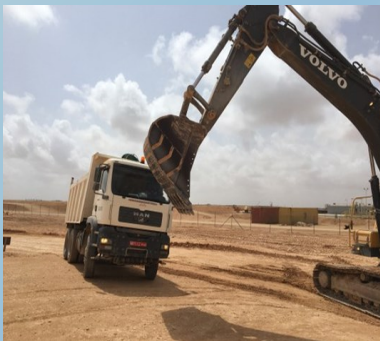
Boom Swings

An excavator had returned to site after re-fueling, while the tipper approached the right side of the excavator at the same time as the excavator operator was rotating his machine. The boom of the excavator impacted with the driver's side windscreen partially crushing the cab "A" pillar, the operator lowered his boom switching off his machine and assisted the tipper driver, who was uninjured.

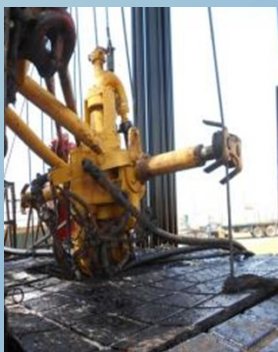
Brake fails

During the drilling in the cement operation, the brake lever got released from the chain, which caused the block to free and fall, then it hit the power swivel and rig floor ; resulting in asset damage.

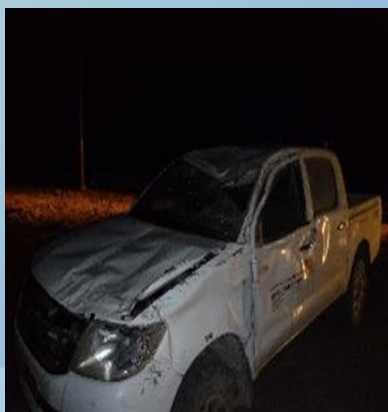
Rollover

Forman Roustabout (Driver) and Roustabout (Passenger) were traveling back from camp to Rig site using Toyota Pickup. Approximately 2.5 km from Rig site, driver approached a S- curve and lost vehicle control which resulted the vehicle to skid out side the road and hit a sand ramp which was in road shoulder and resulted the vehicle to rollover half a turn and rested on its roof.

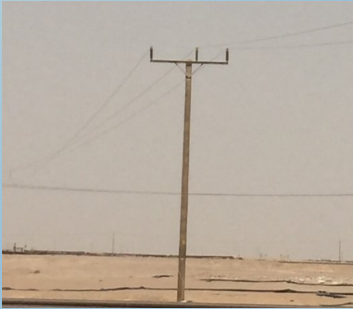
OHL strike 2

While the crane operator taking back the slings after offloading the pipe at pipe rack, the slings of the crane contacted with OHL resulted in spark and OHL cut.

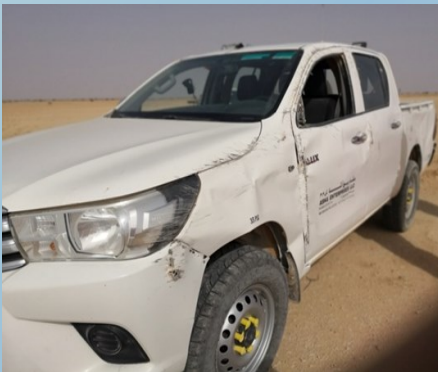
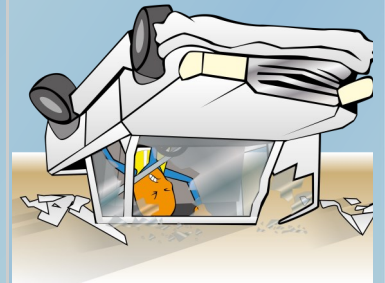
Rollover 2

A line crew in a Hilux were returning back to camp after finishing the job. On approaching the T junction @ Nimr - Sim Sim on the graded road, control of the vehicle was lost resulting in the vehicle rolling over 90° coming to rest on the driver side. Medic with ambulance was deployed to incident site. On arrival and examination the driver was found with an abrasion on the right hand palm (First aid given) and four passengers with no injuries

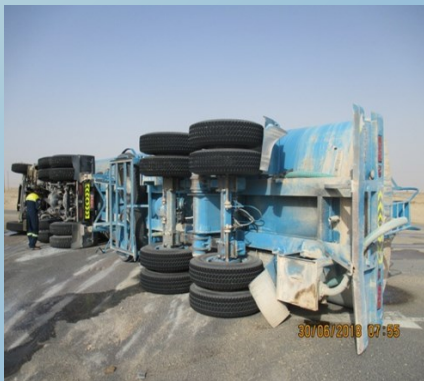
Tanker tips 2

A water tanker on route to Fahud RO Plant (unloaded) from Awaifiah was negotiating the Natih roundabout when it tipped over on to it's passenger side and skidded approximately 5 meters before coming to a stop. Shortly after the incident the driver was picked up by a passing vehicle which took him to the Fahud Sahara PAC clinic.

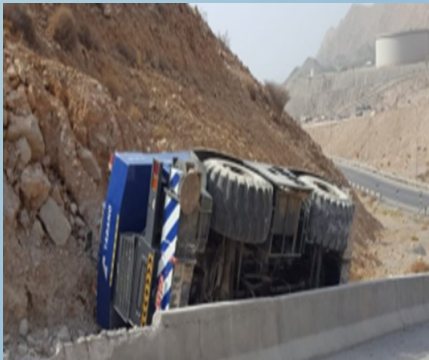
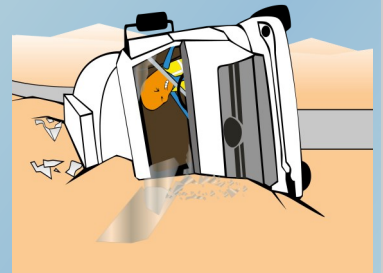
Crane tips over

A subcontractor crane was travelling from MAF Upper Tank Farm (UTF) to Lower Tank Farm (LTF). The operator lost control of the crane while he was negotiating a section of black top road with steep descents and bends causing the crane to hit the road barrier wall & light pole. Finally the crane came to halt with tip over to a trench next to the road barrier.

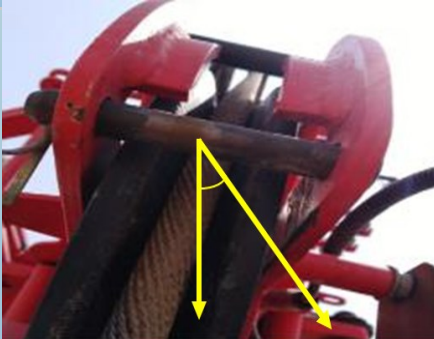
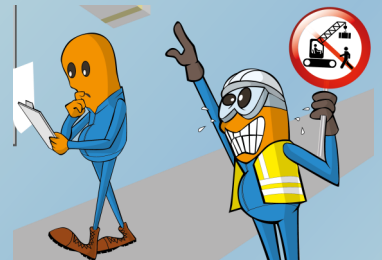
Rope snaps

While running in hole the 11th joint of 4.5" tubing using the crane auxiliary hook, the Wire rope snapped causing the tubing string to slip into the well and the auxiliary hook to drop approximately half a meter from the wellhead. No one was injured during the incident.
