# HSE NEWS : Mr. Musleh News

**WORKING TOGETHER FOR A SAFER WORKPLACE**

### Mr. Musleh's News

Welcome to issue No. 20 of Mr. Musleh's News, the communication which provides a 'one stop shop' for you to receive learning's from incidents in PDO and the oil and gas industry.

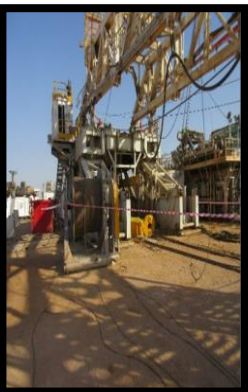
**Down the mouse hole**

While lowering the mouse hole to the ground One sling eye rotated enabling the safety latch to open and the eye came out of the hook from 6M.

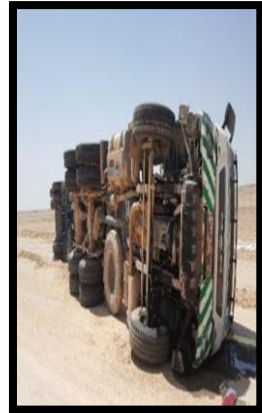
**Tanker tips 2**

A car coming in the opposite direction on high beam distracted the driver's vision, which caused him to swerve off the right side of the road on to wadi slope protection rolling over.

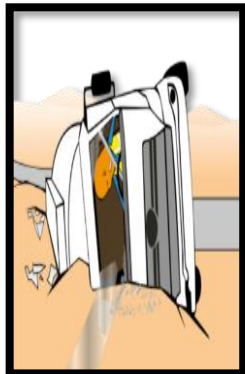
**Chemical tips**

Whilst approaching a T-junction on a graded road the driver failed to slow the vehicle enough, on attempting to take the right turn at the junction.

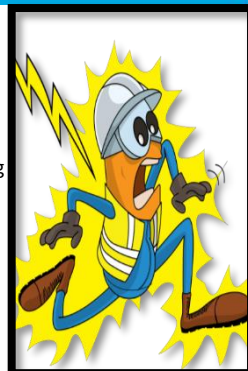
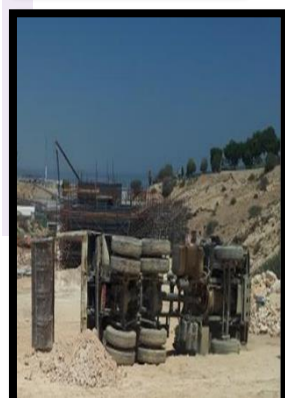
**OHL strike**

The rock breaker crossed underneath a 33KV OHL, the boom touched the conductor damaging the conductor and interruption of power supply to production wells
