Learning From Incident Awareness Alert

Alert NO:	0420122020_LTI#30_Fatality#04	Pattern	MVI
Date	02.12.2020	Target Audience	Construction, Drilling, Operations ,Engineering, Exploration and Logistic

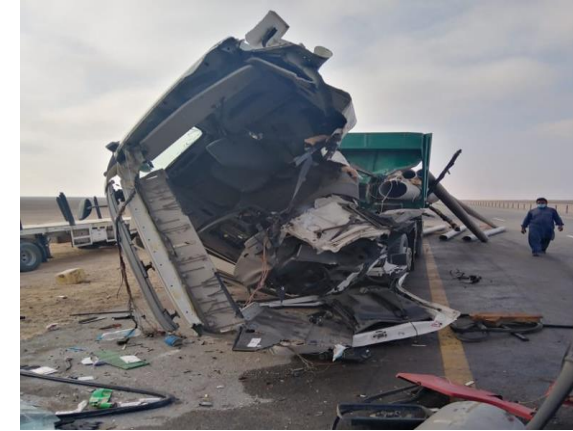
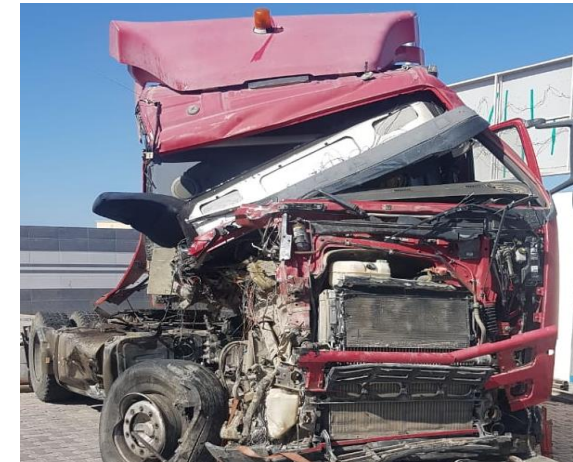
On 2nd of December 2020, at 13:20 hrs, a heavy truck and trailer carrying pipes from Saih Rawl to Sohar on the Salalah-Muscat highway, near Awaifiya, the trailer had a puncture and stopped at the side of the road. The driver called his supervisor requesting maintenance team to help. At around 21:40 hrs, while waiting for the maintenance team, a 3rd party heavy truck collided with the rear of the trailer causing the pipes to go through the headboard into the driver cabin resulting in fatal injuries to the driver.

- Always stop the vehicle in a safe place (The vehicle should be stopped outside the road whenever possible that includes avoiding to keep your vehicle parked or stopped in yellow lane).
- Always report issues with your vehicle on your routes to your journey manager.
- Always ensure your vehicle has spare tires before commencement of journey.
- Always ensure drivers understand emergency response process.
- Always ensure to use hazard warning lights and warning triangle around your vehicle during breakdown (Hazard warning sign must be positioned minimum 100 m before the incident/vehicle).
