Learning from Incidents
Third Quarter of 2021 Incidents

This quarter's Mr. Musleh summarizes the learnings from incidents related to Lost Time Injuries (LTIs), High Potential (HiPos) and High Value Learnings (HVL) which have occurred during this quarter.

PDO Second Alert

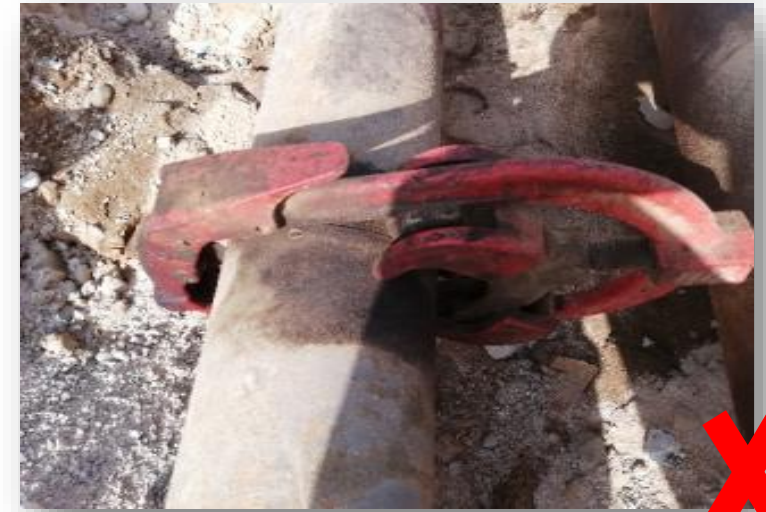
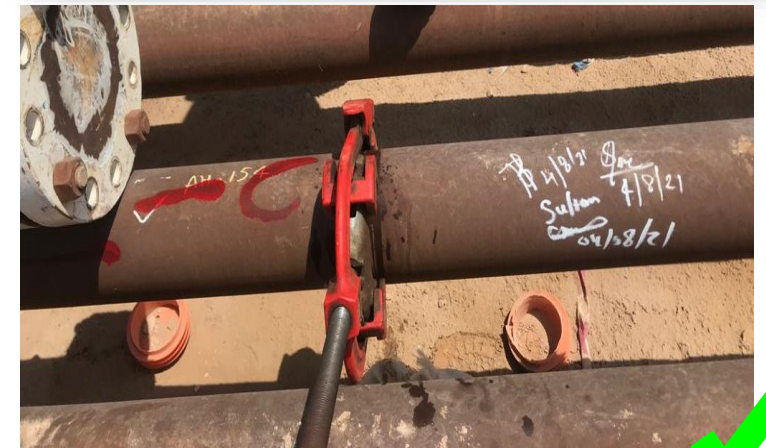
As per the normal cold cutting practice, contractor crew who were assigned for re-routing existing flow lines, identified, line walked and marked 'C' on a flowline at cut points using red paint. They also marked red "C" on adjacent Long Term Closed (LTC) flow line based on the verbal confirmation that it is hydrocarbon free. This was done to save time as this line was scheduled for cut on following day.

At the time of cold cut, additional red marking on the LTC line caused confusion resulting erroneous cutting of the wrong sequence line.

- Always verify identification of the lines before cold cut.
- Always seek clarification in case the procedures are not clear.
- Always follow reliable identification methods like hammering, pigging.
- Sign off flowline by all concerned – Area Authority, Permit Applicant & Holder.
- Never take short cuts.
- Never allow the Permit holder to physically involve in carrying out activities.

Sign off on flow line by AA & PH before cold cut

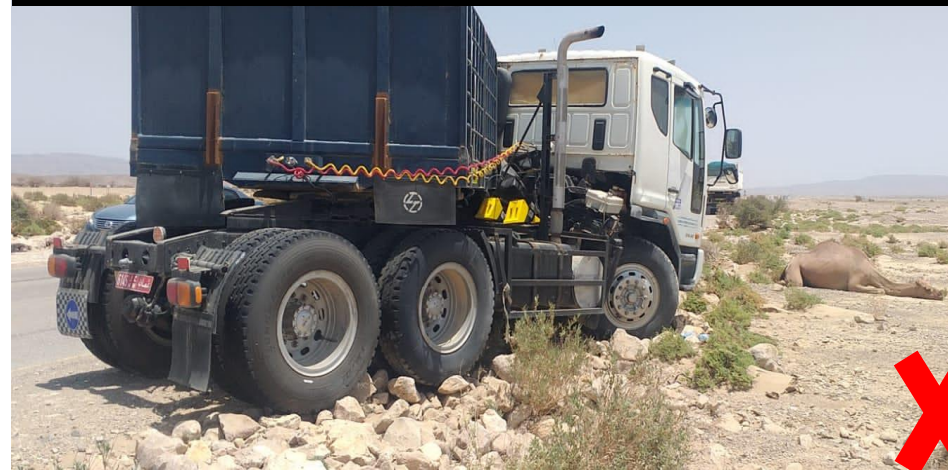
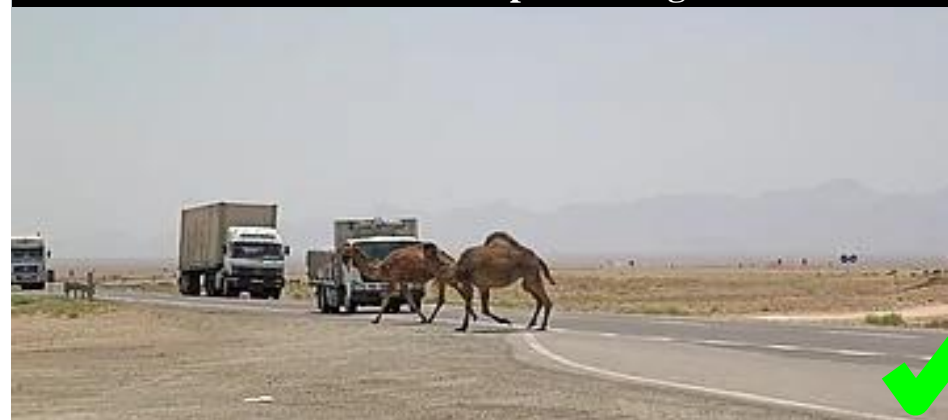
Trailer was moving on the black top and was transporting materials for the project. A camel suddenly ran across the highway. The driver tried to control the vehicle, however the prime mover hit the camel and it died few minutes later. No injuries to driver and minor damages to the prime mover

Driver hit camel while driving

Driver shall slow down the vehicle and give way to the camels before proceeding

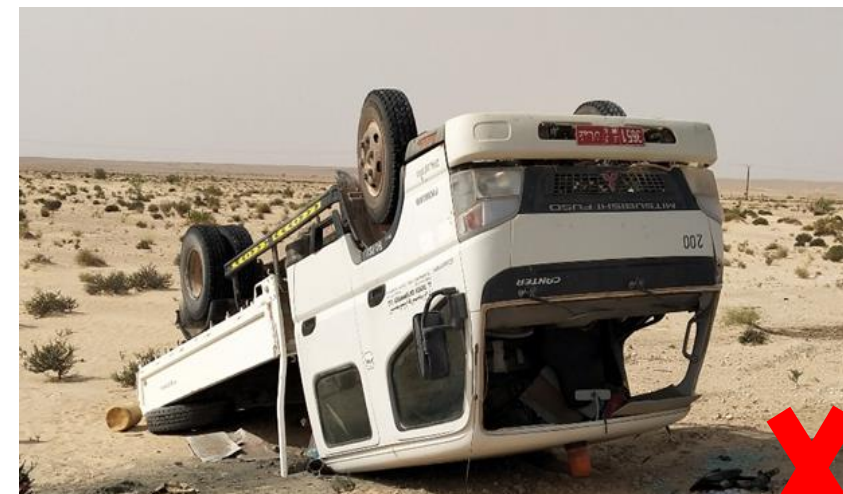
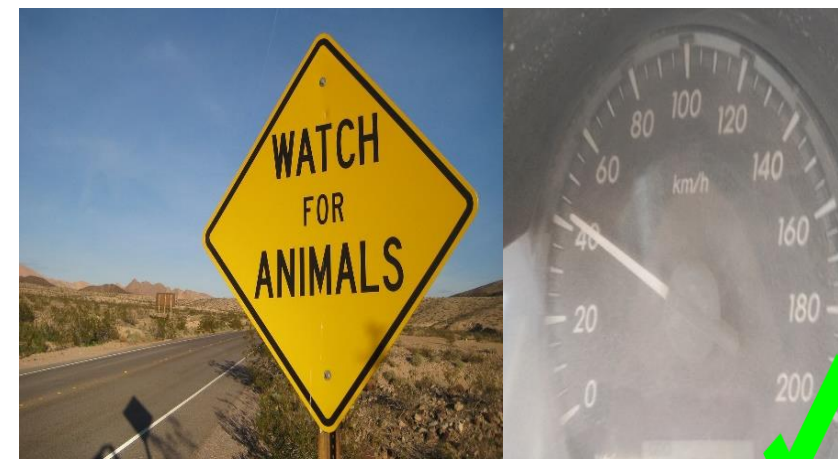
A 3 Ton canter while travelling from harweel to Marmul rolled over while controlling the vehicle to avoid camel hit, slight damage to the vehicle, no injury to the driver and the co-passenger got slight injury on his right arm and he was shifted to PDO Marmul clinic there initial medical management done. Incident informed to ROP.

- Always pay attention scan ahead while driving.
- Always be updated with surrounding environments.
- Always apply defensive driving techniques.
- Always pay attention to the traffic warning signs and react accordingly.
- Always include all road related hazards in Toolbox Talk with Drivers

Always expect an unexpected on Roads; Be vigilant

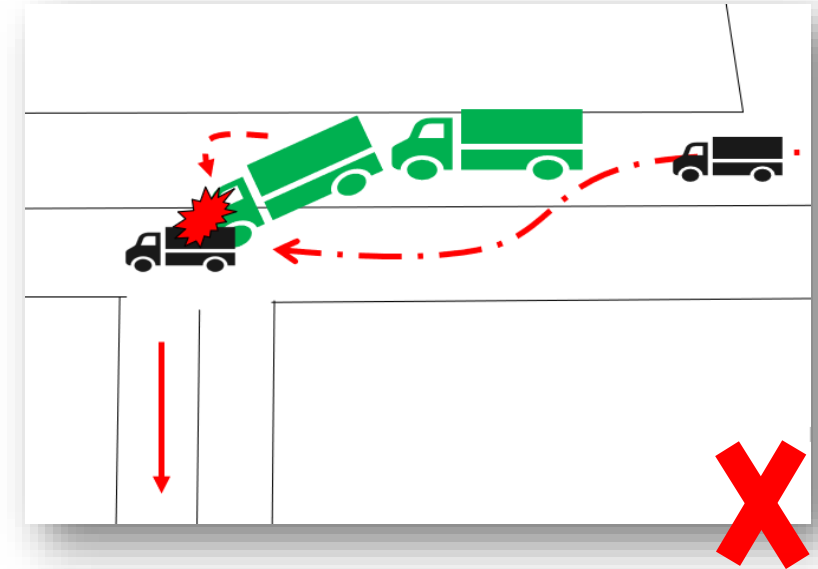
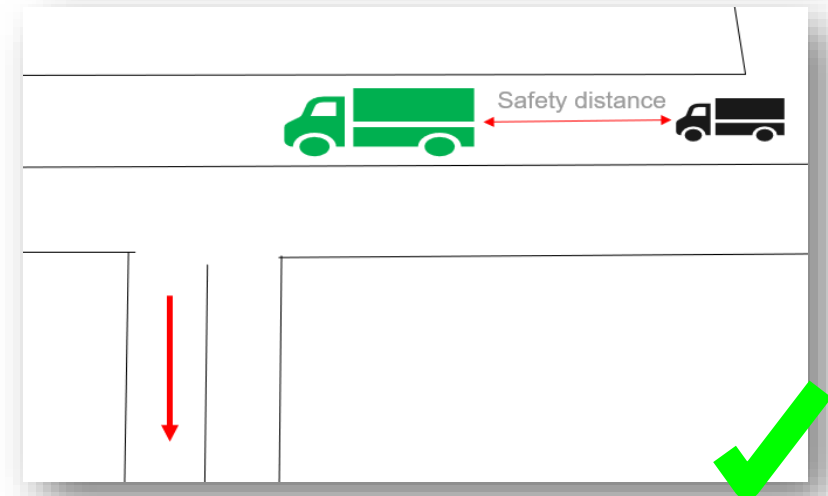
Field specialist was driving Pickup heading to Nimr camp. At approximately 15:49 hrs., there was a trailer moving in front of Pick up. Both Vehicles were headed same direction. Pickup driver was behind attempted to overtake the trailer whilst the trailer was taking a turn on the left side. The pickup driver tried to avoid trailer but eventually that led to a collision between both, the pickup flipped on its left side resulted total damage . There was slight damage to the trailer. Pickup Driver and Passenger reported immediately to the Clinic for medical check and released with no injuries sustained.

- Always ensure it is allowed to overtake before taking the decision.
- Always follow Sp2000 procedure and apply defensive driving skills.
- Always stop the driver if you observe any poor driving behavior.

Do not overtake at the T- Junction

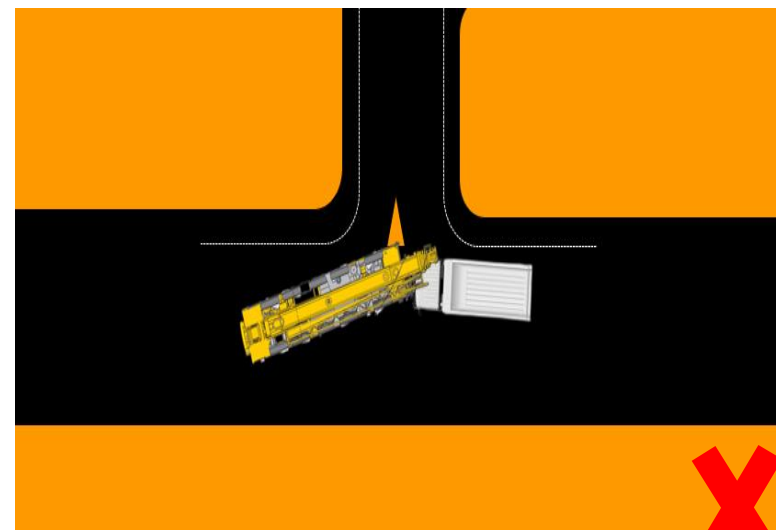
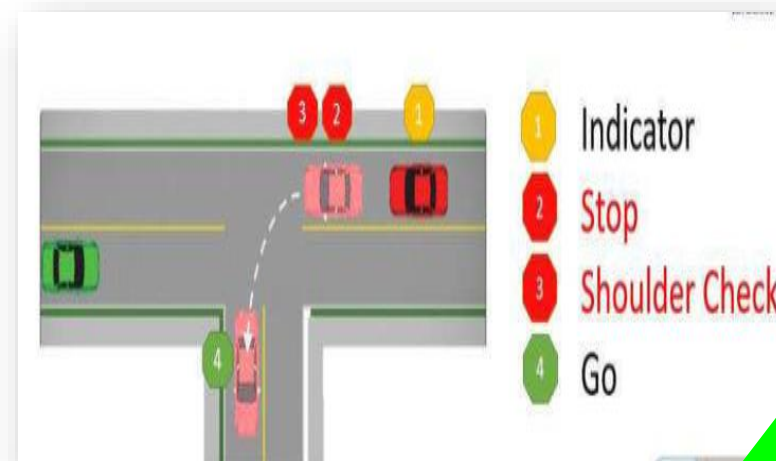
A crane while taking a left turn at Marmul PDO T-Junction came in contact with an oncoming tipper which was coming from DWD station road. Rigger of the crane sustained injury to his right leg and both the vehicles moderately damaged. Fire and rescue services were initiated, and injured person medically evacuated to PDO Clinic and subsequently to SQH Salalah for further medical management

- Always reduce speed while approaching road intersections
- Always wait for traffic at straight lane to clear before crossing the road
- Always make intention clear before commence turning by switching on indicators.
- Always follow defensive driving techniques while on road.

Always wait for traffic at straight lane to clear before crossing the lane

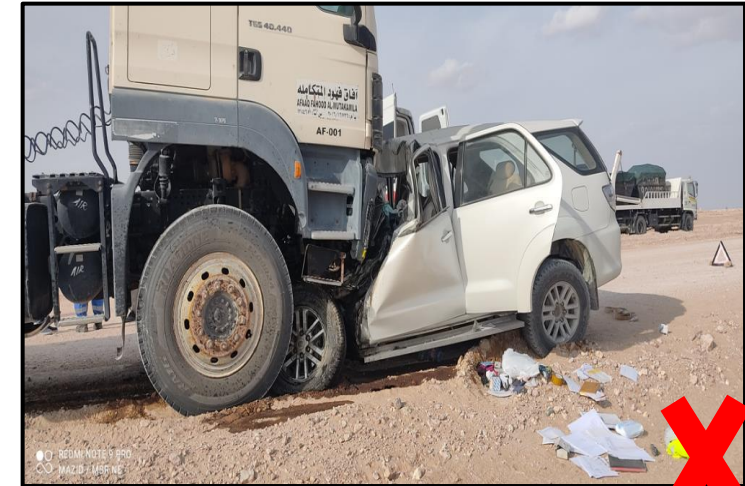
While driving on Mabrouk-Saih Rawl graded road the vehicle was overtaking on a dust cloud and had a head on collision with the water tanker which was travelling from Mabrouk to Saih Rawl that resulted in a fatal injury to the driver and multiple fractures to the co-passenger.

- Ensure to use approved transportation for commuting
- Comply with speed limit and follow defensive driving techniques
- Follow company process when visiting the site
- Ensure that all the drivers have undergone DD training
- Ensure that the visits of coastal based employees of subcontractors are with due approvals
- Ensure that the visitors use only approved vehicles after the designated hubs in PDO concession areas
- Ensure access control in the camp and site
- Ensure immediate escalation to Senior management for any unauthorized unplanned visits observed

Do not overtake in dust cloud

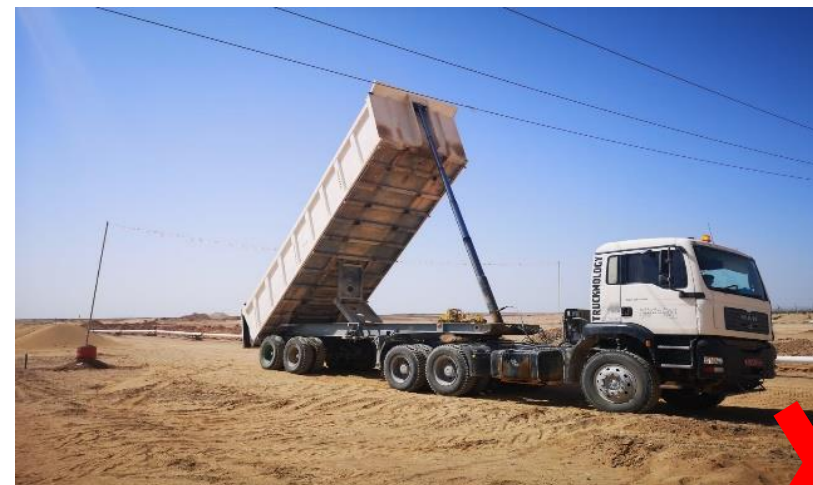
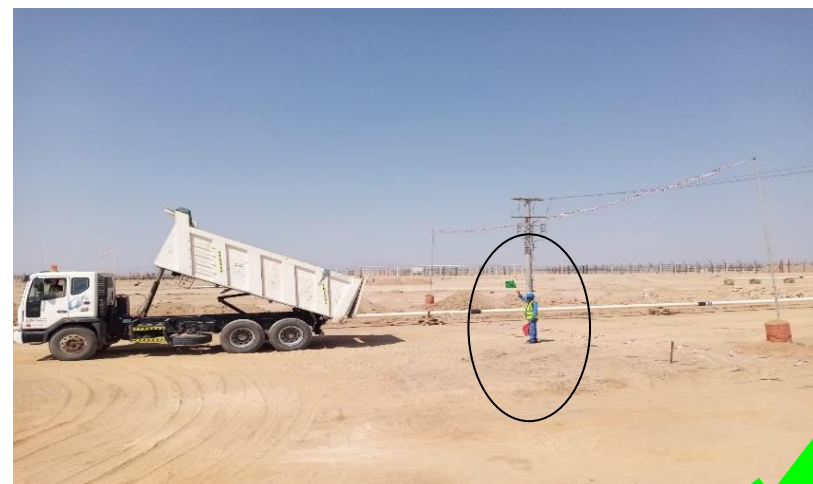
At approximately 17:30 on the 21st of August , a subcontractor tipper while performing a sand dumping activity in Kawthar near RMS 2 station, drove under an isolated Overhead line, While lifting the tipper bed to dump the carried sand, the tip of the tipper came into contact with the line causing damage to the isolated line

- A validated PTW must be available for the activity, a site-specific toolbox carried out by cascading all hazards and control measures
- Always ensure availability of Banksman with vehicles while loading/unloading and reversing activity.
- Always maintain safe horizontal and vertical working distance and provide safety barriers for work in the vicinity of OHL.

Ensure availability of Banksman with vehicles while loading/unloading

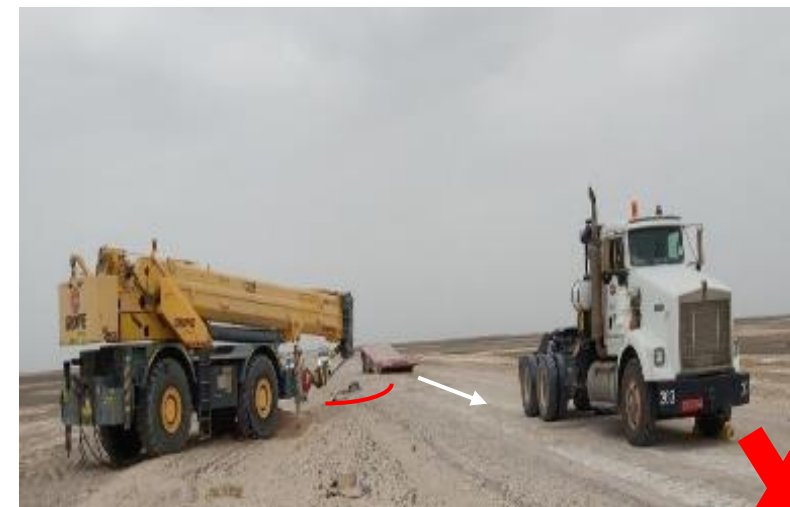
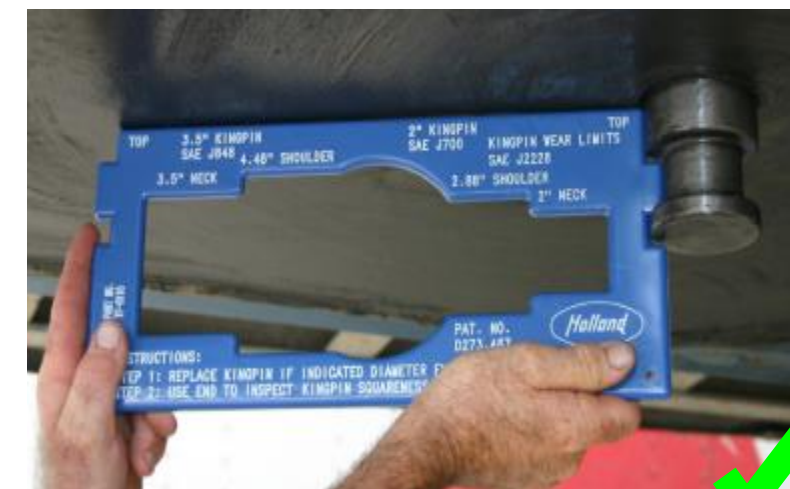
On the 16th September 2021 at approx. 10:15 an OFSAT prime mover and lowbed trailer were transporting an 80t capacity (rough terrain) crane to the old location of Rig 64 which was located in Burhan. When they were approx. 1 km from the old location, the driver and his passenger (crane operator) felt a sudden jerk, unusual noise and the front of the prime mover raised up slightly. After they had stopped, both occupants exited the vehicle to find that the lowbed trailer had disconnected from the prime mover, had fallen to the ground and the restraining chains holding the crane had snapped which allowed the crane to roll forward and off the trailer onto the side of the road

- Always ensure kingpins are inspected and certified.
- Always ensure to reduce speed if the road condition produces excessive vibrations.
- Always report poor road conditions or any other hazards.
- Always ensure restrain chains are inspected, in good condition and installed properly.

Ensure restrain chains are inspected

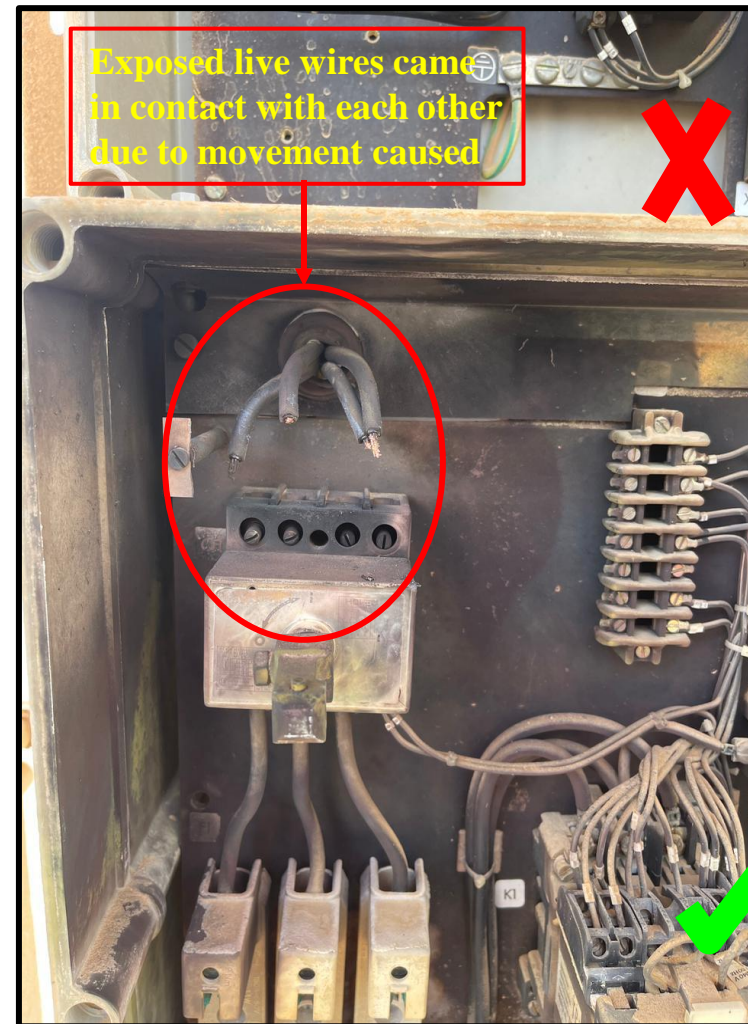
On 10.08.2021, at around 11:05am, while attempting to loosen the base plate inside 415 V feeder for demolition of redundant equipment at Runib Station, a flash occurred from the live, incoming area on top of the feeder, and as its consequence, the Electrician suffered burns on his right hand.

- Do not work on / open live installations without proper authority.
- Use insulated gloves for working on or near live equipment.
- Do not be complacent; discuss the concerns with the Supervisor for a safe solution when faced with challenges.
- Never assume; ask, when in doubt.

Electricity kills; be sure and do not assume.

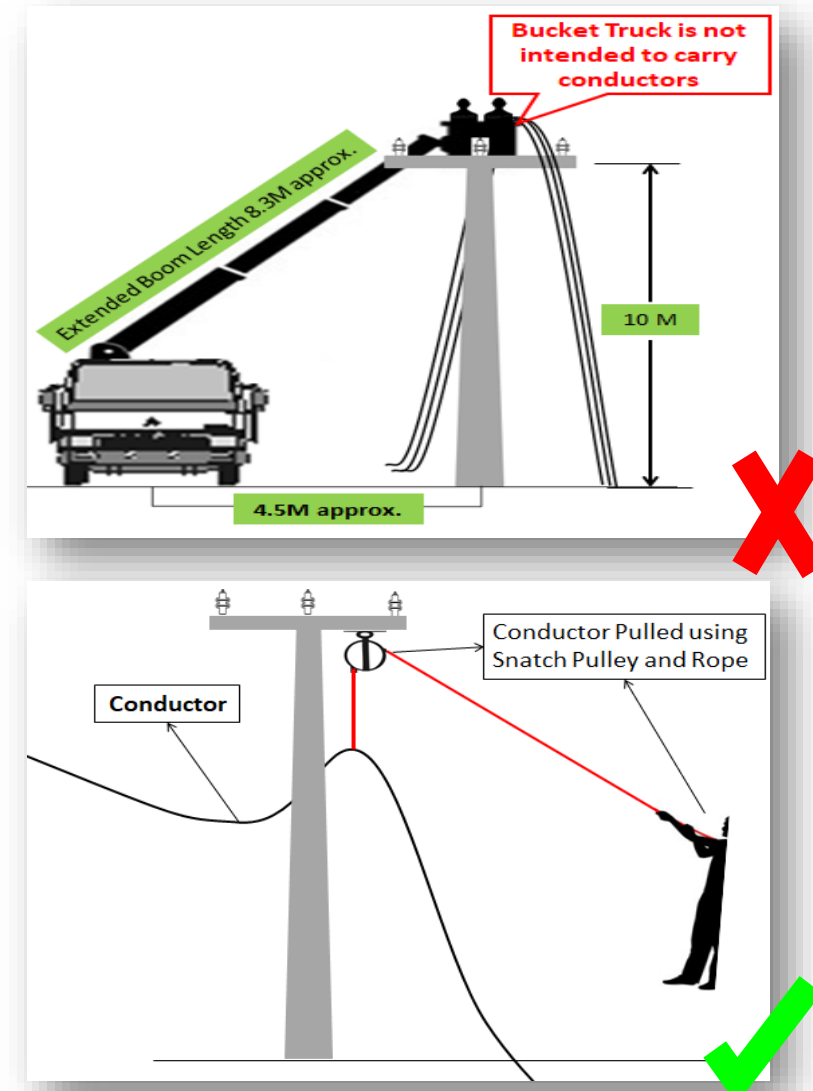
On 07.07.2021 at 11:20 Hrs. Stringing team were engaged in stringing Over-Head line at Rabaa-34 location involving the use of bucket truck. Two linemen were working inside the Bucket Truck which is also loaded with three 33 KV OHL conductors & conductor rollers for installation on the pole's cross arm. While the linemen are in the process of placing the conductors on the cross arm, the Bucket Truck lost its stability and tilted to the ground along with the linemen inside the bucket. The incident resulted in injuries to both linemen, with one of them had a fracture to his right elbow and the other sustained hairline fracture of pelvis. Both the Injured persons were initially treated at Qarn Alam PAC clinic before been transferred to Bader Al Sama, Nizwa for further Treatment.

- Always ensure work procedure is followed.
- Always ensure ground stability before use of any lifting equipment.
- Always ensure not to exceed the Safe Working Load of equipment.
- Always ensure equipment is used for intended purpose only.
- Ensure to conduct pre use inspection of equipment.
- Ensure equipment must comply with PDO and OEM specification.
- Ensure only Competent Operator are operating any equipment and machineries.

Always ensure stability and working below the SWL of equipment

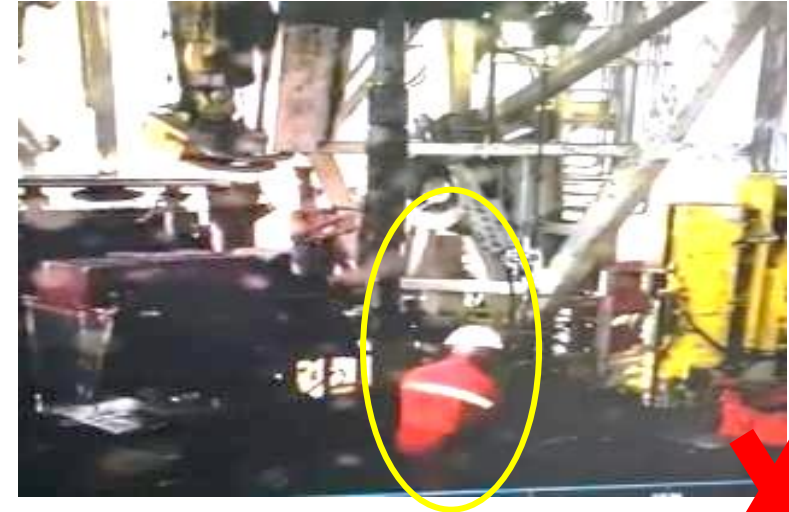
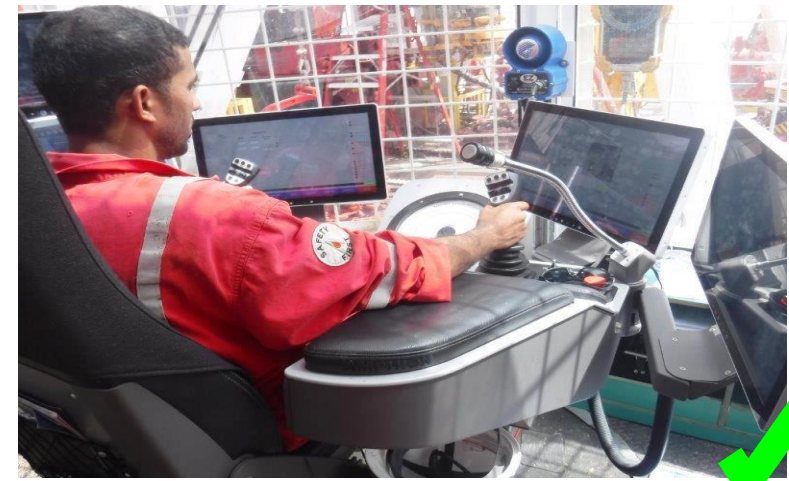
On 29th July 2021 at 17:10 hours, after TCP perforation and reverse circulation, the crew work to disconnect assembly of two crossover, safety valve and lifting-sub. Assistant driller open the elevator unintentionally while floor man used chain tong to unscrew the assembly at EUE connection causing the assembly to fall down on rig floor towards v-door direction. No injury and no equipment damage resulted from this incident.

- Driller/AD should always focus on indicator panel to ensure equipment is in correct condition
- Ensure JSA is updated to include all job steps and hazards
- Ensure elevator is in correct operating position before caring out any task
- Always ensure to have a proper planning for the task and is understood by all involved.
- While rotating any equipment with chain tong crew, should be vigilant of overhead hazards.
- Always ensure to maintain red zone

Intervene and ask to raise MoC when deviating from procedure

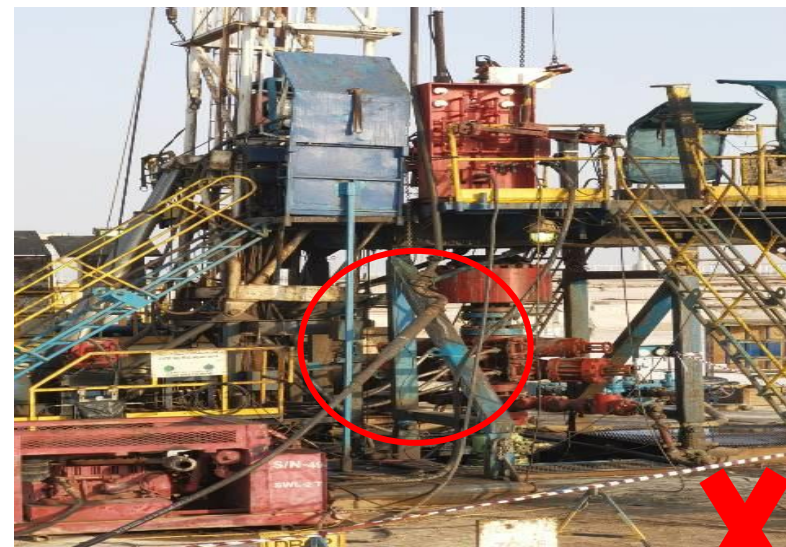
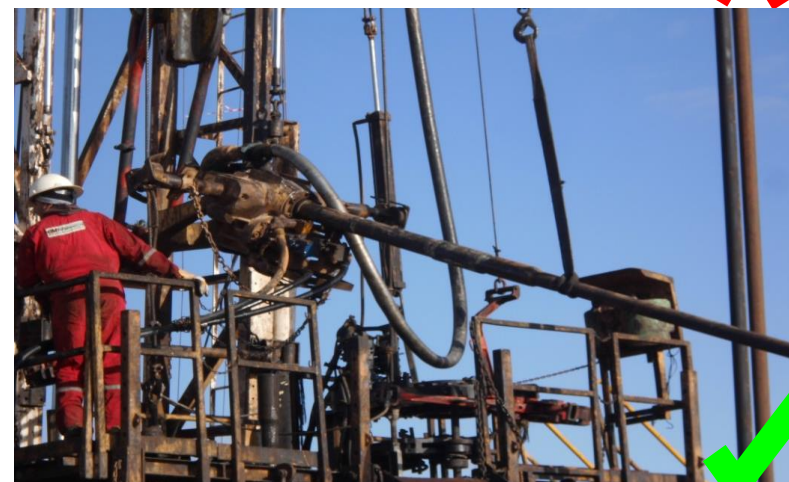
RIH a gas lift completion on 2.3/8" NU tubing was in progress until a hold up observed on top of 4.5" liner, tried with working on the string but no success to pass obstruction. It was decided to connect a standpipe hose and try passing an obstruction by washing down. Operation is carried out by using of 2 3/8" completion Tubing + X/O + FOSV + Circulation head, the makeup done in the V-door due to the high stick up of the string once held up. After stopping of wash down the Tubing was B/O in order to be laid down and it immediately started tilting upside down due to the weight above the Elevator was bigger than the weight of the Tubing below the Elevator. The hanging assembly flipped 180 degrees and the Tubing slid down thru the Elevator dropping near the driller room and on the ground.

- Always ensure relevant SOP is followed, otherwise manage process thru MOC with proper risk assessment done
- Always ensure AD not to be left acting alone on the brake in any non routine operations must be supervised by RM and carried out by the Driller
- Always ensure to utilize Power swivel regardless of string rotation is required or not (otherwise initiate an MOC)
- Always ensure positive Handover happen on the Site location .

Utilize Power swivel for washing down operation

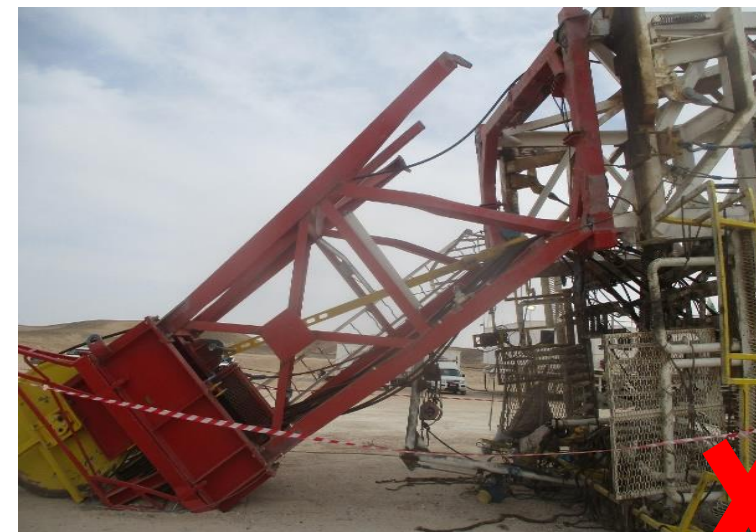
On 21st August 2021, at 17:30 hours, the off-driller side MRC failed at 20 degrees from vertical while lowering the mast. The failure of the off drillers side MRC caused the driller's side MRC to overload and sheared at the top of the fourth stage.

OBSERVATIONS						
SN	Item/Part	Height	Remark	Depth	Remarks	Fig No.
1	Cylinder barrel	1"	SP	1"	Scoring lines observed inside the barrel	2-3
2	Gland	1"	SP	1"	Scoring lines observed on inner ID	4
3	4 th stage rod	1"	SP	1"	Pit marks observed on the outer surface & scoring lines found on inner surface	5-6
4	3 rd stage rod	1"	SP	1"	Piston end rusted and pit marks observed on the outer surface & scoring lines found on inner surface	7-9-10
5	2 nd stage rod	1"	SP	1"	Pit marks observed on the outer surface & scoring lines found on inner surface	11-12
6	1 st stage rod	1"	SP	1"	Pit marks observed on the outer surface	13-14
7	Gland nut for 2 nd stage rod	1"	1"	SP	Threads found worn out	15
8	Gland nut for 1 st stage rod	1"	1"	SP	Wear out observed	16
9	Gland guide bush (2 Nos)	1"	1"	SP	Found deformed	17
10	Seal kit	1"	1"	SP	Worn out	18
11	Piston ring for 1 st stage piston	1"	1"	SP	Worn out	19-20
12	Weld joints	SP	1"	1"	MPI done on weld joints	21-22-23-24

- Ensure to approach the OEM to provide proper inspection procedures for the appropriate NDT method to verify the integrity of the chrome-plated components.
- Ensure that UT or X-ray is used to inspect chrome-plated components for cracks.

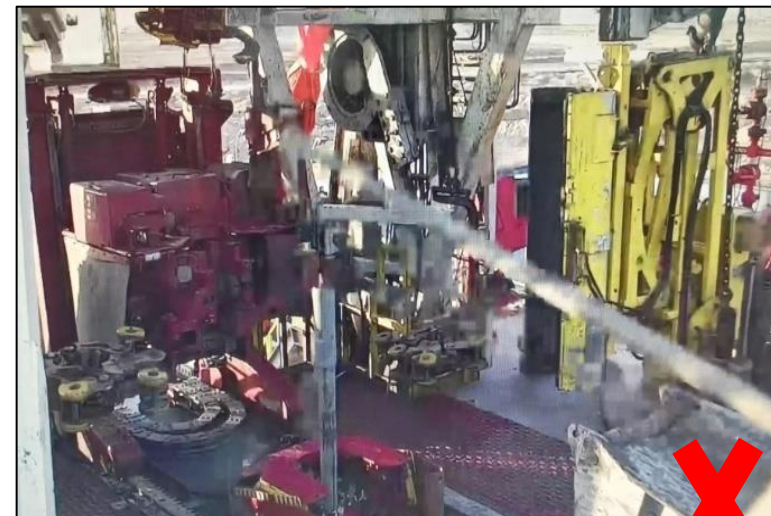
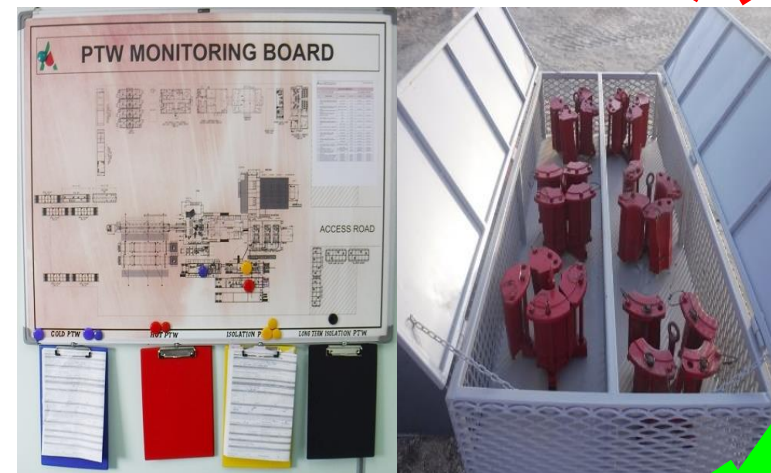
At 18:01 hours, during RIH 4" Drill pipe by lifting stands from the v-door, Elevator was latched on the drill pipe stand. While lifting drill pipe stand, it slipped through elevator and fell down on pipe cat trough from height of approximately 10 meters. The stand hit tool joint of the pipe and trough on its way down and finally rested between pipe cat trough and V-door guardrail. Immediately stopped the operation, secured the area and prepared recovery plan. No injuries and damages observed. Red zone was well managed.

- Always store elevator segment in dedicated area under lock.
- Ensure to use PTW when you have to change BX elevator segment
- Ensure Red Zone and No-go Zone is always managed

Do not change segment size without raising PTW

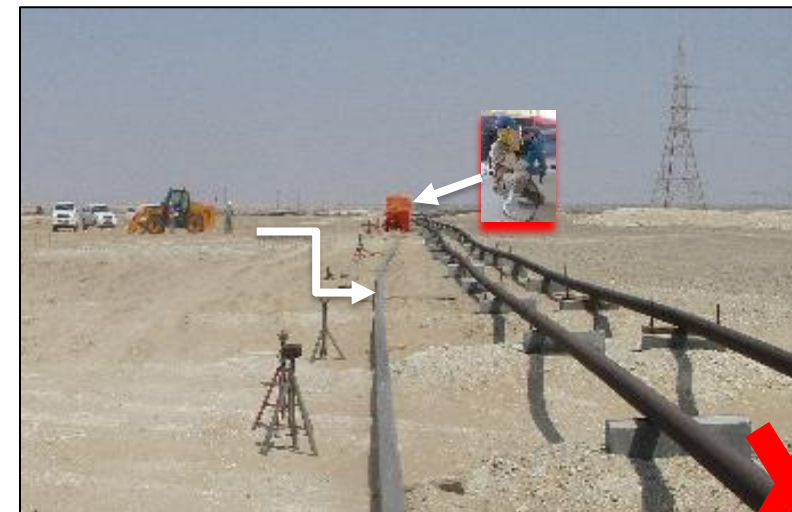
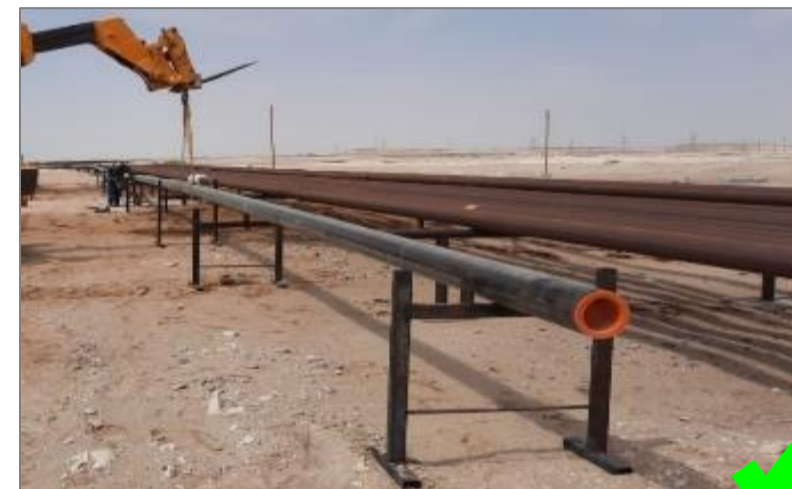
On 08-08-2021 around 8:50 Hrs, A mechanical crew were shifting the pipes on the wooden skids after completion of welding. After complete shifting of one portion they moved another. While shifting it on the wooden skid, tripod jack got unbalanced and started to fall one by one. Pipe hit left side of the hip of fitter who was doing buffing activity inside welding booth. Resulted fracture injury on his LT pelvis.

- Always adhere with procedures and method statements.
- Always ensure to use H Beam support while performing welding activity.
- Always ensure the lifting area is free and barricaded.
- Always ensure proper communication between team members.
- Always ensure not to keep the pipes on jacks for long length.

Don't do shortcuts, comply with procedures

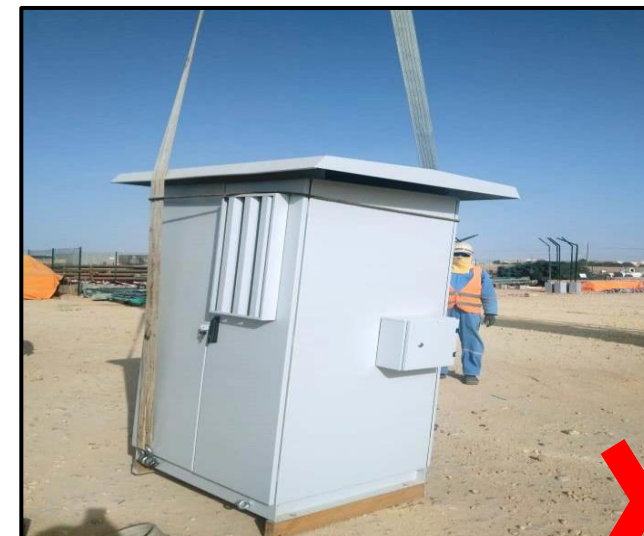
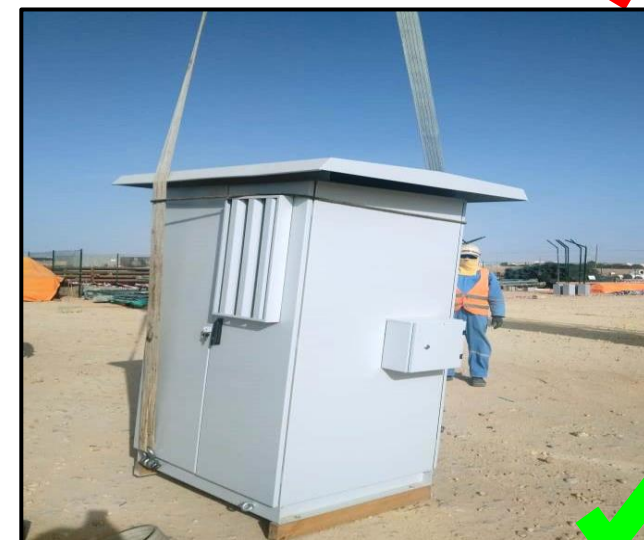
An Electrician suffered injury while engaged in VFD (Variable Frequency Drive) panel replacement activity at MM-576 location as the lifted VFD panel toppled over him.

- Always refer to manufacturer instructions and follow the correct lifting procedure for safe lifting.
- Do not allow personnel within the lift radius and close to lifted load.
- Any work such as skid removal should be carried out on firm surface.
- Do not resort to short cuts; ask when in doubt.
- Use your empowerment to stop unsafe work.

Ensure to obtain lifting plan for all lifting activities
