## SEVERE INJURY WITH HAND AMPUTATION AND SKULL FRACTURE

Lost Time Injury

March, 14<sup>th</sup> 2003

Offshore construction

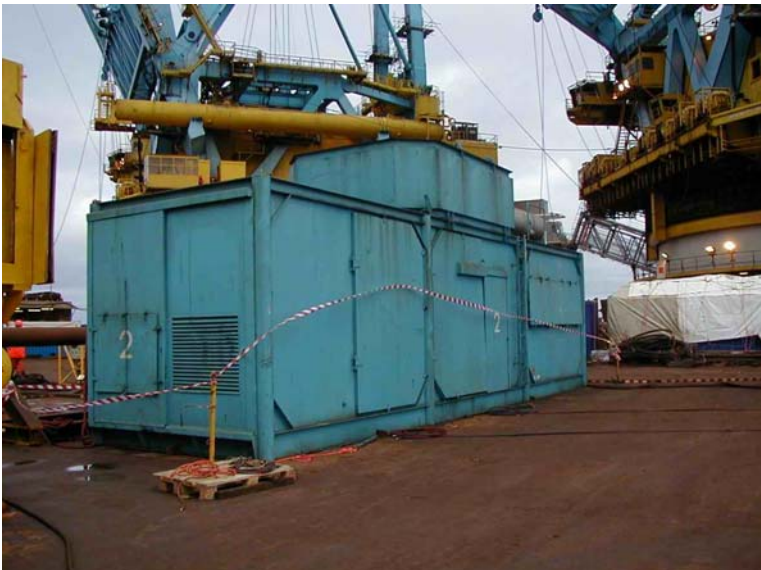
The "Pacco Astra" is a large container (12m x 3m) weighting 40.000 kg containing a Detroit Diesel V16 generating set, a compressor, welding sets and two electrode ovens. It is normally lifted onto platform jackets and used for providing independent power for welding operations. In this incident it has been decided to use the Astra to provide power for testing the some winches rather than having unnecessary lengths of 440v cables running on the deck from the crane tubes, which are the normal source of deck power.

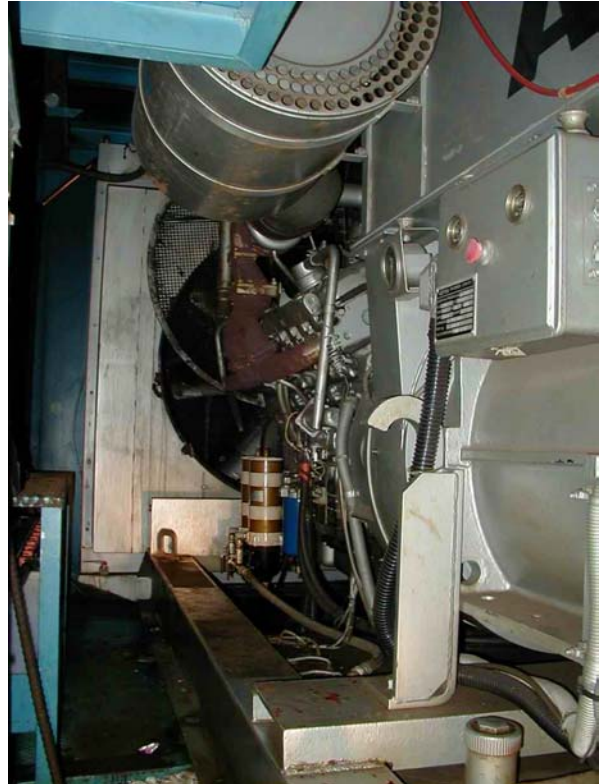
The Motorman – injured person, first adjusted the engine revolution using the remote and then he and the Mechanical Assistant went on the left side of the generator to check the fuel filters (the filter bowls, as in similar previous occasions, had shown evidence of water contamination).

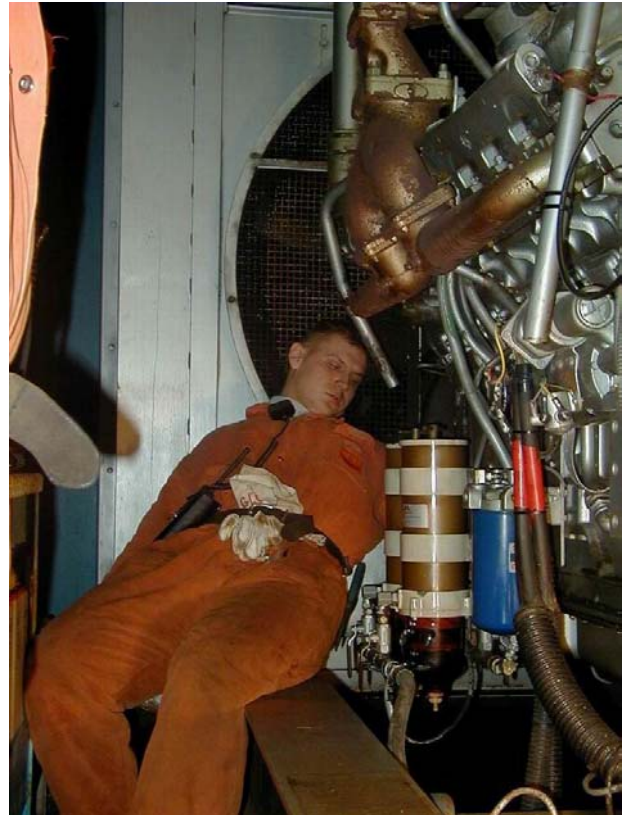
He recalls hearing some strange noises from the container and went back inside. He saw the Injured person in a sitting position on the engine frame with his back against the radiator mesh, he appeared to be looking under the engine.

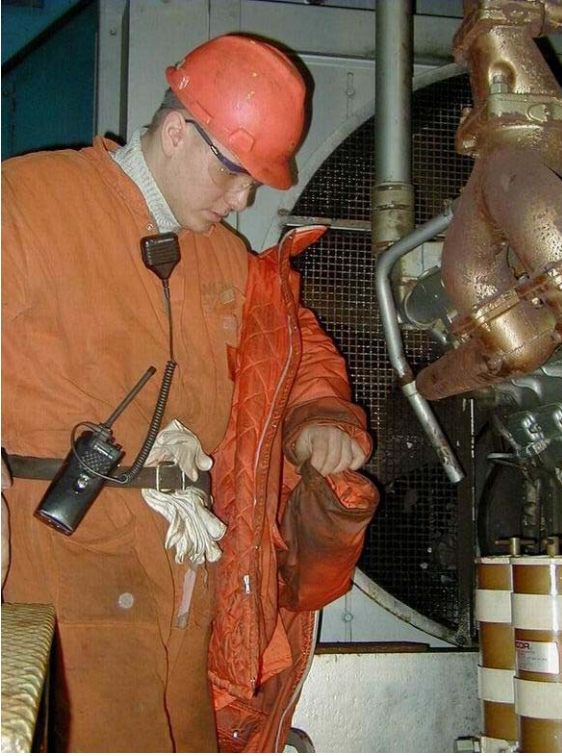
The investigation revealed that in preparation for the filter change, the injured person had partially removed his jacket, releasing his right arm first.

The suction created by the fan pulling in air from outside the container, physically pulled the free part of the jacket and the Injured Person's left hand, which was still inside the jacket sleeve, into the unguarded balance wheel pulley assembly.

One of the main causes of the accident can be considered to be the improper guarding of the pulleys and belt used to transfer the rotating motion to the ventilation/cooling system.

The fan blades are properly guarded while the pulley was not.

- Install protective devices to the rotating parts on the generator and engine, in particular close to the ventilation-cooling system
- Install protective devices for the hot surfaces (i.e. exhaust manifold) of the engine which may come into contact with operators
- Remove the batteries package and place it in less congested area
- Install safety signs at the entrance of the containers, such as “Authorised Person only”, “Hearing Protection required”, the normal PPE requirements
- Ensure the emergency stop is immediately accessible to a stand-by person supporting the inspection operation (see next section - Procedural).

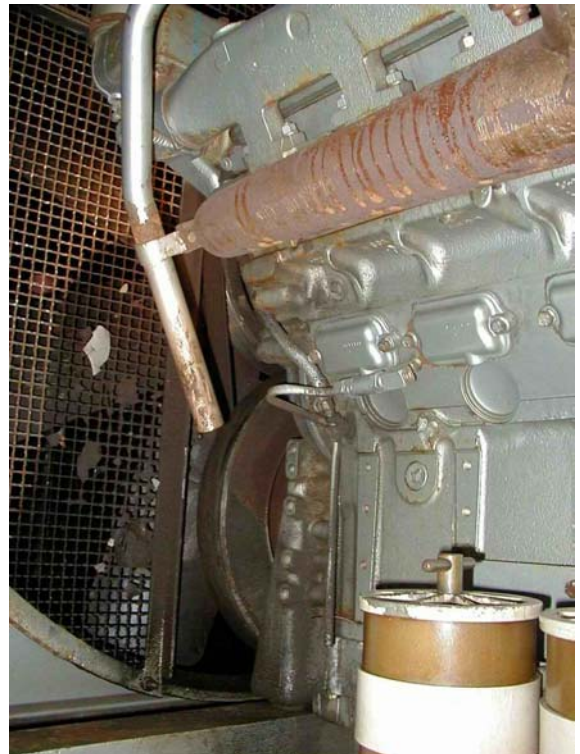
The Motorman – injured person has suffered a traumatic amputation of his left arm below the elbow and a fractured skull as a result of the contact of his head with the cylinder block or exhaust manifold.
