SAFETY FEEDBACK NOTICE 8-2003

RIG FATALITY

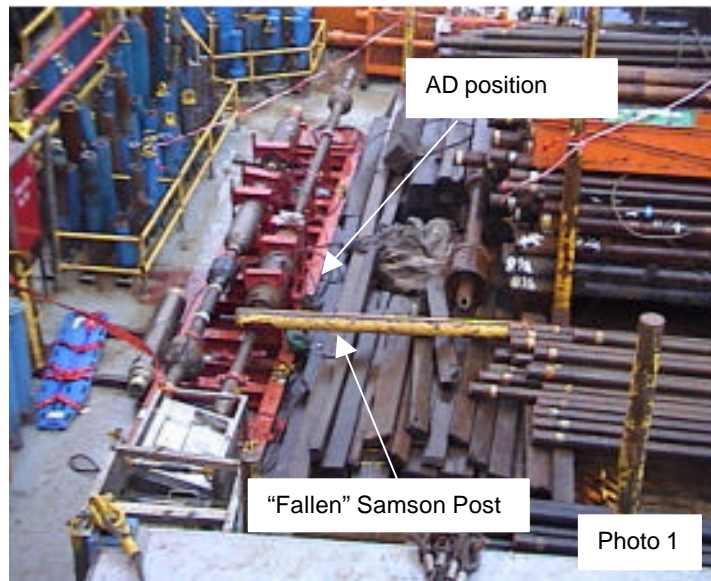
The accident happened at 00.25hrs. The Assistant Driller (AD) had gone to the main pipe deck by himself to look for some slings. Then a roustabout heard a shout and saw the AD lying on a subsea transportation skid. The AD was found to be conscious but with severe head injuries. Alongside him was a "Samson Post" which had fallen from its vertical position. (see photo 1).

1. A "Samson Post" (SP) is a vertical post which prevents the side movement of horizontally stored tubulars on the pipe-rack (see photo 1). In this case the SP was 9'11" long – 7" diameter, 1/2 wall thickness and weighed 320 lbs.

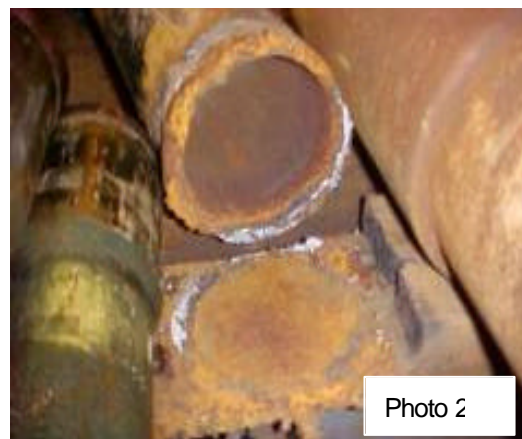
It was found that there had been a failure of the circumferential weld at the base of the Samson Post. (see photo #2). Subsequent investigation identified that the circumferential weld (filet) was of sub-standard quality and that 75% of the weld showed signs of corrosion.

- Records onboard the rig showed that the weld in question had been repaired only 3 weeks before the accident. It seems as if crowding of the deck with equipment had led to the welder having restricted access and thus a poor quality repair was made. No check was made of the repair.

- Only 18 hours before the accident, it was reported that there was a crack in the samson post weld and the Shift Hand-Over Report recorded that “*Samson Post...has weld broken.*” This dangerous situation was not recorded in any type of “STOP” card. No corrective action was being followed up until close out. During these 18 hours there is conflicting verbal evidence whether people were instructed to correct the situation or not. But what is clear is that nothing was done and there was a failure of communications on board.

- The SP was not an original one and has been added during the rig’s life. The design of it’s connection to the deck was not appropriate and the weld repair performed 3 weeks before was not properly done and not inspected.

- Although on this occasion the crack in the SP weld had been identified, SP’s were not included on the rig’s maintenance schedule for inspection. SP’s in their normal day-to-day role get significant and repeated shock impact side-loading. This was particularly true on this rig where the crane drivers views were often restricted and he used the SP’s as “bumper bars” when maneuvering loads.

- Passing this SFN to each of its drilling contractors and agreeing on a specific set of actions.
 - Review whether Samson Posts be simply circumferentially welded or if there should be strengthening / stiffening plates.

- Review whether Samson Posts should be in the regular inspection program of the rig. If not ask to drilling contractor to include all Samson Posts in the inspection program of the rig.

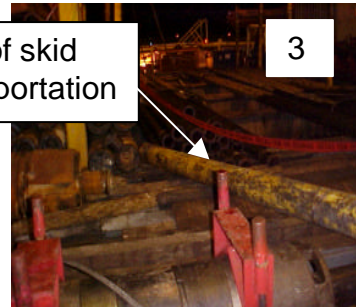
Bolt of skid transportation

2. The AD hit his head on the protruding nuts from the Subsea Transportation Skid (see photo 3). (Halliburton have subsequently issued a worldwide Flash Report about the design of such skids and the need to modify the “protruding” bolt design).

- Passing this SFN to each of its services contractors and agreeing a specific set of actions regarding transportation skids in order to avoid all sharp pieces of equipment

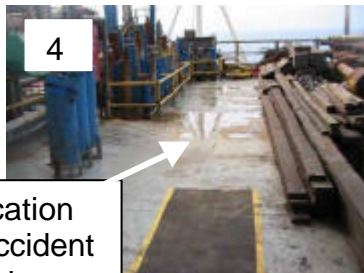
Skid location when accident occurred

3. The Subsea Transportation Skid had been stored on a walkway. (see photo 4).

- Maintaining a high level of housekeeping and deck management on site with formal internal inspections.
- Ensuring that a type of "STOP" card system (or some other form of unsafe act and situation reporting) is in place on site to ensure that all unsafe situations are formally captured and that corrective actions can be followed up until close out.
