## BP HSSE Communication Incident Investigation Update

**Incident:** MIA – Operator Fatal Fall  
**Business Unit:** Whiting Business Unit  
**Location:** Lakefront Water Treatment Plant  
**Date of Incident:** January 1, 2004

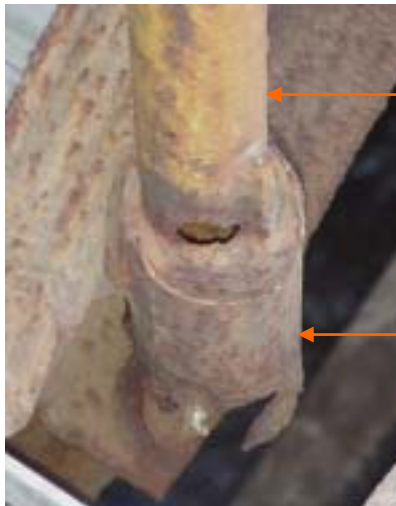
**Primary System Causes:** The 1947 vintage handrail design (where a support pipe is inserted into a larger sleeve) allowed a corrosion cell to develop which created undetected deterioration at the support legs.

Pipe  
Rail

Cup

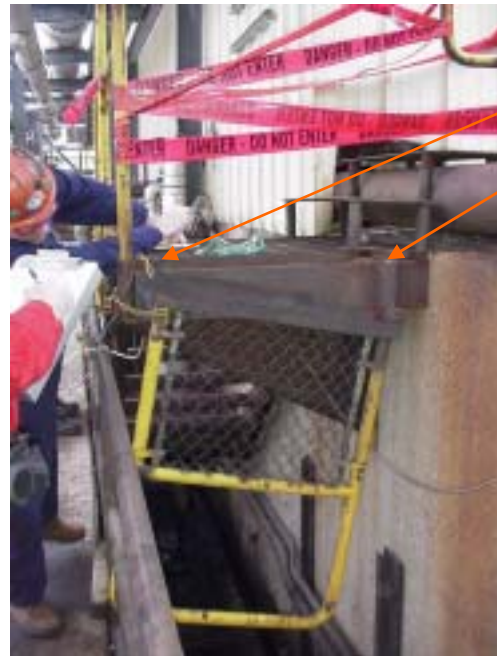
**What Went Wrong (Critical Factors):** Because of corroded support legs, a handrail failed when the operator required it for fall protection.

Failure  
Points

Inspection and testing is ongoing for all "rail & cup" handrail design components (where a support pipe is inserted into a larger sleeve) at the Lakefront.

All such handrails identified as needing repair have been removed from service and will be replaced with an appropriate design before use.
