Lessons Learned Report – ACG_/04

DAFWC- Plate Clamp Incident

Business Unit: AzBU, ACG Project, Delivery Team

Location of Incident: ATA Fabrication Yard, Baku
Structural fabrication shop

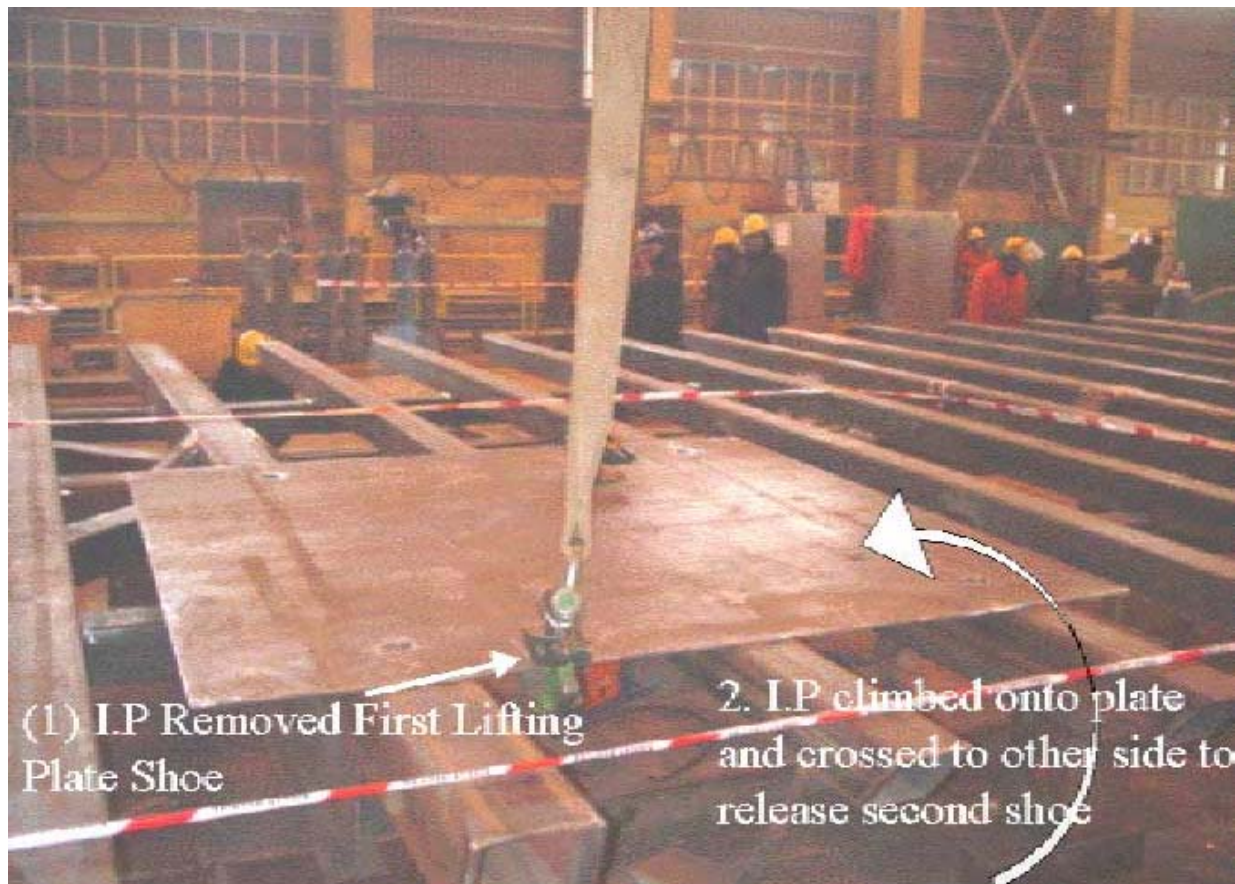
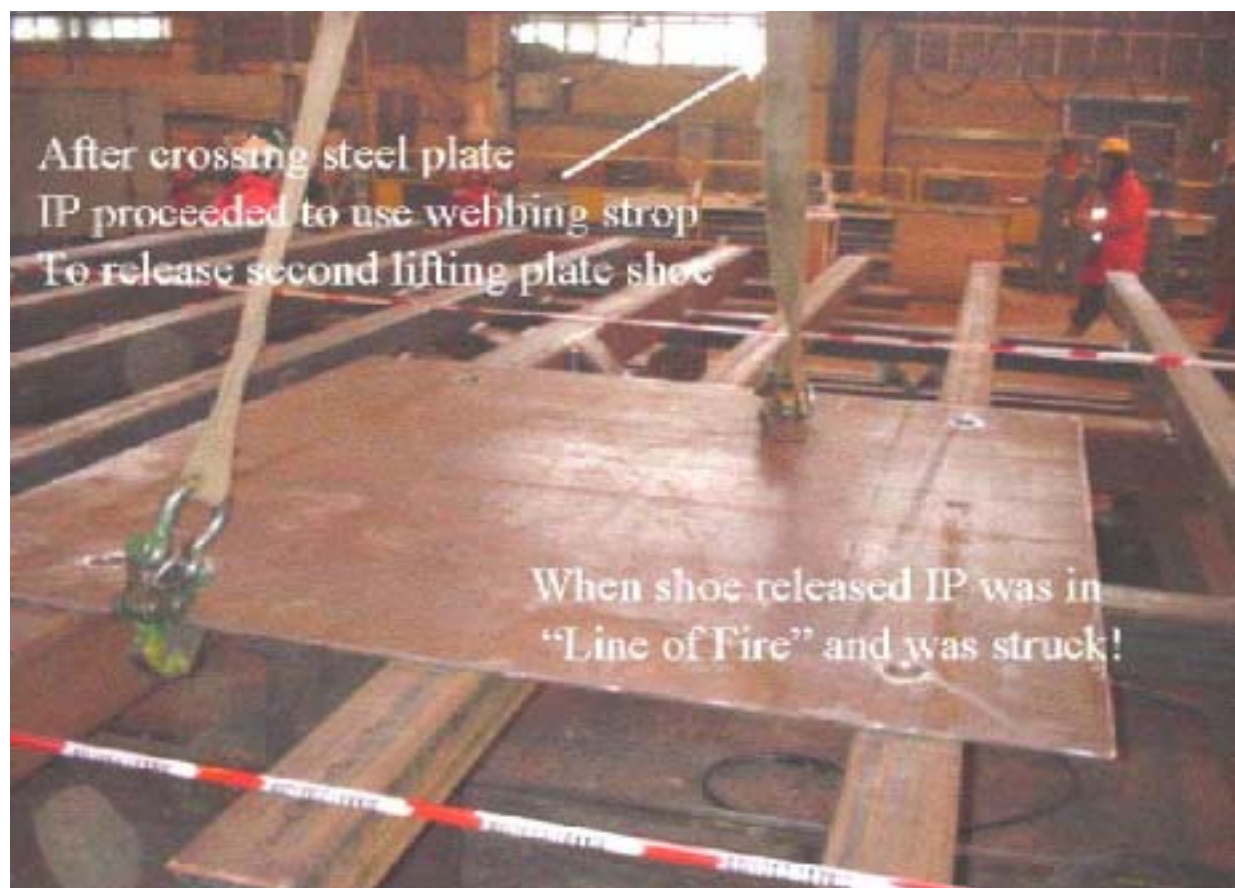
Brief Account of Incident: The activity in progress was the completion of a routine lifting activity that involved moving a steel deck plate with the fabrication shop overhead crane. The plate was positioned on the top of a prefabricated frame that was at waist height. The rigger proceeded to release one the lifting plate shoes, he then climbed onto the frame and crossed the deck plate to remove the second lifting plate shoe, on attempting the release of the second lifting plate shoe using the lifting webbing strop for leverage, the shoe came detached and struck the rigger on the side of the head.

Losses: DAFWC - The incident resulted in a fracture of the skull in the area of the right eye socket, an open wound and soft tissue damage to the right cheek.

- The deck plate was positioned on a prefabricated frame that introduced restricted access for de-rigging the lifting accessories.
- The rigger climbed on the prefabricated frame and crossed the deck plate to release the lifting plate shoe putting himself in the "Line of Fire".
- The method used to release the second Lifting Plate Shoe was unsuitable and did not follow good rigging practice.

- **1.10 Shortcut:** The rigger used the webbing sling connected to the lifting plate shoe for removal, which introduced additional stored energy in the lifting arrangement. It is believed that this additional stored energy was released when the lifting shoe came free and increased the speed of impact and level of injury.

- Communicate incident critical factors and learning to all rigging and lifting workforce.
- Undertake periodic workplace assessments to review working practices to determine if trends exist
- Review workshop to minimise congestion and improve layout
- Include expectation for rigging teams to walk route prior to routine lifting activities taking place in task risk assessments and check list of considerations
- Communicate investigation findings with IP to support understanding of unsafe behaviour displayed.
- Management to focus on incident learning issues in weekly safety walks
- Produce lessons learning report and publish
- Develop and deliver "Line of Fire" campaign incorporating issue of "Stored Energy" risks
