To: KCA DEUTAG Drilling, Land Operations
Cc: KCA DEUTAG Ltd., Director Techn. Support Services for information
From: HSE Department, QS

TOPIC: Fatality due to dropped sliding door

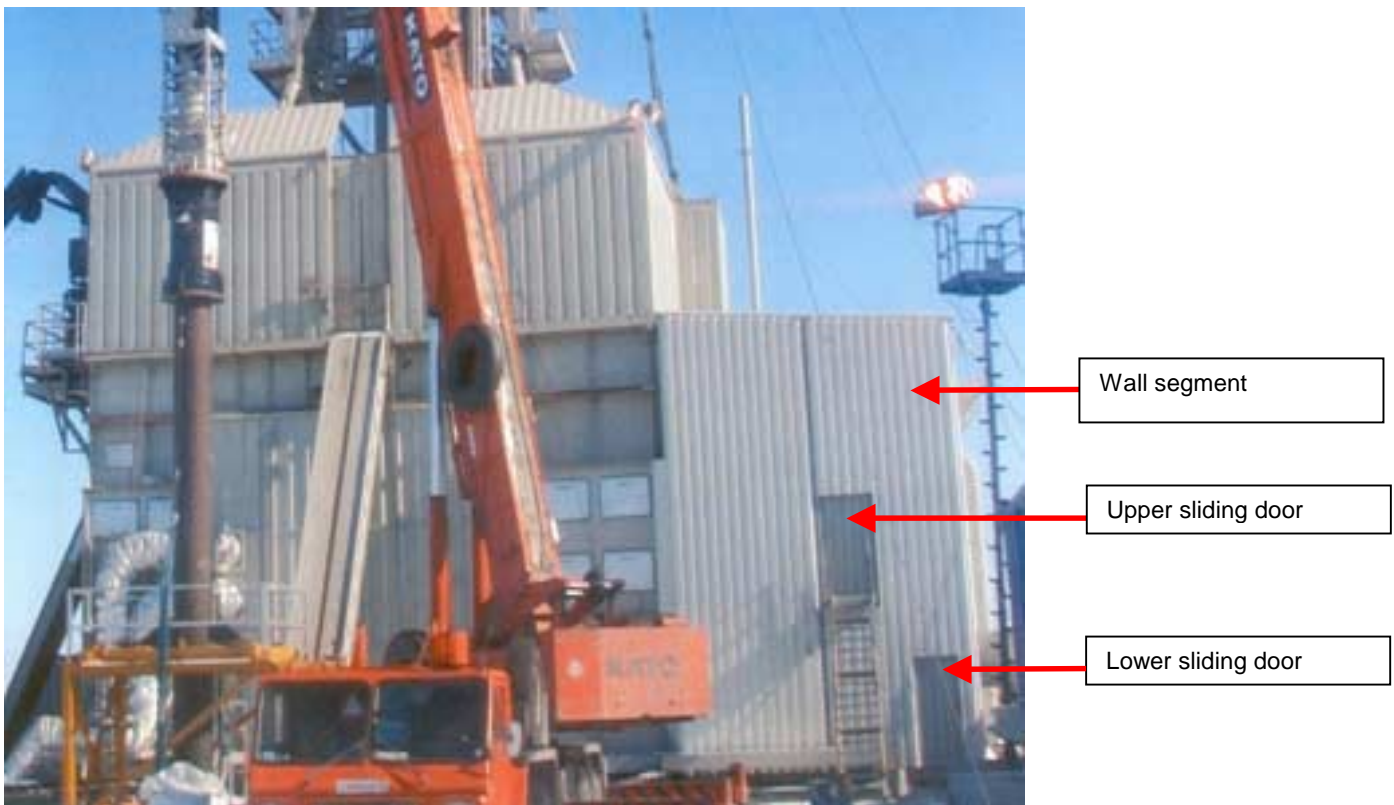
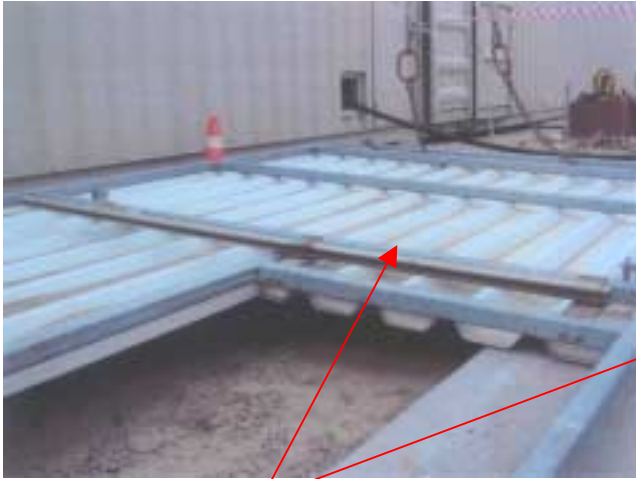
On one of our rigs a fatality occurred. During winterisation of the rig the shaker house had to be installed. The first wall segment was lifted by crane in a upright position. Shortly after having parked the wall segment, the upper sliding door (weight 95 kg) moved and dropped out of the rail, fell down from a height of 3,15m and hit the rigger in the neck before it finally dropped on the ground and covered the victim's body. Due to the heavy impact, the victim died shortly later, although the rig doctor tried to resuscitate for more than one hour.

The sliding door was not secured and the rail had no stoppers at the end.

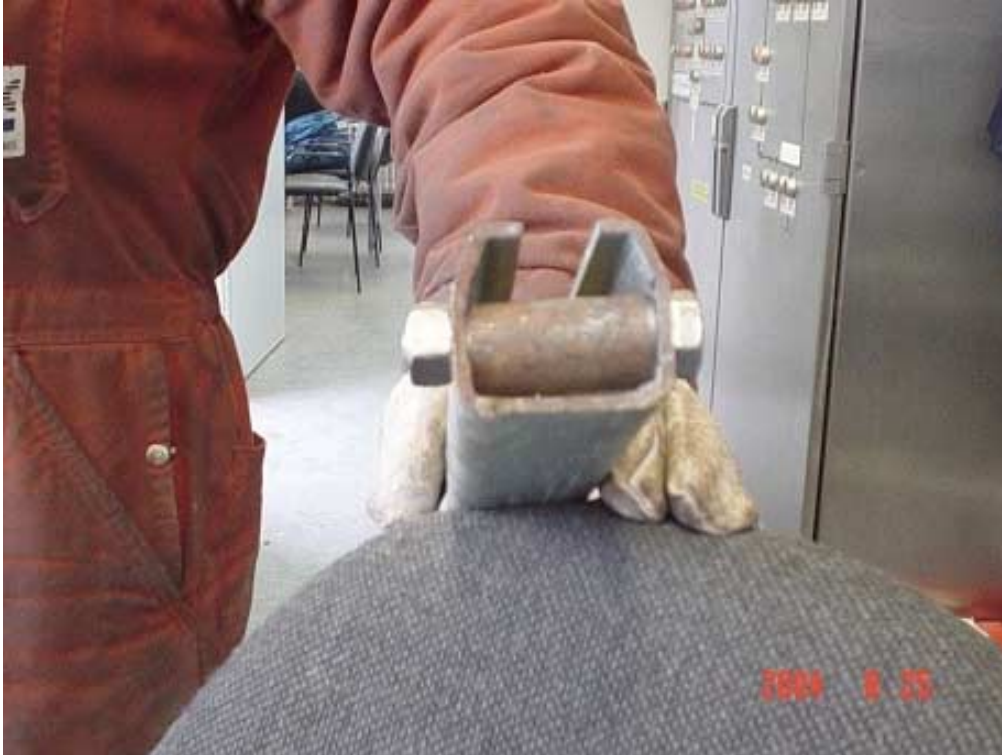
End stopper in the sliding door rail as modified at T-2000

- All sliding doors have to be inspected immediately of the existence of proper end stoppers in the rails.
- All existing sliding door variations on KCA DEUTAG rigs have to be reviewed for the existence of a proper stop and fixation systems. A solution for a stopper could be to drill a hole into the rail and install a bolt with a self-securing nut (see picture below).
