Natgas contractor employee killed during road traffic accident Significant Incident Briefing Note

On the road leading from Tala to Tanta, North Egypt

15-08-04, approximately 10:30 hrs

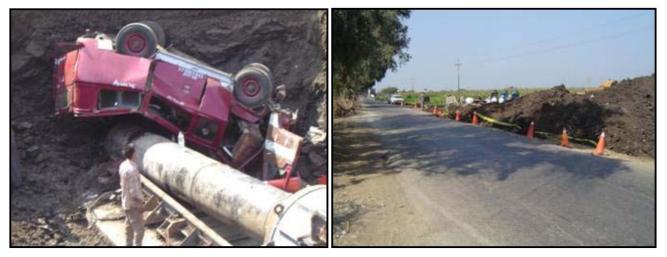
Photographs:

At the time of the incident the LDC contractor employees were working near the Tala-Tanta road, making an underground crossing to connect a natural gas pipeline to a nearby power plant. A third party micro-bus driving with a speed estimated to be over 100 km per hour, overtook another third party micro-bus, which was parked 100 – 150 m away, near the road crossing, to pick-up passengers. During the process of overtaking, a third micro-bus appeared in the path of the first micro-bus, in front of the vehicle he was overtaking. The driver of the first micro-bus applied the brakes. As a result the micro-bus skidded off the road and landed in the digging area, where he struck two contractor employees. Both casualties were taken to the nearby hospital. One of the contractors was pronounced dead on arrival.

Poor driving standards, resulting in speeding and reckless overtaking of an unlawfully parked micro-bus near the place of the groundwork.

- Ensure a one-way traffic flow near the working area.
- Ensure active supervision to prevent illegal parking along side of the road.
- Seek active engagement and cooperation with local authorities to grant approval for additional traffic control measures near the groundwork.
- Encourage approaching traffic to reduce speed by positioning flagging workers some distance from the working area
