SAFETY ALERT

Grinder Injury

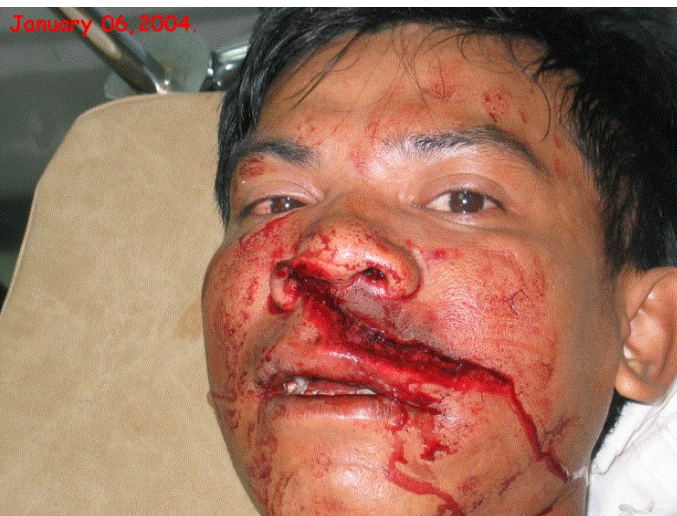
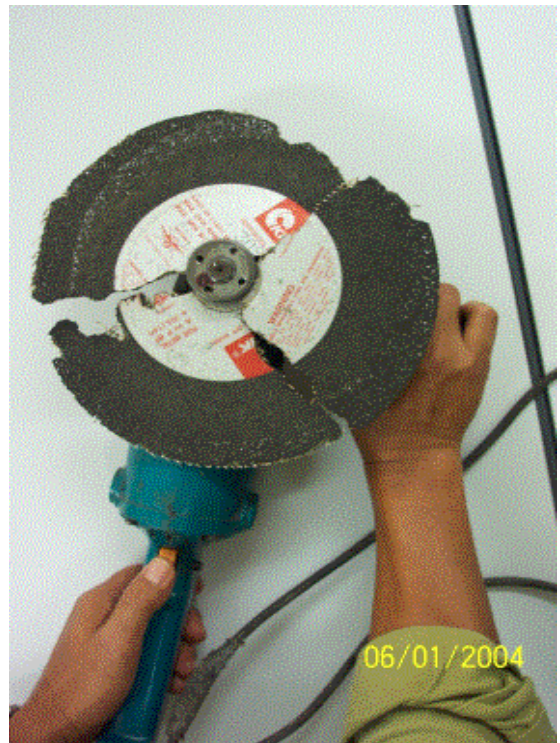
Offshore in Indonesia (non-BP site), a worker was cutting aluminium roof using a granite grinder, the grinder's wheel broke apart and hit his face causing serious injury between his upper lips and nose. After first aid treatment he was sent to Samarinda Hospital for further treatment. The doctor at Samarinda Hospital recommended he be hospitalised for about two weeks.

Based on manufacturer specification, Makita grinder model 9006B should use 6" grinding wheel, speed load 10,000 RPM.

9.5" grinding wheel was used instead of using 6" grinding wheel. This wheel was over sized and allowed only to be run at 3400 RPM.

Grinding wheel was running at 10,000 RPM (over rated speed) causing the wheel fly apart and hit the mechanic's face.

- Utilised improper tool.
- No grinder safety guard.
- Not using face shield for PPE.
- Mechanic has been warned but he ignored it.
