Contractor killed by discharge of gas from pressurised bottle

SPDC Nigeria

Kidney Island Pipe Yard, Port Harcourt

31-08-04 at approximately 09:30 Hrs

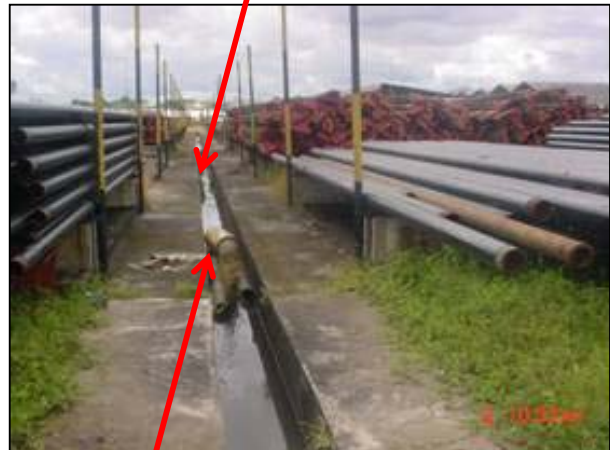
Original position of cylinder in Gutter before incident

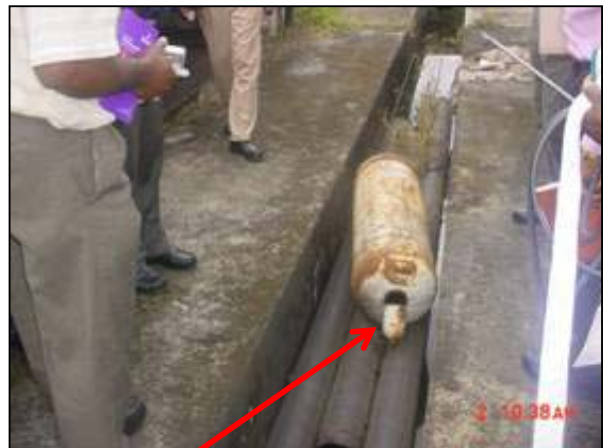
Position of Cylinder after incident

Fractured Cylinder neck
