Chirag drillfloor, 0015 hrs, 11/01/05 - dropped inspection plate from hammer

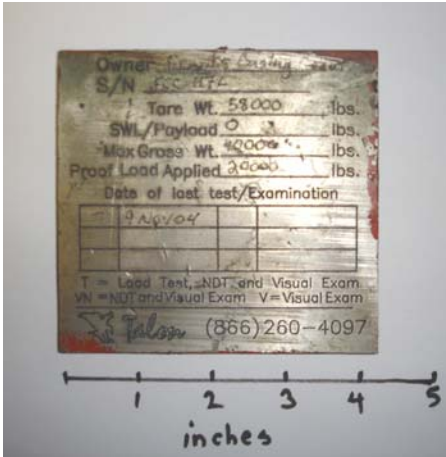
Fig 1. Inspection plate (front)

When preparing to lay down a joint of 26" conductor, an inspection plate (see fig 1) fell from Franks D100 hammer (see fig 2) to the drillfloor deck.

The plate fell ~3.5 m from the hammer to the drillfloor.

The inspection plate is 4 $\frac{1}{4}$ " x 4 $\frac{1}{4}$ " x $\frac{3}{8}$ " aluminium, weighing ~150 g & was held in position by adhesive.

Job resumed at 0030 hrs, 11/01/05. After laying out the conductor joint the hammer was inspected. No other potential dropped objects could be identified. The operation continued and the hammer was laid down as per programme.
