DROPS
DROPPED OBJECTS
PREVENTION SCHEME

SAFETY FLASH ALERT

Subject : Collision with Skid Deck Bunding results in Dropped Object (Southern Upper Staircase)

Platform/ Site : Chirag 1

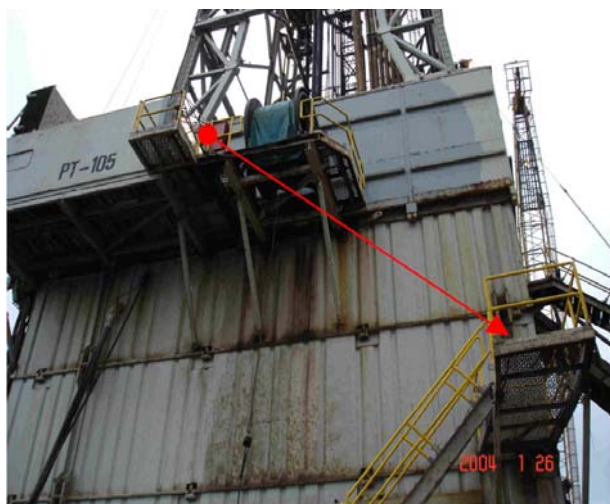
After completing the skid south the rig was skidded to the west. At 02:30, after skidding 1.75-metres to the west, the upper section of the stairway of the SOUTH stairs between the skid deck and the drill floor fell to the skid deck.

View of missing upper stairway

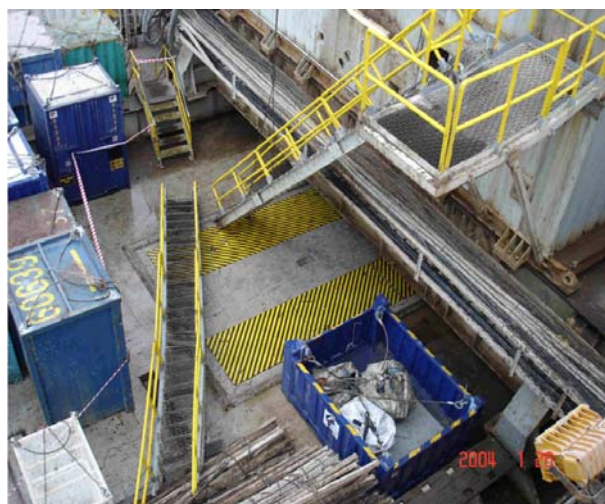
The foot of the upper staircase which was resting on the intermediate platform was bent away sufficiently from its normal position, to allow the foot of the upper staircase to swing free. During this swinging action it unhooked itself from the landing at the drill floor level and fell to the skid deck. It struck a handrail and made contact with cables and cable tray before coming to rest on the skid deck. By the final position of the staircase it appears the staircase also twisted round laterally by 180-degrees prior to landing.

Position of dropped stairs on south skid deck

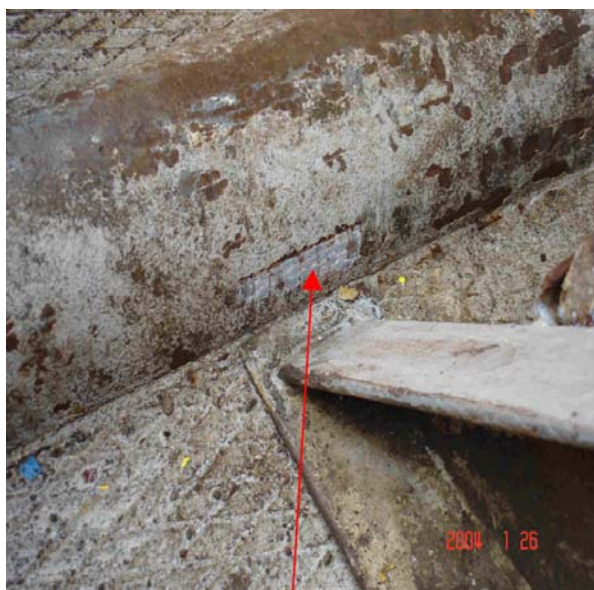
The lower section of the stairway had contacted the bund around the well bay hatches (bund height 5.75 inches). As the rig continued to skid the lower staircase remained stationary, this resulted in the top of the lower staircase unhooking itself partially from the intermediate platform until the safety sling prevented further movement. As the rig continued to skid force was applied to the intermediate platform via the safety sling, resulting in the platform being bent.

1. Failure to confirm adequate clearance between stair footing and bund during skidding to west.
2. Failure to fit safety slings to upper staircase (drops prevention).
3. Requirement to lift stairs to allow skidding operation

Point of contact on bund

5. In view of learning's from this incident it is recommended that a critical review of any "Drops" inspection / survey at present in use is carried out platform wide.
Consideration should be given to all potential collision areas during general crane and skidding operations or where there is a potential of equipment being dislodged

6. An overall engineering review of the rig's suitability for skidding operations including:
 - (1) Manual handling hazards around the handling of hoses cables and general equipment.

- (2) Suitable and certified lifting points.
 - (3) Collision prevention
 - (4) Pinch points
 - (5) Slips trips and falls
7. Check the run of the deck in comparison with north / south skid beams.
