2 7/8" PACDS DRILLPIPE NEAR MISS

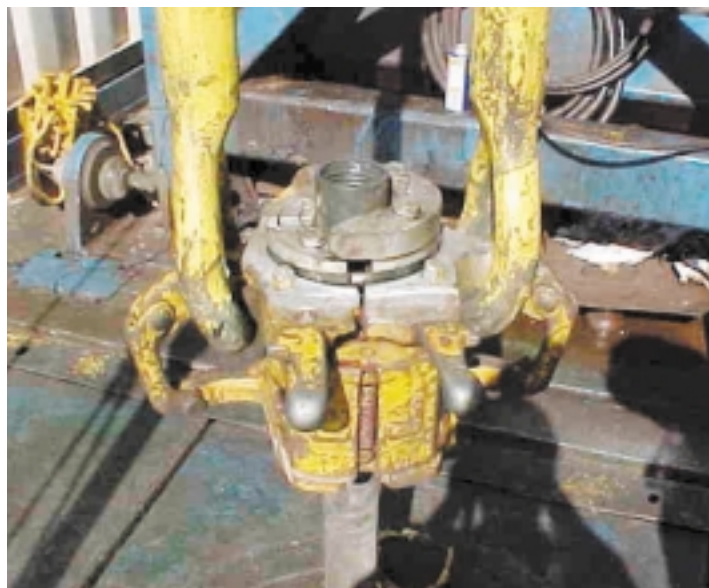
While POOH with the 2 7/8" PACDS Drillpipe fishing string, the slips where set and a drillpipe single was broken out and layed down without incident. The roughnecks latched the 2 7/8" MYT insert elevators around the joint suspended in the rotary table. The driller picked up and the elevator setting plate failed to interact with the nominal 3 1/8" upset on the tooljoint.

- Eccentric wear and reduction in O.D. of tool joints.
- Rapid reduction in drillpipe tool joint O.D. caused by tong die slippage during make up and break out operations.
- Tapered wearing of tool joints (NO box tool joint hard banding on PACDS work string)
- The MYT setting plate and drillpipe tool joints have minimal allowable wear before they will fail to interact with each other.
- Worn MYT setting plate as a result of incorrect fit with worn drillpipe tool joints.

- Hold pre job Toolbox Talk to ensure all crew members understand that running flush or near flush tubulars requires special attention and they should consider and treat this operation as abnormal.
- During prolonged runs especially in open hole crews should be requested to continually monitor the general condition of the tool joints, reporting any anomalies.
- **Encourage rig crews to STOP the operation if there is any doubt regarding the equipment.**
