## FOOT INJURY

### INCIDENT

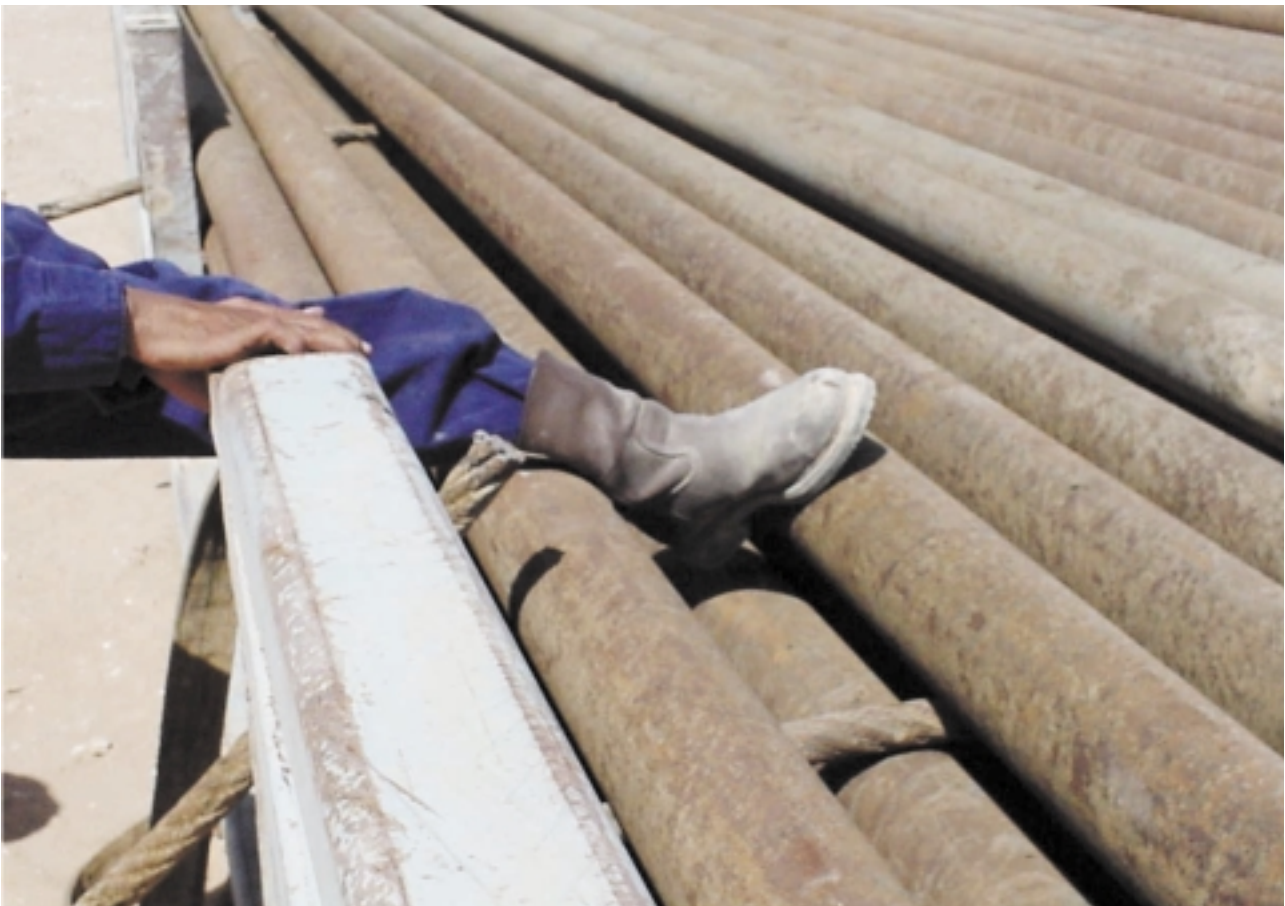
- HWDP was being transferred from pipe bin to pipe rack. Rig's forklift truck was not available, so crane was being used to sling the pipe. Roustabout was installing sling under the HWDP.
- Man used his foot to roll the HWDP. As the HWDP rolled back, the heel of his safety boot got trapped between the lower pipes and the HWDP bent his foot upwards.

Man did not use the right equipment for the job.

USE THE RIGHT EQUIPMENT FOR THE JOB.
