Pulling Tubing

INCIDENT

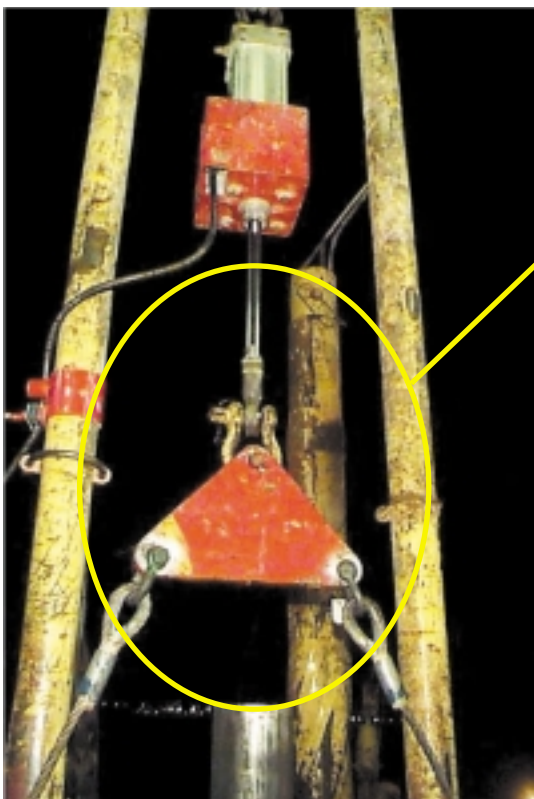
The tension in the compensator assembly broke the connection between the piston rod and the compensator piston (screwed connection). The piston rod together with the tripod fell down and hit the side of the spider elevator. On impact the safety split pin from the hinge pin sheared. This resulted in a disconnection of the shackle and piston rod. The piston rod and the shackle weighing 3 kg. fell down on the rig floor from a height of about 13 m.

- Overloading the compensator assembly
- Use of unfamiliar equipment by the rig team.
- Tool box talk not repeated during shift handovers

- Rig Team should be made familiar with the relevant operating procedures for the equipment, before starting the operation.

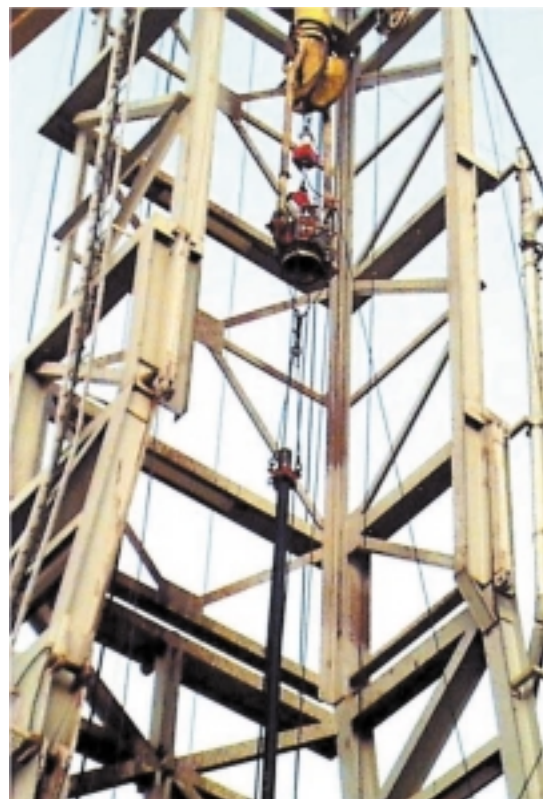
This fell Down
