HSE Incident Lateral Learning

No: 0402

Near Miss Side boom lifted off the ground during lowering operation

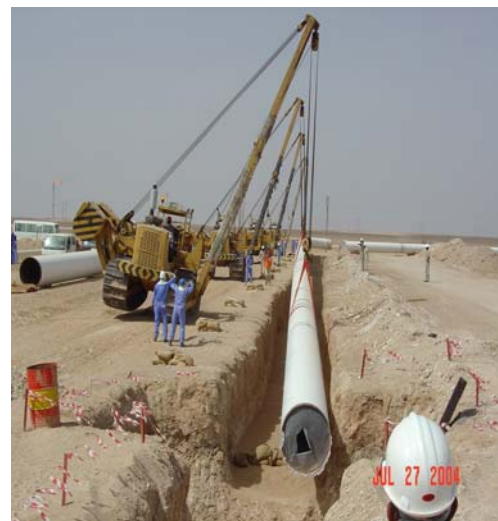
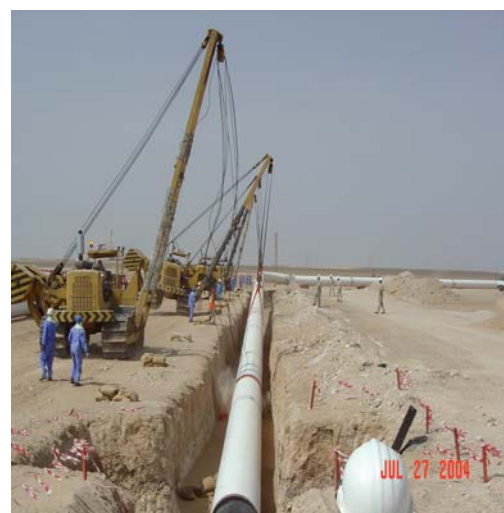
While lowering 48" gas export line, one side boom, lifted off the ground due to excessive load. The side boom operator realised that he was in danger of toppling; he panicked and he immediately released the pipe into the trench. This action caused the load to shift to the second side boom, which caused one side to lift off the ground as well. The second side boom operator did not panic and he slowly released the pipe into the trench.

- ☞ Inadequate design considerations for selection of Type & number of side booms.
- ☞ Inadequate procedure for lowering of 48" Pipeline.
- ☞ Operator familiarization of Side Booms & 48" lowering skills not considered necessary.
- ☞ HEMP not reviewed while planning the lowering operation.

- ☞ Review of design for selection of Type and number of side Booms.
- ☞ Lowering procedure to incorporate all site conditions for lowering.
- ☞ Review of operators' qualifications & experience.
- ☞ Update HEMP and conduct workshop for the lowering crew.
- ☞ Prepare organogram with defined roles and responsibilities for Lowering of 48" pipeline.
