# Exploration HSE

### Sledge Hammer LTI

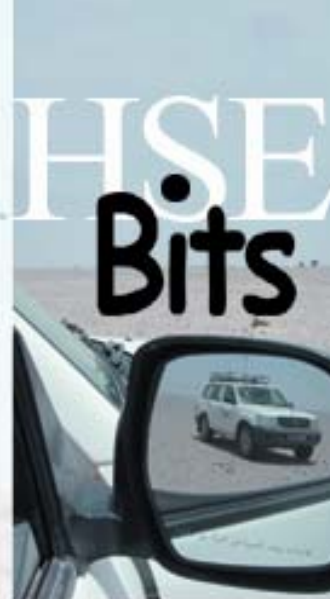
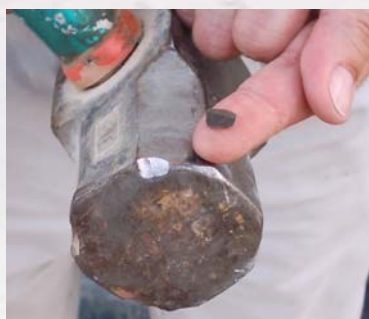
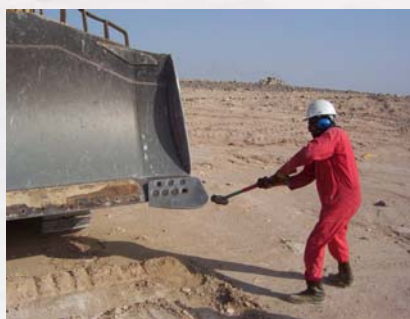
On 13<sup>th</sup> August 2004, whilst removing a bulldozer blade cutting edge using a sledge hammer, a small splinter of metal came off the hammer head striking the employee in the stomach. It punctured his small intestine before becoming lodged in the stomach cavity. An operation was required to remove the fragment.

The investigation identified that :

- 1) The manufacturers procedures for removal of the cutting edges were impractical in a field environment.
- 2) There were improvements that could be applied to the common industry practice for edge removal that had developed over time.
- 3) The hammer is of the drop forged type. While these are robust, they are more susceptible to splintering than some other types of hammer, when used on very hard surfaces.
- 4) Inspection of the head showed that other splinters had come from it in the past.

If you use hammers, check the condition of the head carefully before use. If there are a number of chips or the head is mushrooming, the hammer should not be used.

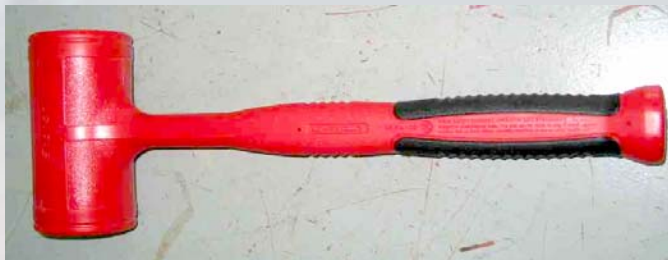
Other alternatives are available. The example below is made of a high impact plastic. The head is semi-filled with sand, minimising the kick back.
