13/02/05 PDO NM 1A C3P

MAF Office, While plugging in a Sony Ericsson mobile phone charger to a wall socket it exploded. The explosion did not cause injury to the person holding the charger (apart from soot on his fingers) however it had sufficient force to strip out wires and part the casing

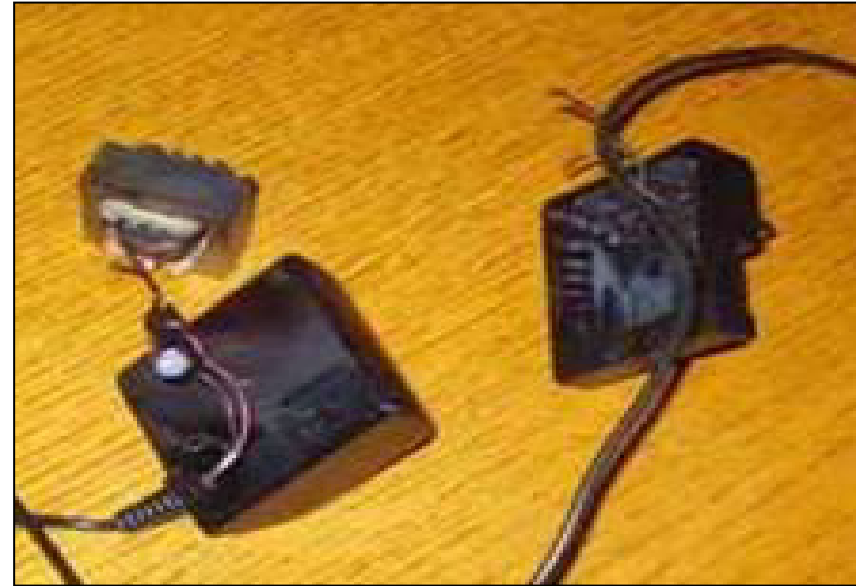
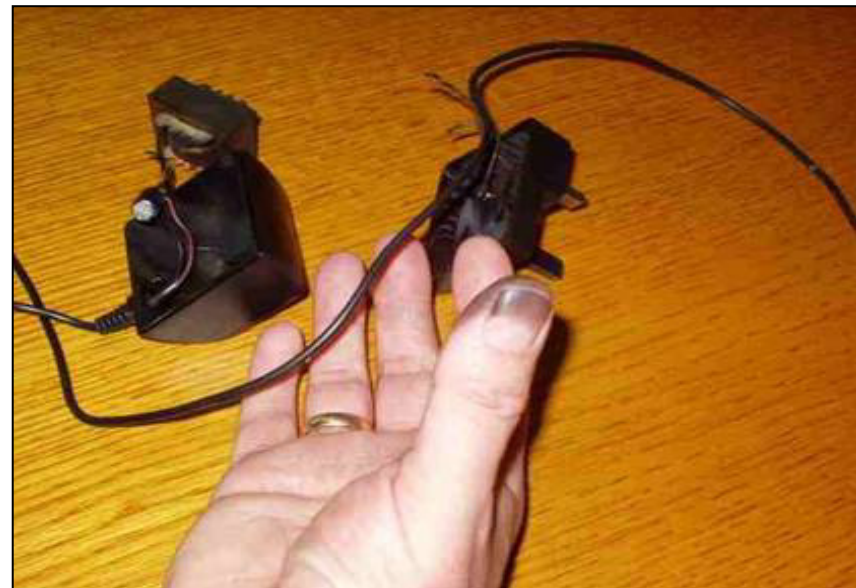
The charger involved was for a T68i and came from the original box. However there are no markings on the charger to indicate that it was an original part. It was probably a 3 pin replacement as the original phone came with a 2 pin charger, not approved by PDO. After the event BEC (HXM) office electrical maintenance were called, they looked at the wall socket and remains of the charger they concluded that moisture inside the charger could have caused a short circuit, although no evidence of water was seen on the remains of the charger. Poor construction is another possible cause

- Short Term:** Several offices in MAF have been affected by the recent rain. Check your office for moisture ingress, could your charger have been affected? If so get it checked by telecoms department
- Long term:** the telecoms department are looking at withdrawing all Non original chargers
- Be aware when you buy non original parts that they may put you in danger. Always look for quality constructed equipment Certified to an international standard
