Lessons Learned Report – Shah Deniz PU SD 02/05

Near Miss– Painter hit by dropped object

Business Unit: Shah Deniz Gas Export Project

Location of Incident: Zykh 3, Baku, Azerbaijan

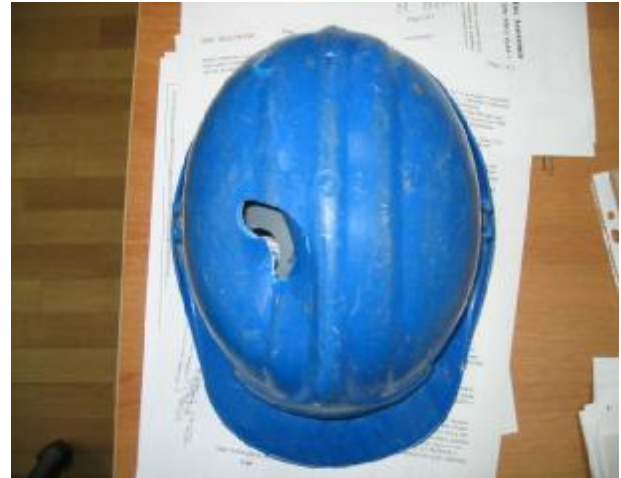
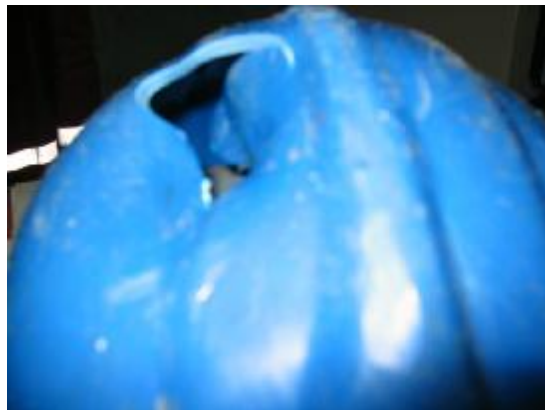
Simultaneous work involving scaffold cleaning, removal of cables from a welding machine, and a painting crew was underway at the 50m high leg base 2 of the TPG 500 under construction at the Zykh fabrication yard in Baku. A painter working at ground level was hit on his hard hat by an object dropped from a height of 30 to 50m.

The hard hat was penetrated by the dropped object, but prevented the painter from suffering any physical injuries.

- Not all control of work procedures had been approved for use, and basic HSE requirements contained in the draft versions had not been implemented at site.
- A risk assessment associated with simultaneous operations had not been completed. The Simultaneous Operations procedure did not address dropped objects.
- A general Permit to Work was issued without a risk assessment addressing simultaneous operations and access control to a high risk work area.
- Tool box talks were general in nature and not specific to the actual work on leg base 2.
- Inadequate communication between supervisors and crews at the leg base 2 work site relating to simultaneous operations.
- Housekeeping issues relating to accumulations of debris and scrap at heights on scaffolds and access platforms.

The result of procedural and implementation weaknesses and lack of risk assessments and communication between work crews led to work being performed without work crews paying sufficient attention to the other activities in the leg base 2 area.

1. Relevant control of work procedures in draft form to be reviewed and issued for use.
2. Develop and implement an access control system for high risk barriered areas.
3. Ensure Area Responsible Person is identified and coordinates simultaneous operations.
4. Ensure all crews are aware of simultaneous operations in the area where they are working.
5. Ensure simultaneous operations include a risk assessment for dropped objects.
6. Improve housekeeping on scaffolds and work platforms.
7. Do not allow people to work underneath scaffolders or cleaners, unless adequate protection for dropped objects is in place.
8. Establish clear HSE responsibilities for all activities at site.
