LTI-23 KNEE INJURY (FOUNTAIN ID 78692)

Project: C31-0514

Contractor: Petrofac

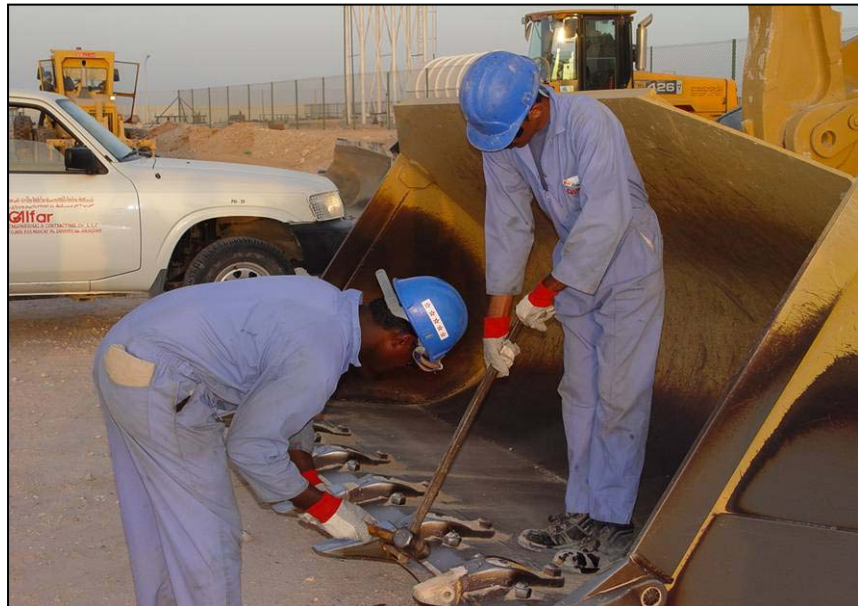
Metal chip from edge of the teeth cap flew due to the impact of hammer

- Flying object hazard not identified for this specific activity
- No HEMP specific for removal of teeth cap from the teeth of the shovel bucket
- Teeth cap can only be removed by hammering due to the accumulation of hard mud in between the surfaces

- Hitting the cap on the side.
- Check the hammer's surface before use.
- Check that the hammer "head" is fixed tight with the handle and that the handle is in good shape
- Check the surface you want to strike the hammer with before you start the job.
- Use safe tools to remove the pin.
- Stay on safe side and avoid moving forward object.
- Check the stability of the ground.
- Ensure the other person is safe from the hazard of moving hammer.
- Use the agreed PPE all the time.
