# A tale of three pigs

This paper considers three incidents, which involve the pigging of pipelines. In one case there was a departure from normal operations and the other two were one-off activities. In each case the recognition and assessment of risk was inadequate.

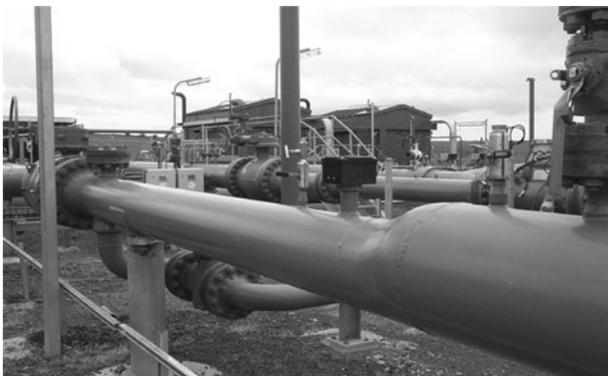
FIGURE 1: SHOWING MAIN ISOLATION VALVE ON LEFT AND THE SECOND PIG SIGNAL DEVICE (BLACK BOX ON TOP OF RECEIVER BEFORE TRANSITION SECTION)

Operators at the plant observed that the first pig signal activated indicating that the pig had arrived. However the second signal did not operate, indicating that the pig had failed to move completely into the receiver. The operator vented the pressure off the receiver and in a few seconds there was a noise and the second pig signal activated, showing that the pig was in the receiver. The receiver isolation valve was closed and standard procedures followed to vent the receiver and remove the pig.

The team concluded that the root cause of the incident was that if the pig remained in the transition section of the receiver the design of the system did not allow pressure upstream of the pig to be bled off.

- The lower pressure in the gathering line increased the potential for the pig to become stuck.
- Lack of pressure indication immediately downstream of the receiver isolation valve prevented the operators from identifying that pressure had been trapped, and lack of depressuring facilities at this point prevented it being vented.
- The work instructions for pigging operations did not adequately identify the potential for pigs to become stuck in the receiver.

- ReHAZOP the pig launcher and receiver.
- Install pressure gauges with bleed valves to atmosphere immediately downstream of the isolation valve before carrying out any further pigging operations.
- Modify the vent system to allow simultaneous venting of both ends of the receiver.
- Rewrite pigging procedure to reflect hazards of stuck pigs in the receiver and use the new pressure gauges to check that the receiver has been correctly vented. Include a sign-off checklist approach.
- Update P&IDs.
- Carry out JSEA on the new pigging operation work instruction and attach as part of procedure.
- Revise JSEA procedure to include guidewords of 'trapped energy' and 'trapped pressure'.

- Conduct pigging safety awareness training to advise all shift personnel of the incident and the modifications to equipment and procedures.
- Review mechanical isolations procedure with respect to single valve isolation when opening pig receiver/launcher doors.

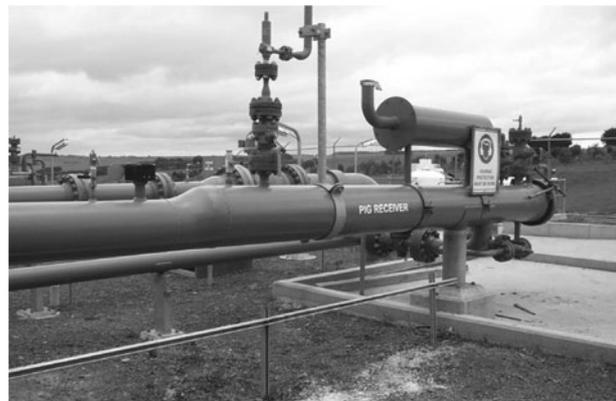
FIGURE 2: SHOWING, FROM LEFT TO RIGHT, SECOND PIG SIGNAL RECEIVER, TRANSITION SECTION, PSV, VENT AND VENT VALVE, AND RECEIVER DOOR

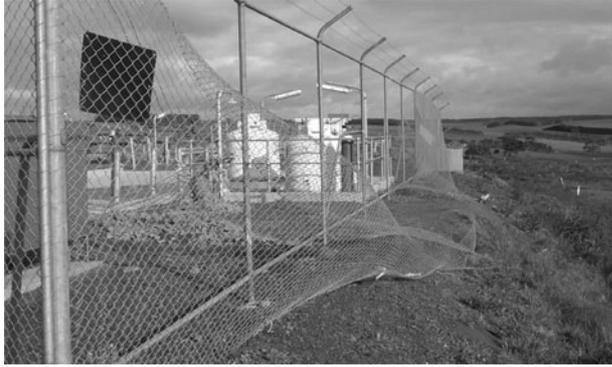
The pig was not immediately visible and as the operators prepared a pig retrieval stick the pig blew out of the receiver and landed approximately 50 metres away, demolishing part of a fence in the process (see Figure 3). Approximately one minute had elapsed since the door had been opened. Nobody was injured.

FIGURE 3: SHOWING DAMAGE TO THE PERIMETER FENCE

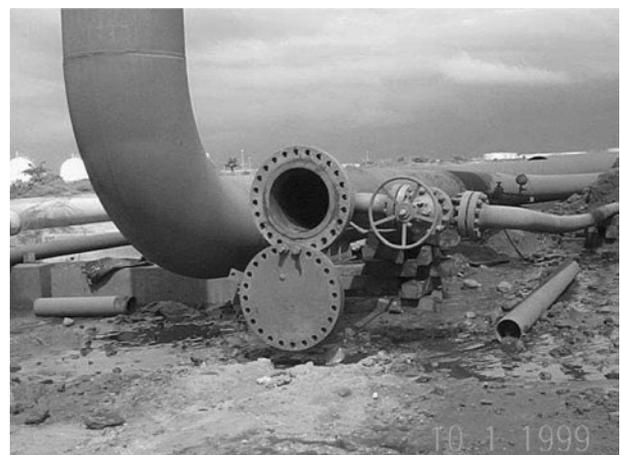
A contractor was dewatering a 10 mile section of pipeline after a hydrostatic test. The water was being displaced by a foam pig which was being propelled by compressed air. The displaced water was being removed from the line through a 12-inch by-pass. For reasons unknown at the time the pig stopped moving. Deciding that some obstruction was preventing the pig from moving freely, the end of a temporary pig trap, which was nothing more than a blind flange, was removed (see Figure 4) and the decision was taken to increase the air pressure to 400 psig to remove the pig from the line.

A quick calculation would have shown that the differential force on the pig was approximately 45,000 pounds force, but it seems the figure was never calculated.

FIGURE 4: SHOWING TEMPORARY PIG TRAP WITH OPEN END FLANGE

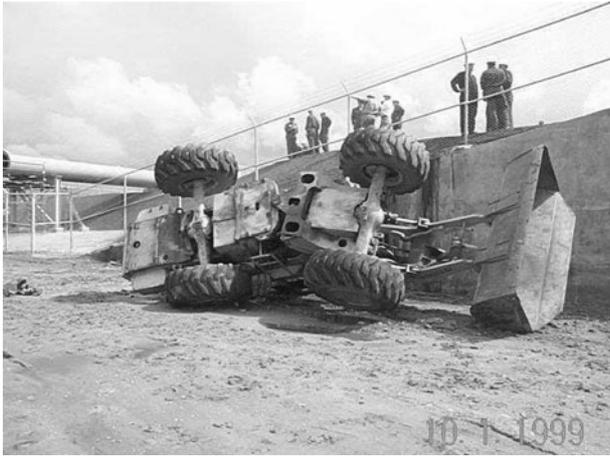
When the pig shot out of the trap it completely flipped the loader over (see Figure 5) and continued for an additional 150 yards, destroying a wooden platform on the way. The contractor did have the foresight to remove all personnel from the 'line of fire' as otherwise there would surely have been fatalities. The final picture (Figure 6) shows the remains of the pig. The overhead line in the distance is beside the pig trap and shows the distance covered.

FIGURE 5: THE LOADER AFTER FAILING TO CATCH THE PIG

No details of the subsequent investigation or its report are available but the incident serves to show the care that must be taken when dealing with pig traps and differential pressure. A simple calculation would have shown that the pig would have a force of over 20 tons on it, and that rather more appropriate control measures were needed.

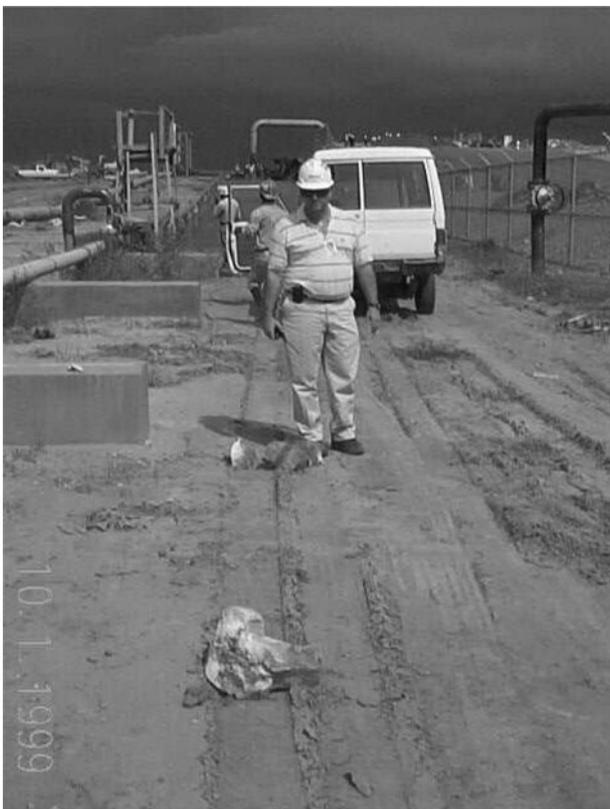
FIGURE 6: REMAINS OF THE FOAM PIG
