A : Accident description

SAFETY FEEDBACK NOTICE ELECTRICAL FATALITY

Ref: 21 - 2006

Issued: 15/12/06

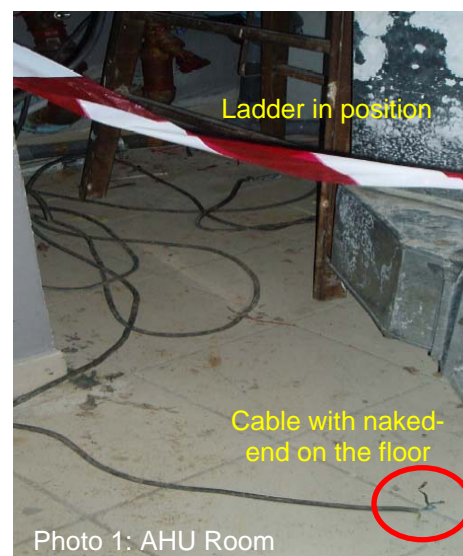
Photo 1: AHU Room

- (1) **Fall from the ladder.** There were two possible causes of his fall: **fatal electrical shock** or **medical pre-condition**.
- (2) **Live wire** in the room and **unauthorised electrical connections**. A **naked-end cable** which probably had been used for other purposes **lay on the floor** (see photo 1). It **had been connected into the same strip connector** as the temporary lighting used by the workers to light the room. The unauthorised connections were possible because of **unrestricted access to the power supply**.

- (5) **Metal ladder without isolation.** The victim worked on an A-shape movable metal stepladder with no isolation.
 - ➔ So, most probably, **one of the ladder legs came in contact with the naked-end cable** lying on the floor. **No protection system cut off the power supply** because no real short-circuit occurred; there was just **electrical potential at the metal ladder**.

3. **Temporary electrical installations.** Any modification in an accepted situation must be considered as a downgraded situation (e.g. in this accident, the accepted temporary distribution box, which has differential protection, was removed). Temporary electrical installations shall be risk assessed. Based on this assessment, the appropriate work planning is to be defined by or/and with contractor. Both risk assessment and work planning must be communicated to all personnel involved.
Action: Verification of the temporary electrical installations to be implemented (action: all affiliates).

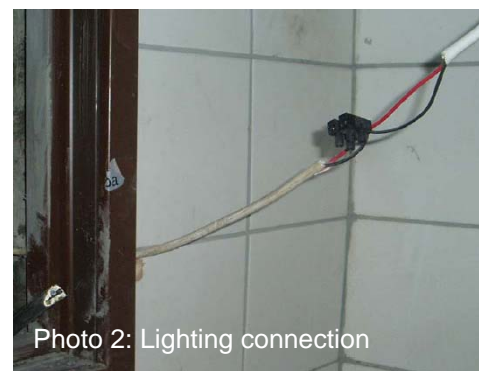
Photo 2: Lighting connection

- (3) **Poor handling of cable extensions.** Arriving through an opening in the wall, there was one cable to power the temporary lighting (see photo 2) and another lying on the floor.
