## QATARGAS II PROJECT FATALITY - DROPPED BLAST DOOR TRANSOM PANEL

### INCIDENT DESCRIPTION:

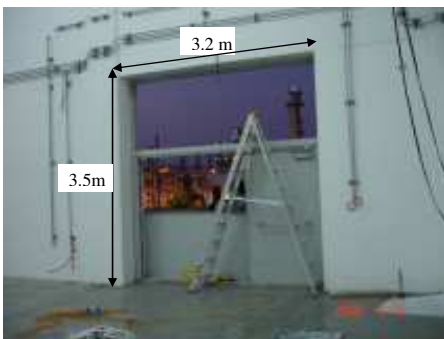
Fig. 1: Blast Door Partition Area, Interior View

- On 14 September 2006 at Ras Laffan City, Qatar, a QGII Subcontractor Civil team was assigned to remove the upper door partition (transom panel) of a blast resistant door in preparation for switchgear installation. The transom panel (320 kg) was fastened to the door frame by 36 hex bolts and supported on a removable door frame beam.

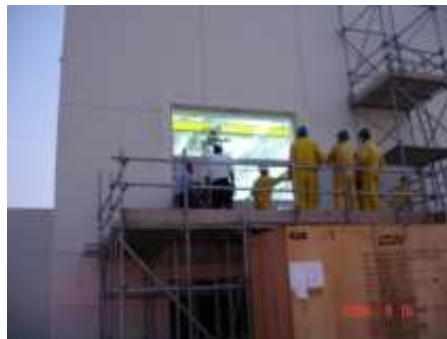
Fig. 2: Blast Door Partition Area, Exterior View

- The Charge Hand overruled the workers & the Safety Officer. The two workers on the ladder were changed out by the Charge Hand and the new workers instructed to hammer/push out the panel. As the panel began moving, it rotated & fell towards the workers standing outside on the elevated wooden platform. Two workers were thrown partially clear & received minor injuries, while the other two workers were pinned beneath the dropped panel, resulting in a fatal head trauma injury and a severe chest injury (i.e. eight broken ribs).

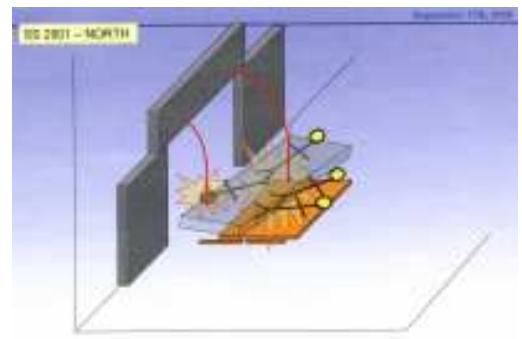
Fig. 3 – Worker Positions Following Incident

- **Work Direction / Preparation + Pre-Job Briefing:** No Toolbox Talk or JSA was performed to analyze this infrequent work task.
- **Work Direction / Selection of Worker / Not Qualified:** The Charge Hand (acting Foreman) may not have been qualified for this work task.
- **Procedures Not Used or Followed / No Procedure:** No Method Statement or procedure existed for this infrequently performed work task.
- **Workers Not Truly Empowered to Stop Work:** Message had been communicated but process/culture not in place to truly stop work
- **Dominant Behaviors:** Dominant behavior by the charge hand propagated unnecessary risk
- **Interface Management :** Project interface management/communication between design, engineering, and construction did not highlight transom weight/handling procedures in work task instructions.

- **Pre-Task Planning / Job Safety Analysis (JSA) + Last Minute Risk Assessment (LMRA):** Ensure that effective JSA and LMRA processes exist and supervision/workers are adequately trained to address unplanned work activities &/or hazards/problems.

- **Supervision Qualifications:** Ensure appropriate controls exist (i.e. training, tools, etc.) to ensure adequate supervision competency.
- **Roles, Responsibilities and Accountabilities:** Ensure that safety-related roles, responsibilities & accountabilities are communicated and clear for each level of the project organization (i.e. Project Manager, Managers, Engineers, Supervisors, Safety Officers, Foremen, Workers)

- **Right/Obligation to Stop Work:** Ensure if ANY personnel observe an Unsafe Act &/or Condition, a systematic process exists that both empowers and obligates them to stop work & implement appropriate controls.

- **Interface Management:** Ensure interfaces are clear between design, engineering, and construction teams and that potential hazards are clearly identified and handed off.

- **Dominant Behavior:** Ensure procedures/training/controls are put in place to mitigate dominant behavior by supervisory personnel.
