Asphyxiation of Welder on LNG Construction Site

23 August, 2009

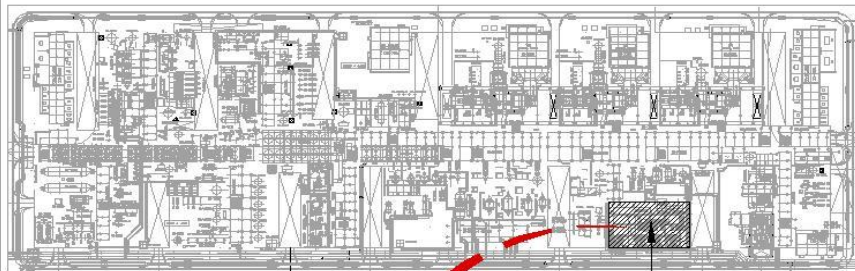
TRAIN - 7 KEY PLAN

LOCATION OF INCIDENT

53-XH0603 @ 20m Level

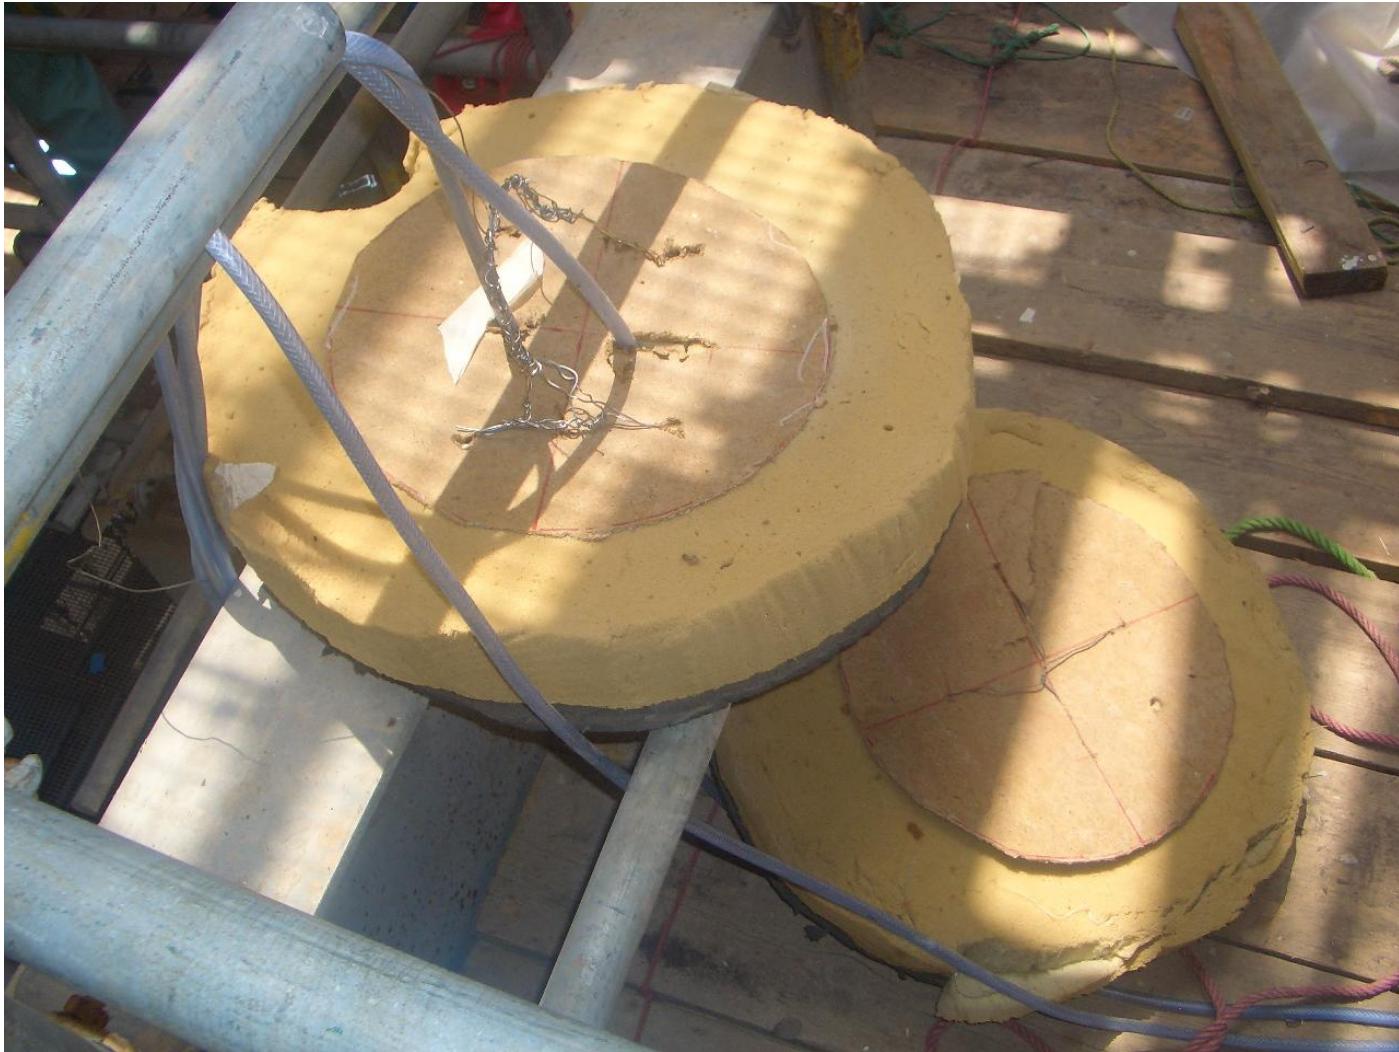
Purge Dams
for Argon Purging

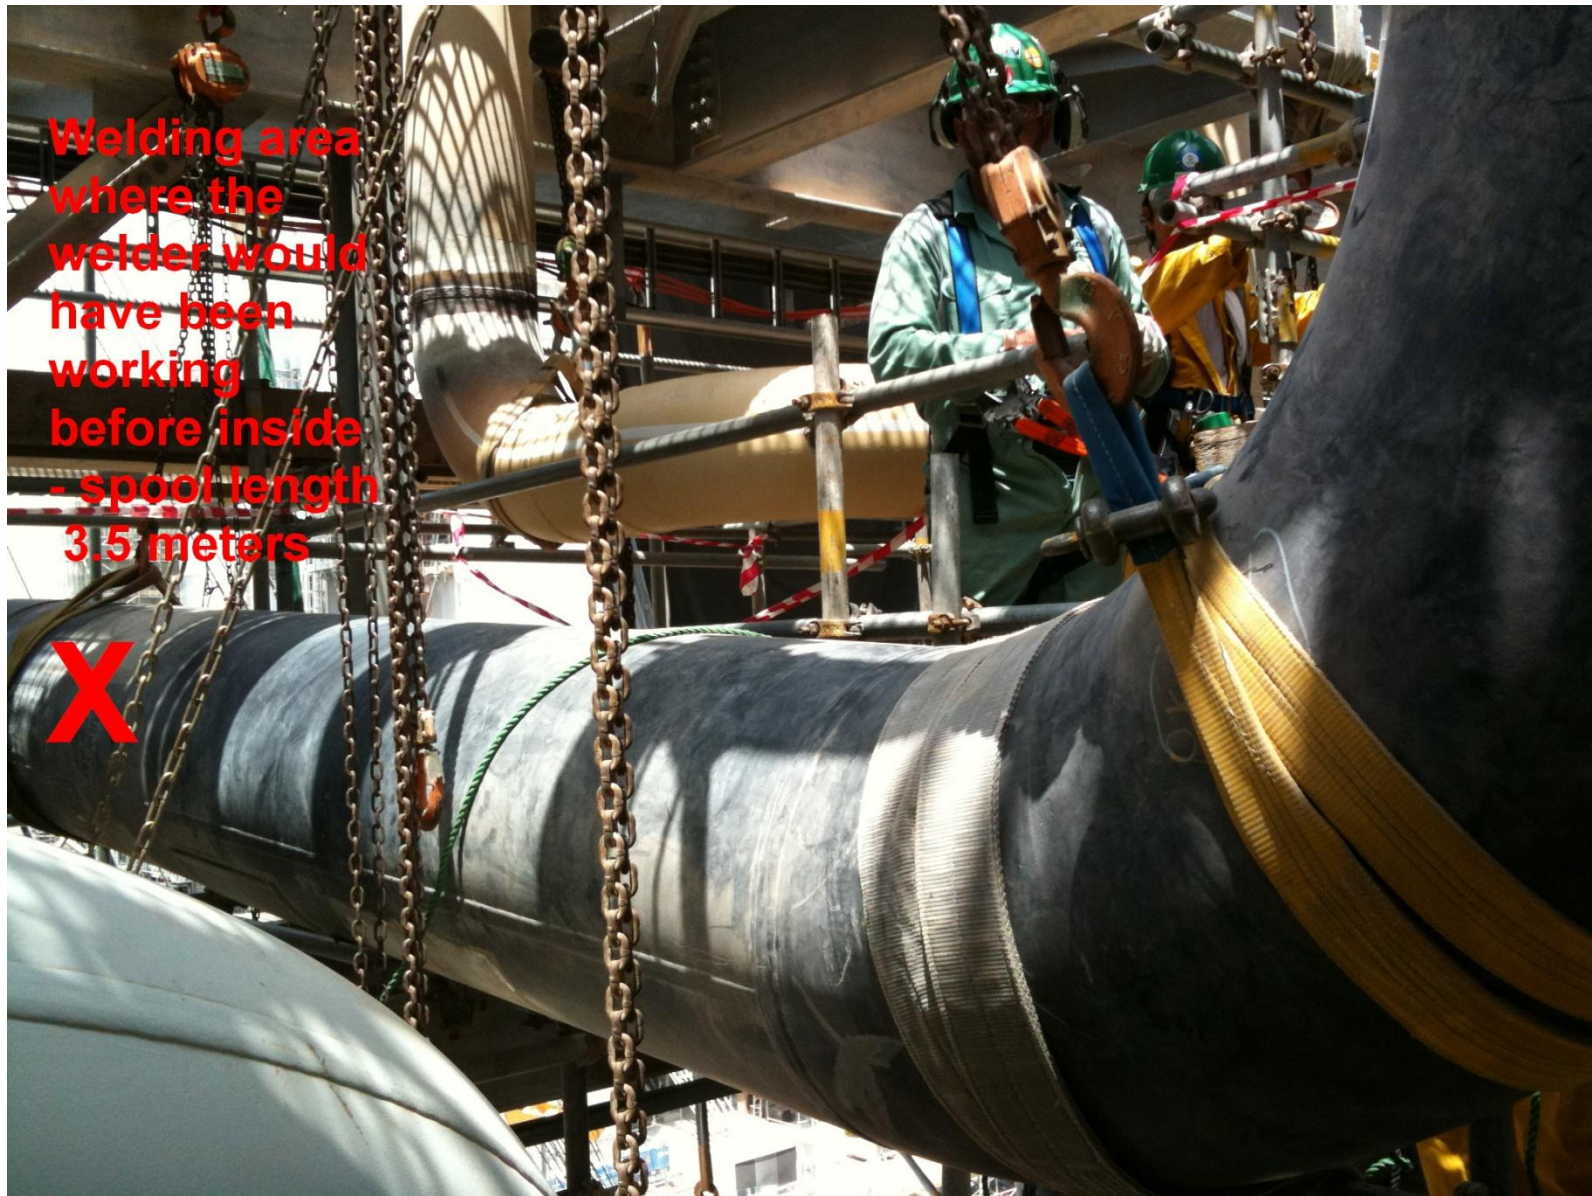
Welding area
where the
welder would
have been
working
before inside
- spool length
3.5 meters

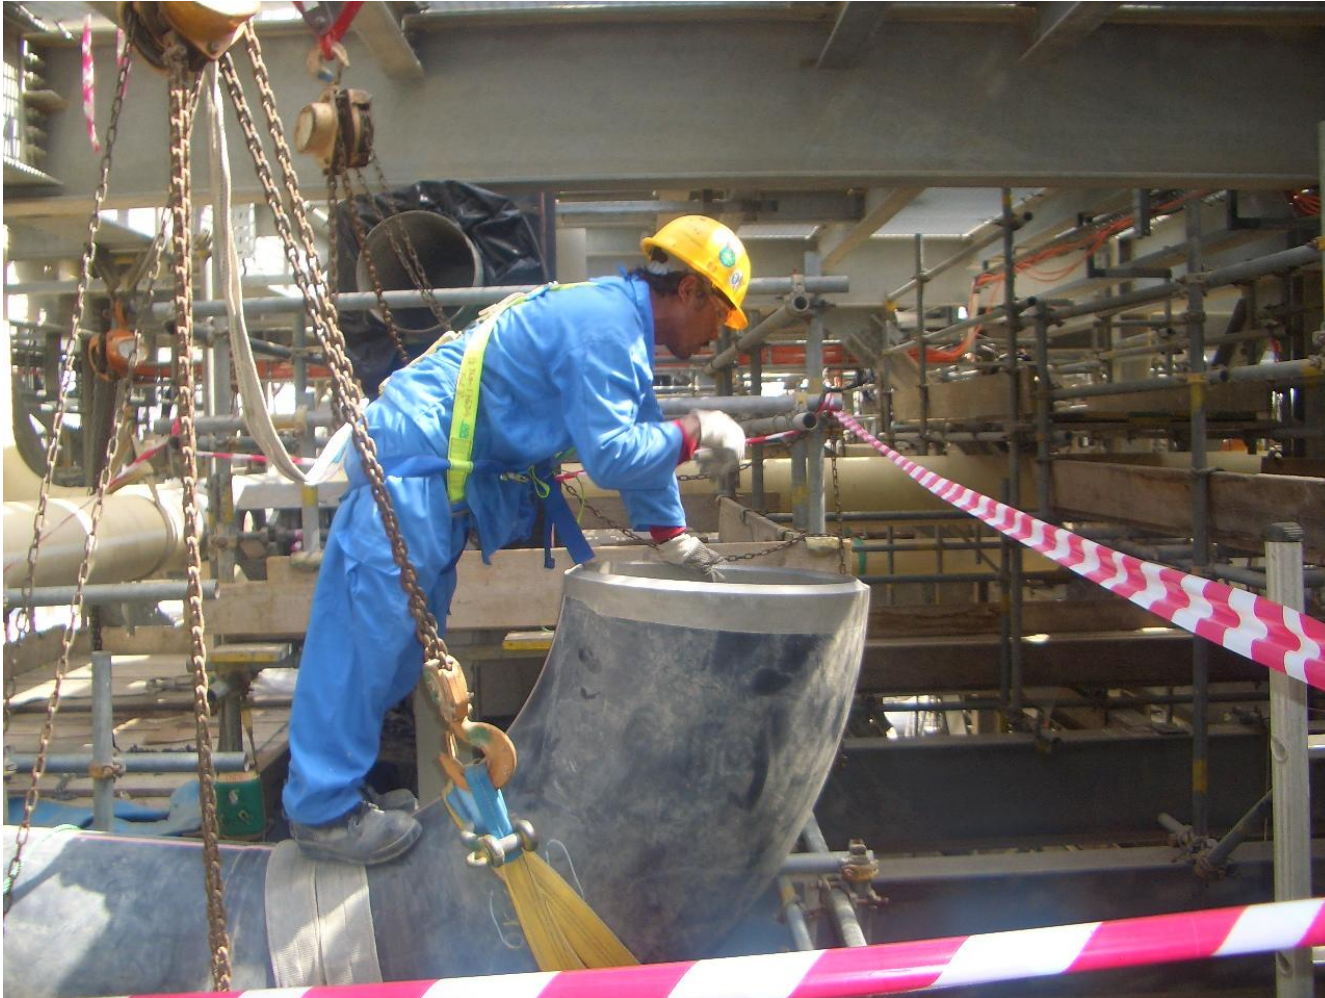
Re-Creation

Victim's last known position

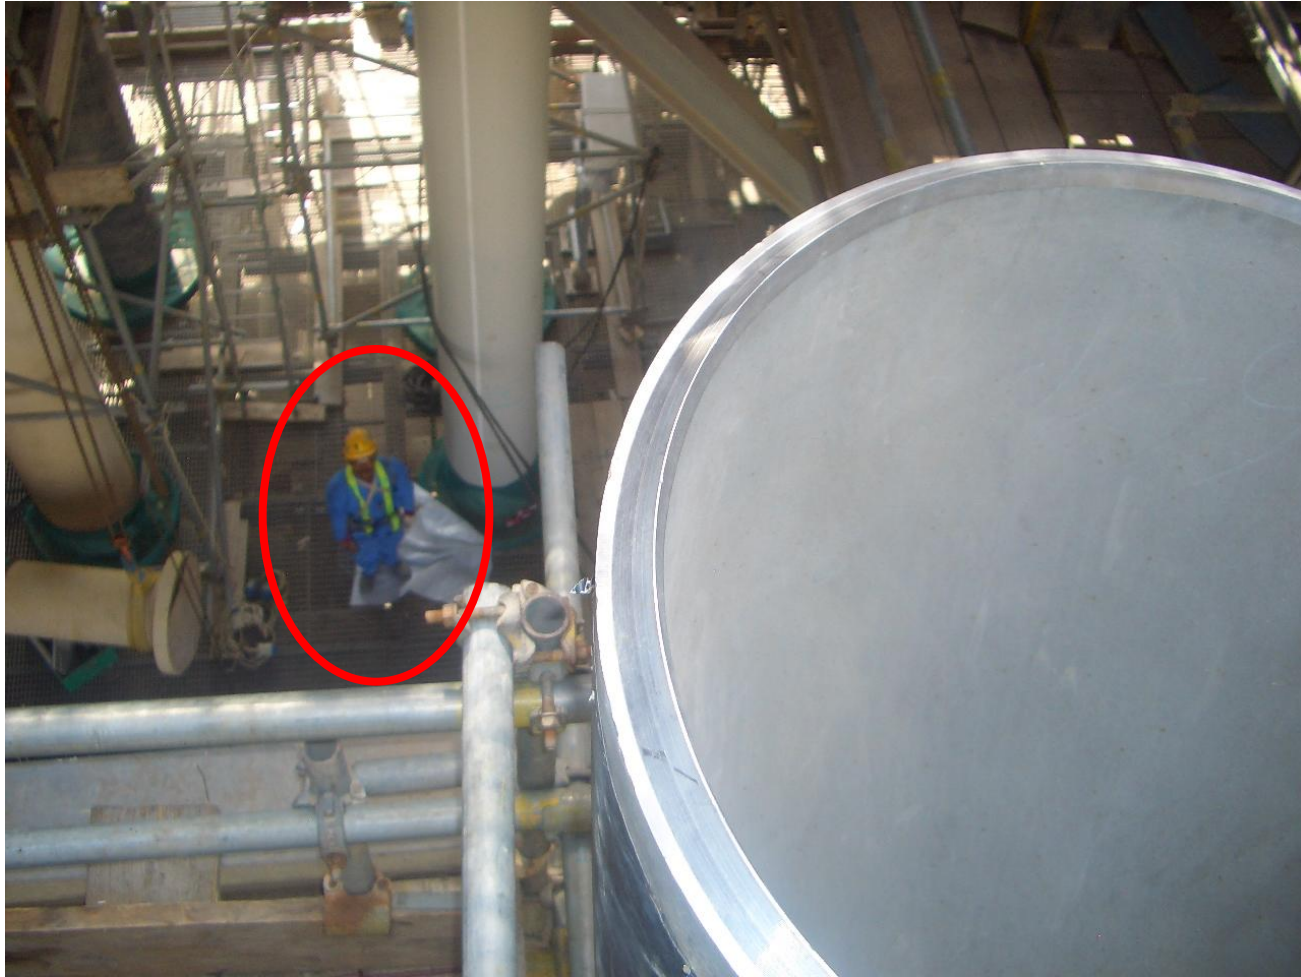
Re-Creation

Position of helper when last saw Victim
