SAFETY ALERT #361

Title: FALL OF MATERIAL DURING LIFTING

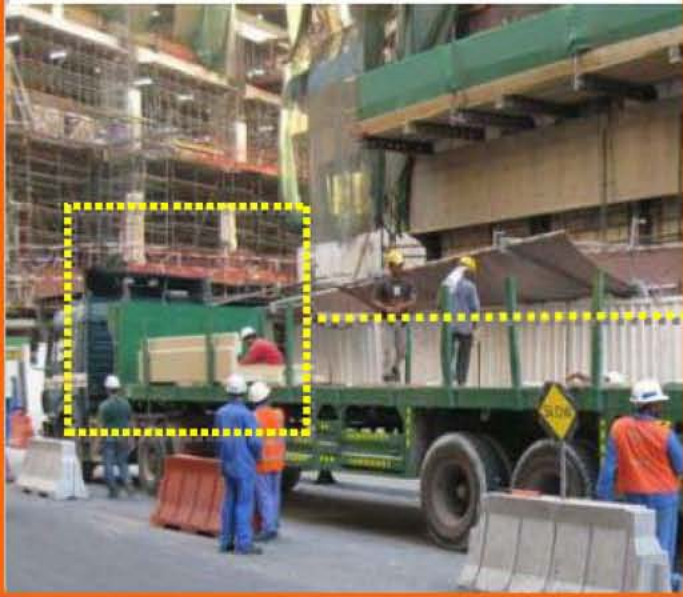
Sample of the GRC panel on top of a trailer bed

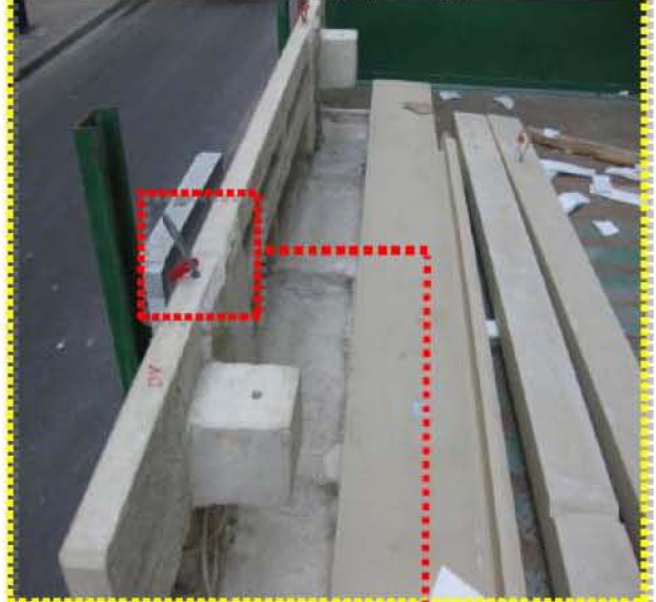
GRC panel is to be lifted by tower crane attached to two (2) lifting points

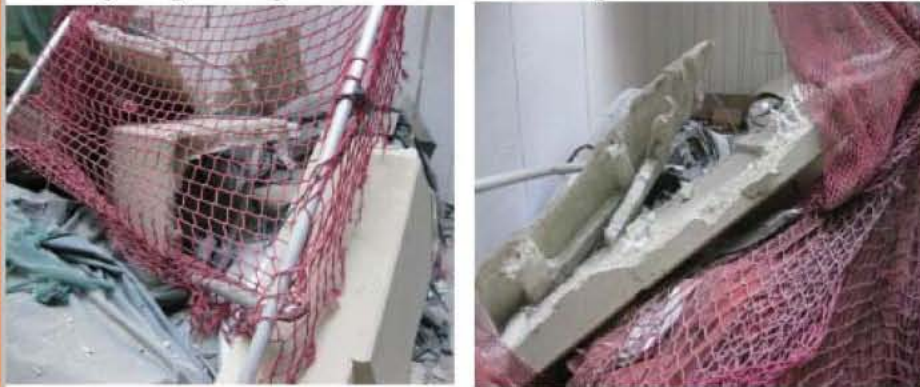
Safety net gave way due to the excessive weight of the fallen material

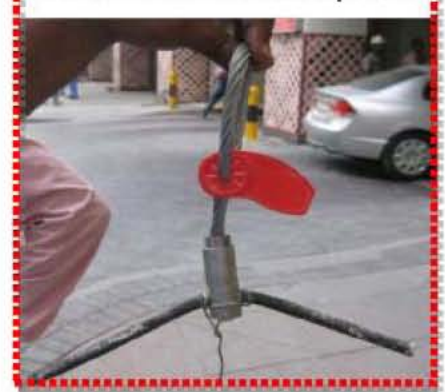
One of the detached lift points

- ❖ Final analysis of the root cause of the incident is still pending. However, initial investigations into the failure of the lifting points cast into the panel and other design issues are currently under investigation.

1. Risk assessment and method statement to be reviewed and amended to be more specific and detailed showing control measures for elements of work.
2. A thorough redesign of the lifting points cast in to the panel to include a factor of safety in case one lift point fails in the future.
3. Tighter quality procedures from the manufacturer to minimize the likelihood of poor workmanship.
4. Specific design drawings and calculations to be provided for design check by engineer prior to any lifting of panels using cast in lift points.

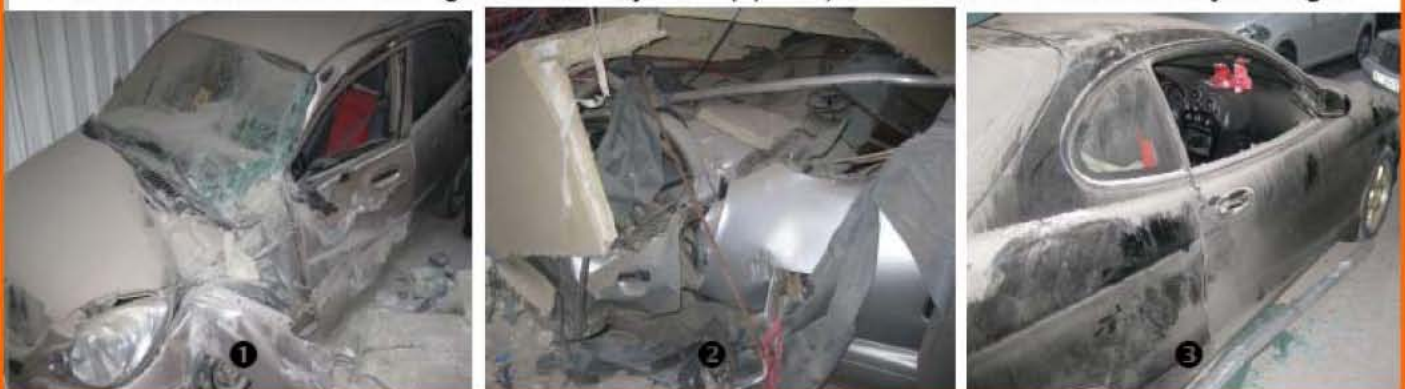
Pictures below show the damage sustained by three (3) cars, where cars 1 & 2 were heavily damaged

This is a dangerous occurrence as there was an alarming amount of serious property damage. Cars should not be parked below the lifting area as this will force people to that area to retrieve a vehicle.
