Learning from incidents

AWARENESS ALERT

Volvo FM Series Truck Fires Due To Loose Engine Insulation

GRP/AW/201011

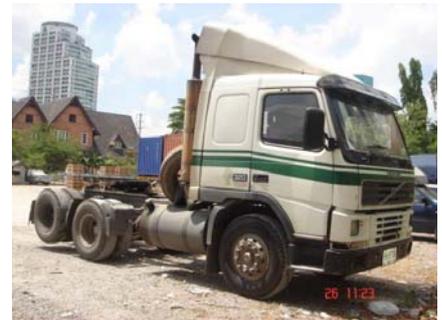
Example of the effected Volvo FM series

1. Inspect the insulation material mounts of Volvo FM Series similar to the model in the photo on the right ("Example of the effected Volvo FM series"). .
2. Ensure the integrity of insulation material mounts is included in all ongoing vehicle inspection programs. .

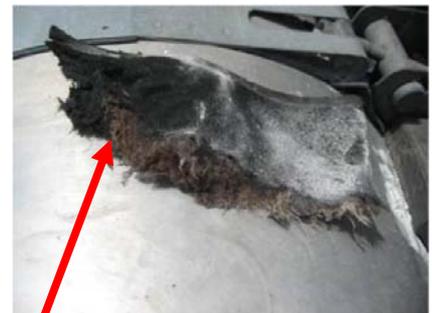
Insulation material from underneath the cabin bonnet (cab over model) fell onto the exhaust manifold and was ignited due to the hot exhaust manifold temperature (up to 600 °C). This caused the air inlet housing to melt/burn.

The insulation material serves to reduce engine noise and heat radiation. When aged, the pins holding the insulation may fail and give way.

Remains of damaged insulation
