#### Gt. Yarmouth Base Pressure Testing Incident, 16/8/01

- Pressure testing 5K choke
  manifold TX 54-10
- Choke tested inside GY base well test pressure test bay
- Workshop Foreman and Technician inside test bay to inspect for leaks
- Thermowell (3/4" NPT) failed
- *Hit Workshop Technician in leg, resulting in serious injury to right knee*

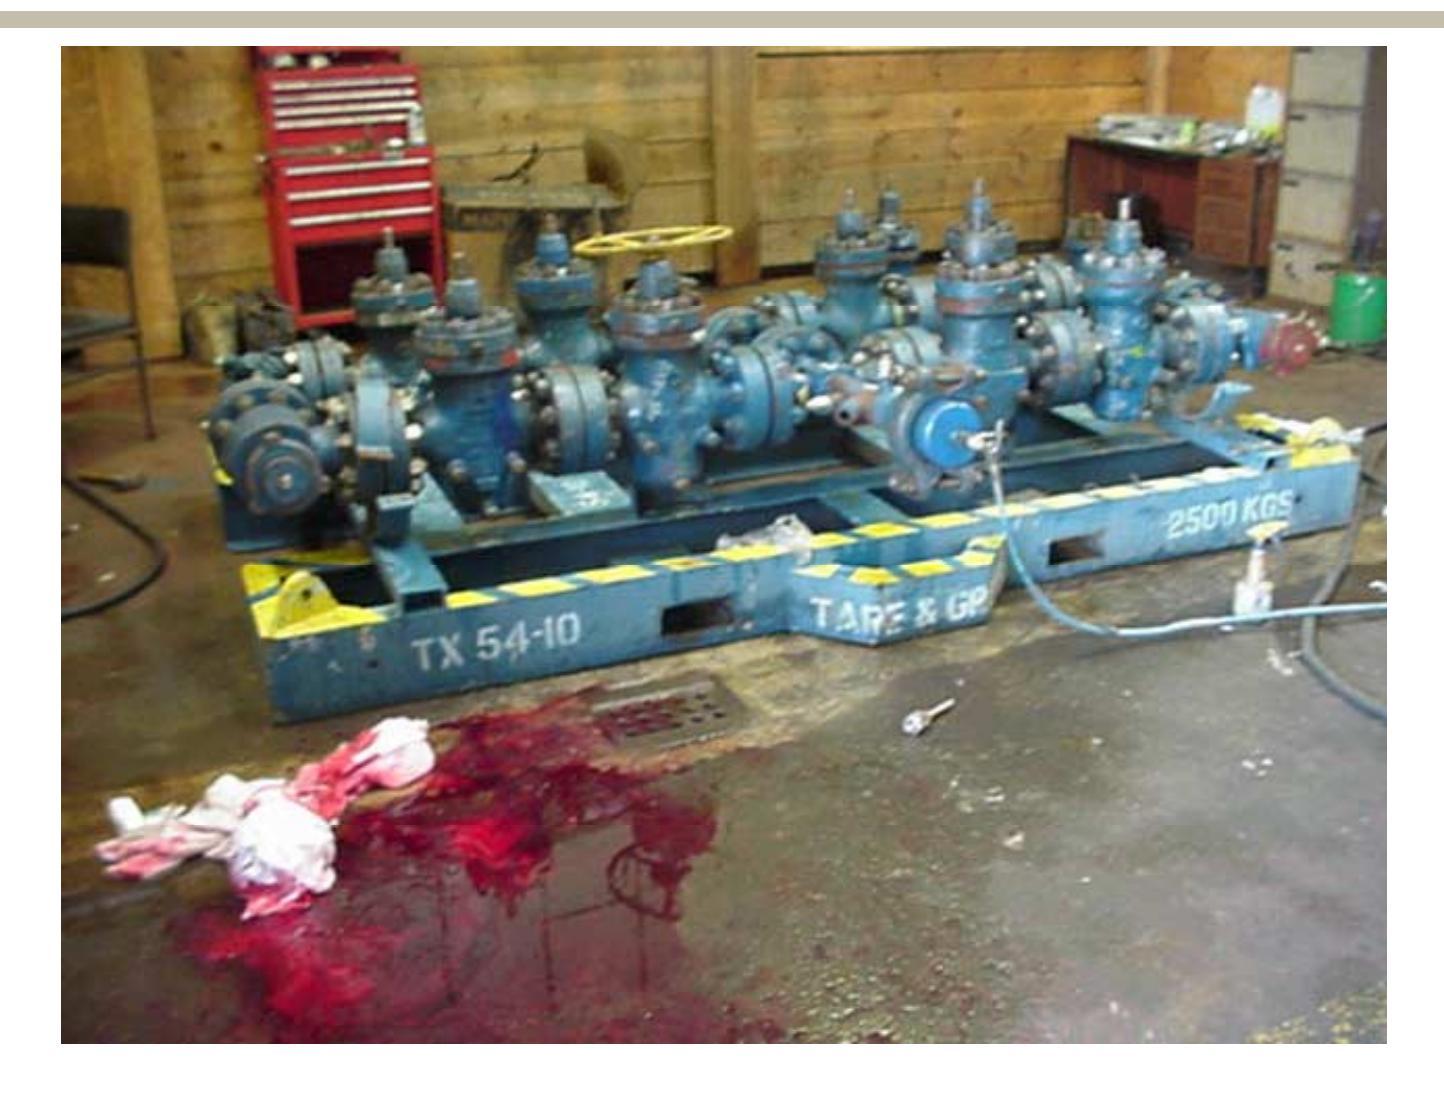
Incident Scene

The injury was caused when the Technician was struck by a thermowell ejected from a 3/4" NPT female tapping in a 5K choke manifold during a pressure test.

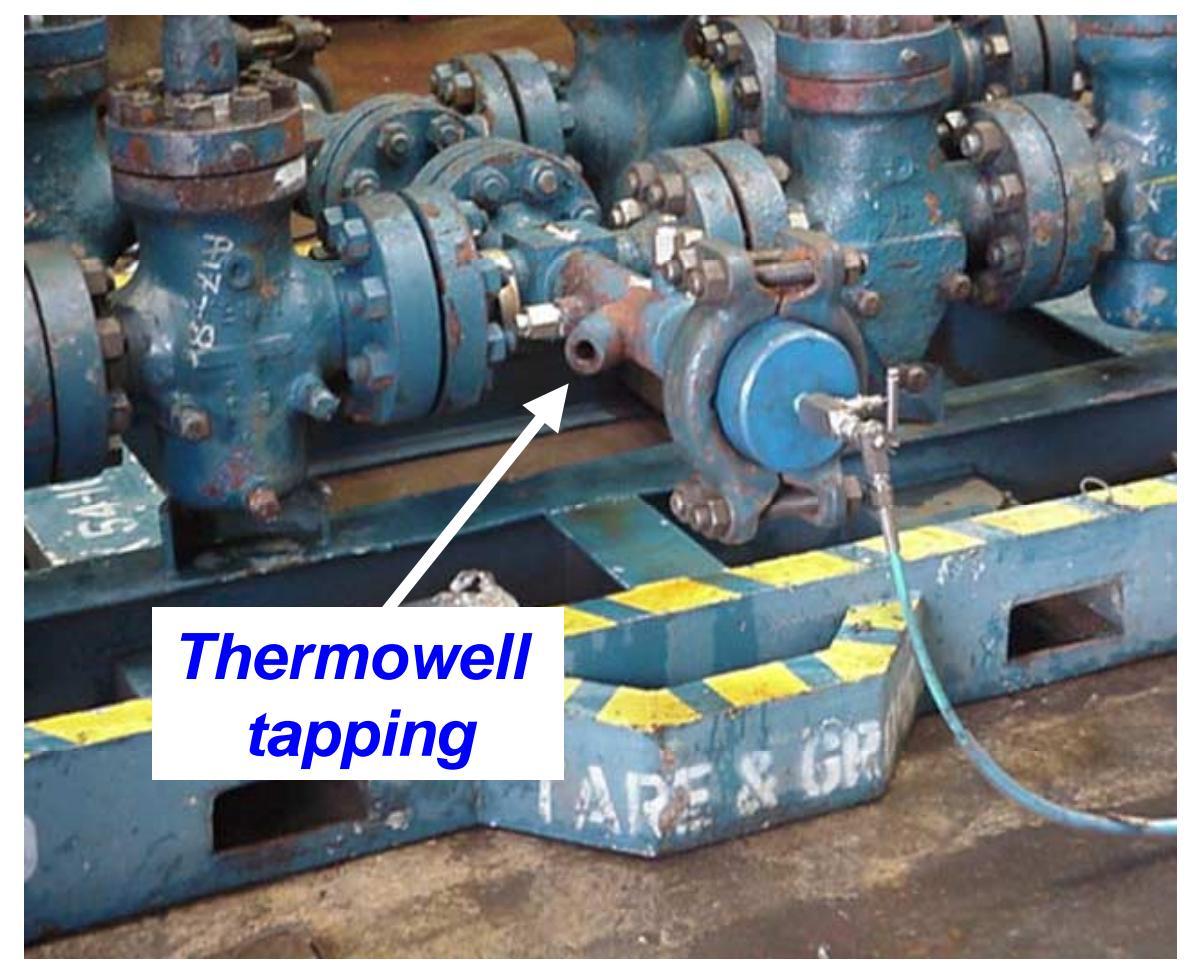
3/4" NPT Thermowell

The thermowell is about 9 ins long and weighs approx 1 kg.

*It struck the Technician on his knee from approx 0.5 metres.*

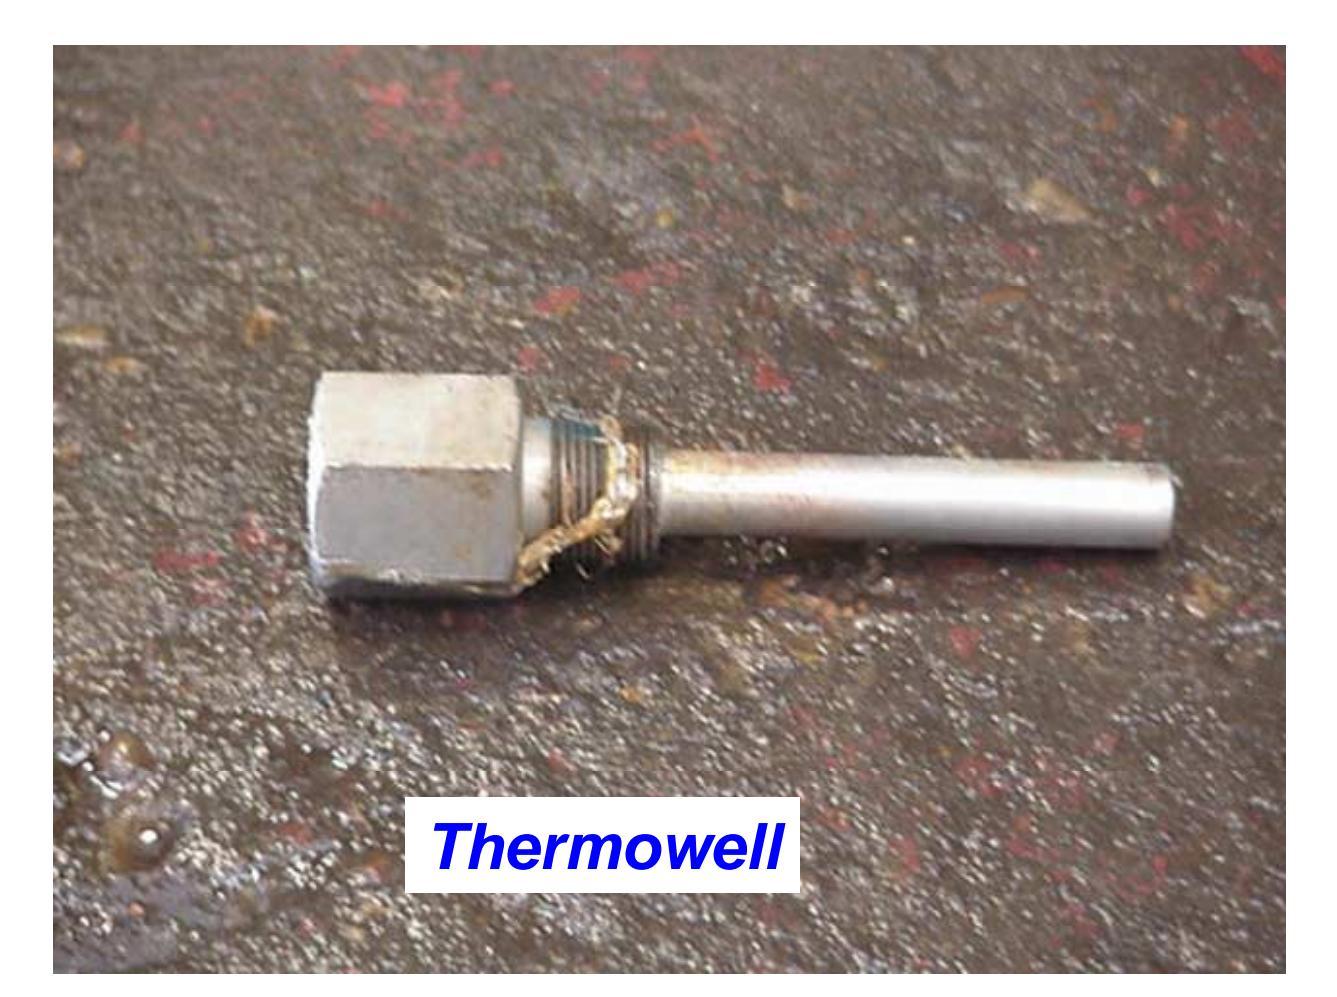
Severe corrosion had affected the mechanical integrity of the female thread.

The forces generated by the 5000 psi test pressure overcame the mechanical strength of the corroded thread and caused the thermowell to be ejected.

Dismantle and inspect ALL pressure retaining threads on Yarmouth Base equipment using calibrated thread gauges. Ensure condition of threads are established and deficient components are scrapped and replaced as required prior to any further pressure testing activity.
