# ChevronTexaco

Lesson Learnt Report:- 2005/02

# **Dropped Object – Retaining Ring**

Date of Incident 31.01.05 Type of Rig: Platform Injury to: N/A

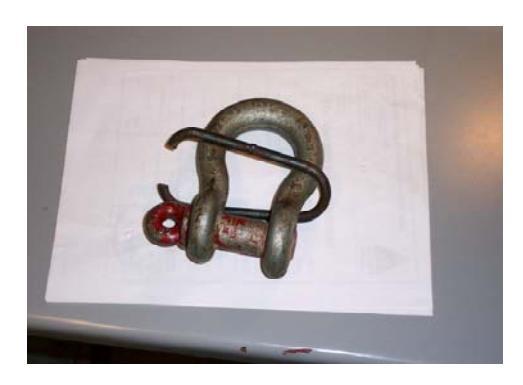
Fig. 1

Whilst the HP riser was being pulled, the Assistant Rig Manager noticed that a 6.5 ton shackle did not have a retaining ring attached. As he was removing the shackle the floorman appeared on the drill floor with the missing retaining ring stating that it had fallen and struck his left shoulder (Fig.1). No injury was sustained. The weight of the retaining ring was checked and found to be 122 grams (1.25 Lbs). Height of the fall was 16 metres (50 Ft). The lifting arrangement for the HP riser formed part of the newly certified lifting equipment. The lifting equipment had been examined and accepted 4 weeks previously. Corrosion of the break indicated that the ring had been broken for some time before this incident.

This incident has identified a shortcoming in standards regarding the testing and safe use of lifting equipment. The lifting bridles had recently successfully undergone inspection by a competent lifting examiner but damaged retaining rings had not been identified.

The retaining rings have been fitted to ensure that the lifting bridles are kept in sets and cannot be easily separated. Whilst these retaining rings are not part of the critical load path and not necessarily part of the current inspection criteria it is not unreasonable to include them in any inspections.

All similar lifting configurations require to be inspected as soon as is practical and before each use. Where equipment is in unsatisfactory condition they should be removed from service.

We are also considering alternative methods of securing the shackles using a less hazardous / more robust material. I.e. Ty-Wraps in a figure - 8 configuration.

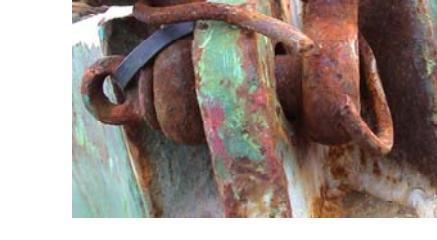
Fig. 2

As a consequence of this incident the containers in the yard were inspected for similar issues. Only 30% of those inspected had retaining rings fitted. Four were found to be broken (Fig. 2) and a number of others were deformed. Two of these containers had recently been inspected and certified.
