Crane Cabin Struck by Load

INCIDENT

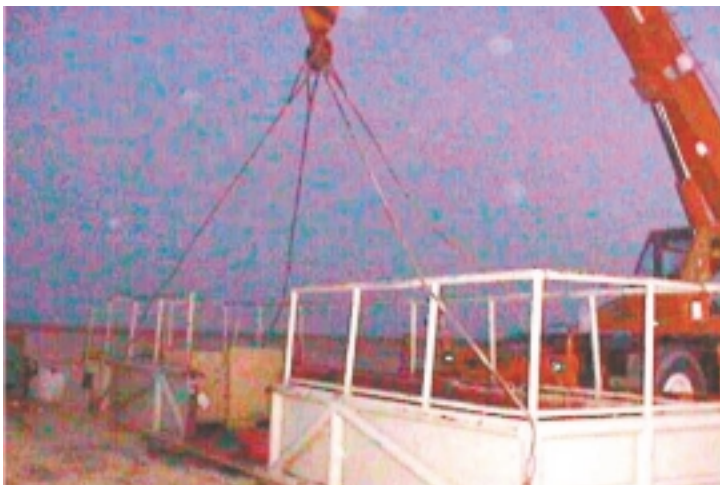
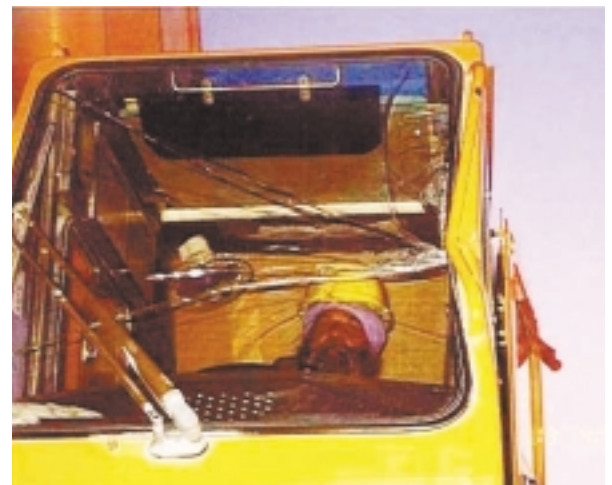
Crane was off loading sand blasting skip from the trailer bed. Four wire rope slings were used to lift the skip by attaching onto the loading hitches. One of the slings became caught on the corner of the skip - this was not noticed by the Foreman or Crane Operator.

The load swung towards the crane owing to the uneven sling length. To rectify the situation the Crane Operator was instructed to lower the skip back on the trailer bed. Whilst lowering the skip it swung and struck the crane cab window.

- **Failure to Follow Procedures** the banksman failed to ensure that the slings were clear of obstructions before commencing lifting.
- **Failure in communication** The crane operator did not confirm with banksman about the integrity of the load
- **Inadequate Inspection** Pad eyes were available on the skip for lifting, however these had no indication of SWL and current colour code.

- **It is the responsibility of the Banksman and Crane Operator to ensure that the load being lifted is free of any obstruction**
- **Lifting Pad Eyes must be inspected and marked with SWL.**
