Safety Alert...

A Van Explodes

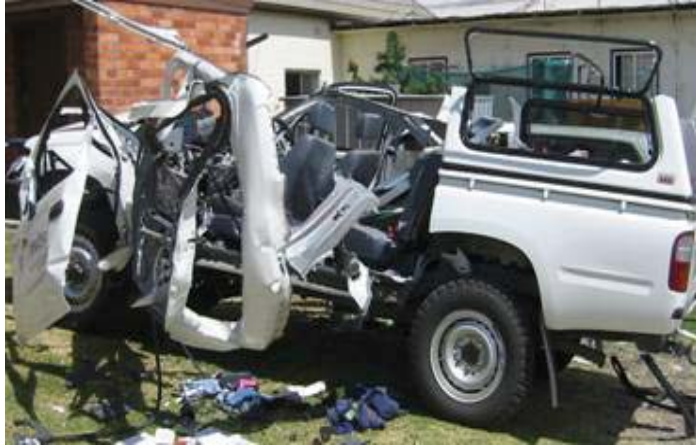
On Monday morning the fitter approached the van and opened the door, a large explosion took place. The Acetylene cylinder may not have been fully closed resulting in a small leak and Acetylene accumulated in the van over the weekend. It is believed the ignition could have been caused by either the internal light, the automatic door control or by a mobile phone which was on the front seat of the van. The fitter was also a smoker. The fitter suffered injury to his ear drums and facial. The Toyota dual cabinet was completely destroyed.

- There was a gas leak from the acetylene cylinder, acetylene gas is combustible.
- The escaped gas was contained within the cabinet.
- The Opening of the van cabinet door exposed the accumulated Acetylene gas to either internal or external sources of ignition thus causing an explosion.

- Cylinders should ideally be stored in the **open**, protected from sun and rain, and be raised off the ground.
- Cylinders **MUST** be chained, and in **upright** position, if they are full or partially filled. Do not store flammable gas cylinders in enclosed spaces!
- Keep cylinders away from electrical welding tools and sources of heat or sparks.
- Do not use magnets or chain slings for lifting. A purpose-built basket, skid or container, subjected to lifting equipment certification and inspection requirements, shall be used
