Failure to Engage the Kenworth's Bonnet Locking Mechanism Causes Injury

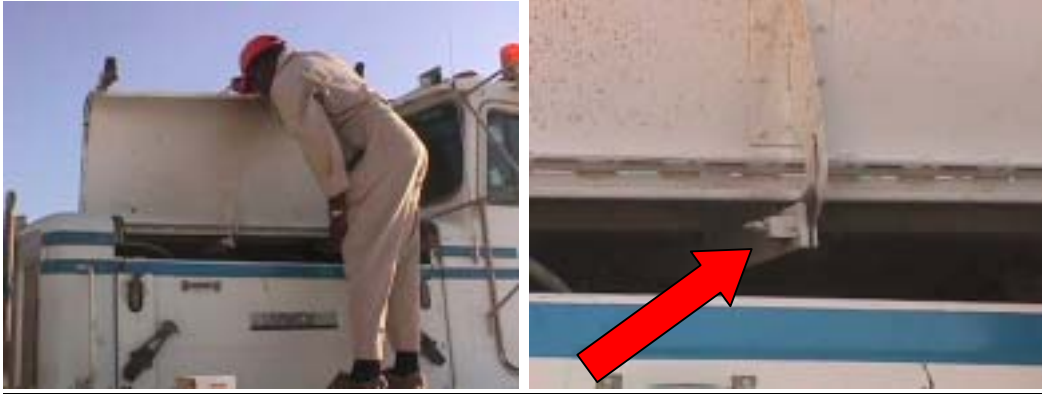
Opening the Kenworth's side bonnet or hood.

When the bonnet is opened and extended fully the locking mechanism activates and locks the hood with a click sound.

Truckoman Kenworth oilfield winch truck helper opened the bonnet to carry out the routine oil level check of the hydraulic power steering. With his head and neck looking into the engine, the bonnet fell on the back of his head causing his nose to hit against the edge of the engine compartment. The result was that the helper injured his nose and had to be treated in the clinic. **(IF THE WIND HAD BEEN STRONGER THE CONSEQUENCES WOULD HAVE BEEN MUCH WORSE)**

The helper failed to open the bonnet correctly. He did not push the bonnet far enough to activate the locking mechanism. Helper **assumed** that the bonnet has been locked and so he continued to carry out the task.

All drivers of all vehicles must ensure that the bonnet is firmly locked into position before attempting to work inside the engine compartment, failure to do so will result in incidents such as the one described above.
