# Shell Gas (LPG) Incident Alert Number 8

## Road Traffic Accident Involving LPG Tanker and a Stationary Heavy Goods Vehicle, Portugal

National road IC1, km 301,250 between Gaia and Porto.

26/ 03/ 2004 – 13h 10m

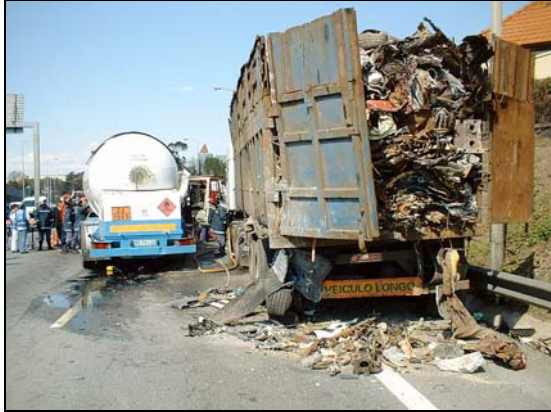
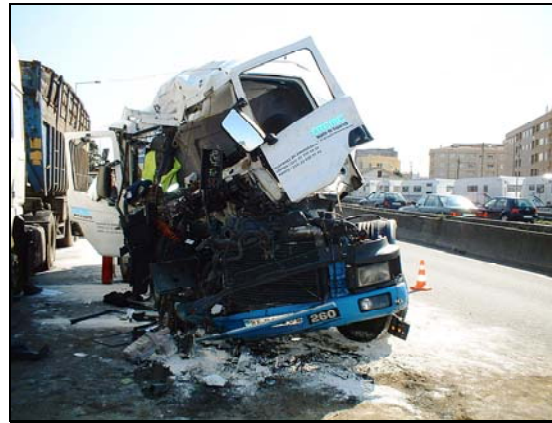
A contractor's bulk tanker, Shell-branded, on its way back to Shell Gas Portugal's Matosinhos Depot, crashed into the rear of a heavy goods vehicle carrying scrap metal that was parked at the side of the road, partially obstructing the inner lane of the road. The road was straight with three lanes in each direction, with an additional section of road about 1.9 metres wide at the right hand side, where the HGV was parked. The road was in good condition. The day was sunny and clear, with good visibility. The driver was 34 years old with 11 years experience in dangerous goods transport. He had been working for Shell Gas Portugal since December 2003.

**Assets:** Extensive damage. The tanker's cabin destroyed; chassis and mechanical parts unrecoverable; pressure vessel and LPG equipment undamaged.

<p><b>Immediate Actions Taken:</b></p>	<ul style="list-style-type: none"> <li>• Shell Gas Portugal initiated its crisis management plan in case of media interest in the incident.</li> <li>• The driver was visited by both Shell Gas Portugal staff and the RT contractor, both while in hospital and at home.</li> <li>• Psychological assistance to the driver arranged by the RT contractor.</li> </ul>
<p><i>This Alert contains all the facts about the incident that are currently known. Further information will be provided as and when it becomes available.</i></p>	
<p><b><i>This Incident Alert is not to be released outside of Shell Gas (LPG) without the authority of the Head of HSE and Technical of Shell Gas (LPG)</i></b></p>
