NEAR MISS – FALLING OBJECT

After 30 minutes jarring on stuck pipe, the latch pin retainer on a B&V CL-350 elevator fell 26m to the rig floor without striking anybody. The latch pin weighed 300 grams. The nearest person was about 2m from the point of impact and all other personnel were clear of the area.

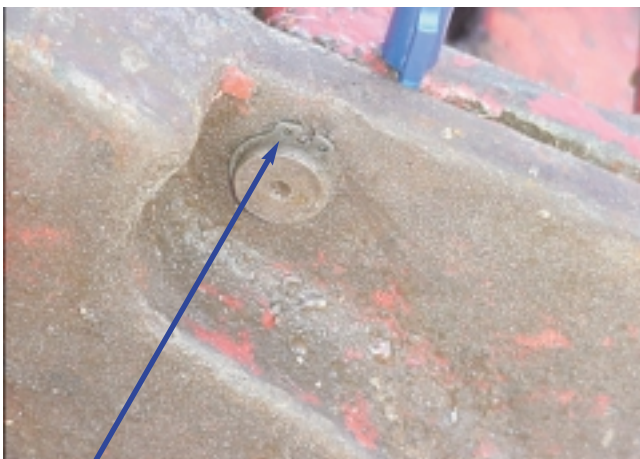
- The latch pin was missing a cir-clip retainer which was probably worn and fell out of its groove. This allowed the latch pin to jump free while jarring.
- The OEM issued no Safety Alert even though the latch pin retainer had been changed from cir-clip to split pin on newer elevators.

Cir-clip installed on latch pin

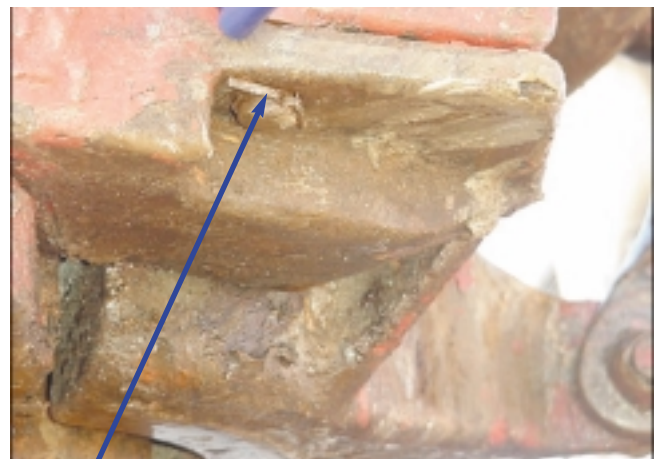
Cir-clip replaced by split pin
