## Crane Incident – Crushed Chest

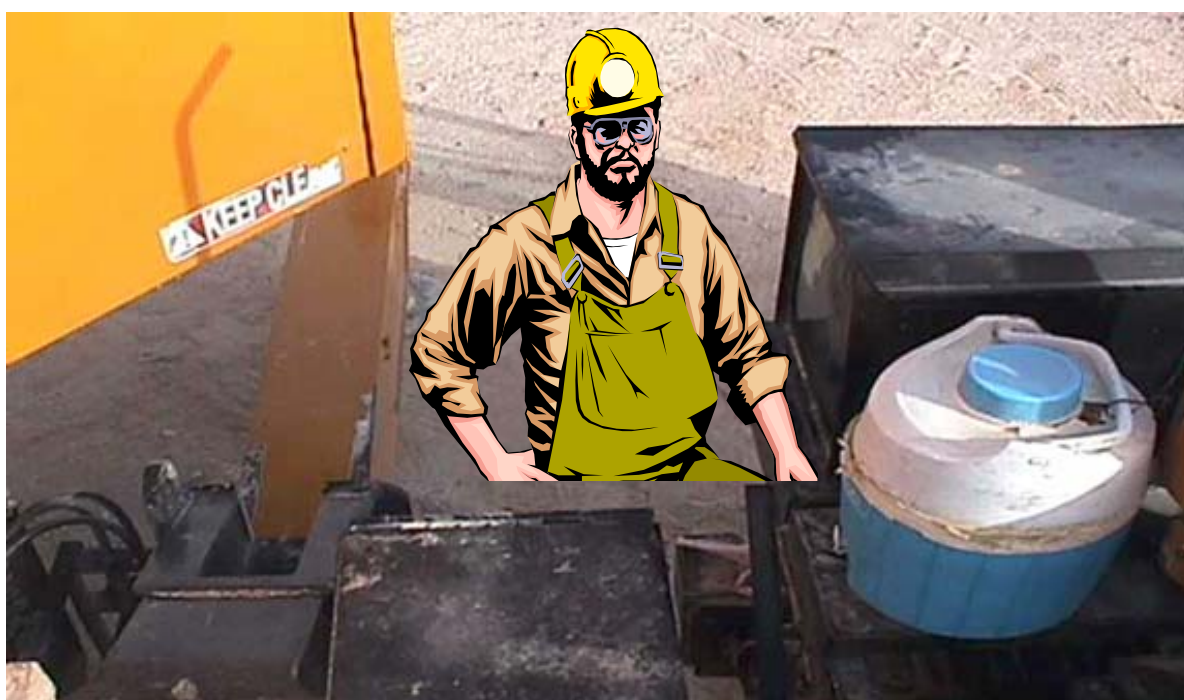
A crew of 5 (a supervisor, a crane operator, and 3 helpers) were shifting GRE pipe lengths for end trimming at the pipe lay down area. The supervisor had given the signal to start shifting the pipe, unaware that one of the helpers had approached the crane from the back for a water jug. The helper did not notice the rotating crane's counterweight turning, which began to squeeze his chest against the toolbox adjacent to the water jug. He then shouted out. Upon hearing the shout, the crane operator reacted swiftly by stopping & reversing the crane, thus avoiding a possible far worse outcome.

- Precautions during crane lifting operations were not followed – personnel were allowed within working radius of the crane moving parts
- No dedicated banksman for the lifting operation – supervisor was acting both as banksman and supervisor
- Water jug was placed at unsafe position on the crane

- Ensure precautions during lifting operations are strictly adhered to (**COMPLIANCE**); with single point communication between crane operator and banksman
- Include in daily tool box discussion the hazards identified during the HEMP (Hazards and Effect Management Process) for the activity
- Workers (in this case the supervisor) are empowered to STOP work they consider it unsafe to continue with available resources and equipment, and request a re-evaluation of the work.
- Do not place tools, water cooler, food stuffs, etc., on or near crane moving parts.
- *Ensure Crane Operators and Riggers/Banksmen are trained and assessed in accordance with PDO specification SP1251. Successful operators/riggers/banksmen will be issued appropriate PERMIT.*
