Pressure testing incident Summary

- *Pressure testing 5K choke manifold TX 54-10*
- *Choke tested inside GY base well test pressure test bay*
- *Workshop Foreman and Technician inside test bay to inspect for leaks*
- *Thermowell (3/4" NPT) failed*
- *Hit Workshop Technician in leg, resulting in serious injury to right knee*

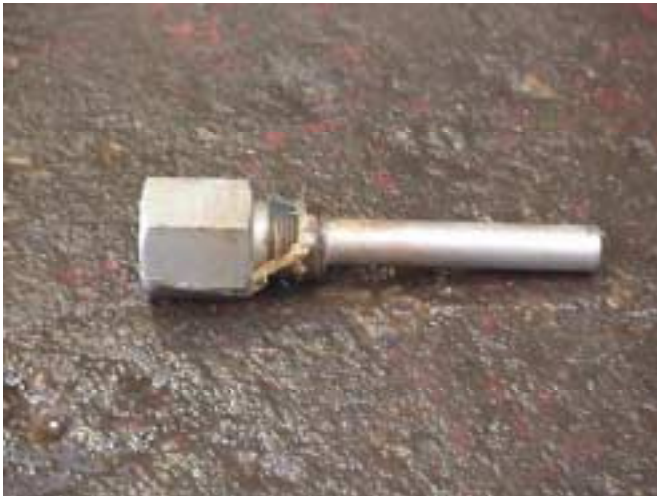
Severe corrosion had affected the mechanical integrity of the female thread.

The forces generated by the 5000 psi test pressure overcame the mechanical strength of the corroded thread and caused the thermowell to be ejected.

*When the NPT
thread failed...*

Dismantle and inspect ALL pressure retaining threads on Yarmouth Base equipment using calibrated thread gauges. Ensure condition of threads are established and deficient components are scrapped and replaced as required prior to any further pressure testing activity.

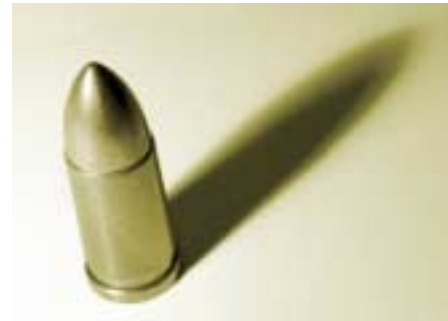
*... the stored energy was
released and propelled...*

*...the thermowell
at a velocity of
42 metres/ sec
or*

94 MPH
