#### Three High Potential Incidents involving H<sub>2</sub>S in oily water treatment occurred in 2006

# SAFETY FEEDBACK NOTICE

## HYDROGEN SULPHIDE (H<sub>2</sub>S)

**DGEP / HSE**
**Ref: 02 - 2007**
**Issued: 16/02/07**

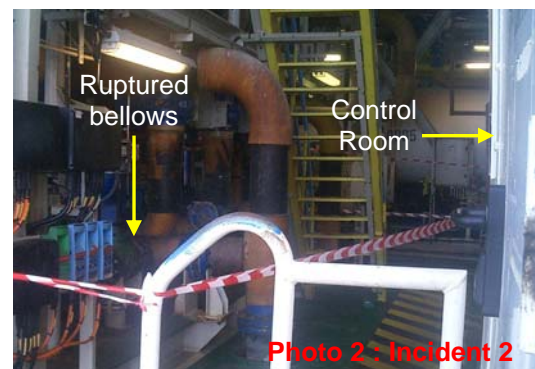
- (5) **The internal lining of the new bellows installed was not suitable for the service**. Inappropriate bellows were **purchased** and **delivered**. The **material data sheet** which detailed the incompatibility of certain materials with hydrocarbon was **ignored** (Incident 3).

- (1) Revise design and operating philosophy of the oily water network downstream of the oily water tank.
- (2) Do the preventive replacement of bellows on lines containing hydrocarbon and insure of their compatibility with H<sub>2</sub>S and hydrocarbon.
- (3) Enforce correct use of airlocks and restricted access to the Control Room through field instructions.
- (4) Downgraded situation follow up at weekly meeting, under GM chairmanship.
- (5) Reinforce quality control on spare parts before shipment to site.
