HSE NEWS

MR. MUSLEH'S

Learning from Incidents

Welcome to issue No. 17 of Mr. Musleh's News, the communication which provides a 'one stop shop' for you to receive learning's from incidents in PDO and the oil and gas industry.

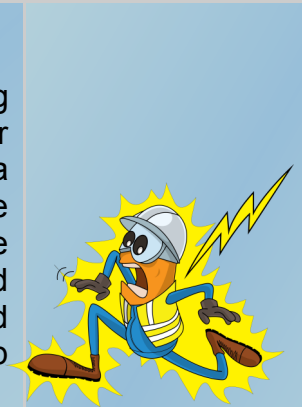
Shocker

During rig up, the night electrician connected the power cables and turned on the light switches from MCC (motor control center). While walk around the electrician noticed that the light on the water tank was not on. Upon inspection he found that the cable to the water tank was not connected. He then attempted to plug the socket and turned it (Twist Switch) to switch on the power.
