Learning from Incidents
Third Quarter of 2021 Incidents

This quarter's Mr. Musleh summarizes the learnings from incidents related to Lost Time Injuries (LTIs), High Potential (HiPos) and High Value Learnings (HVL) which have occurred during this quarter.

PDO Second Alert

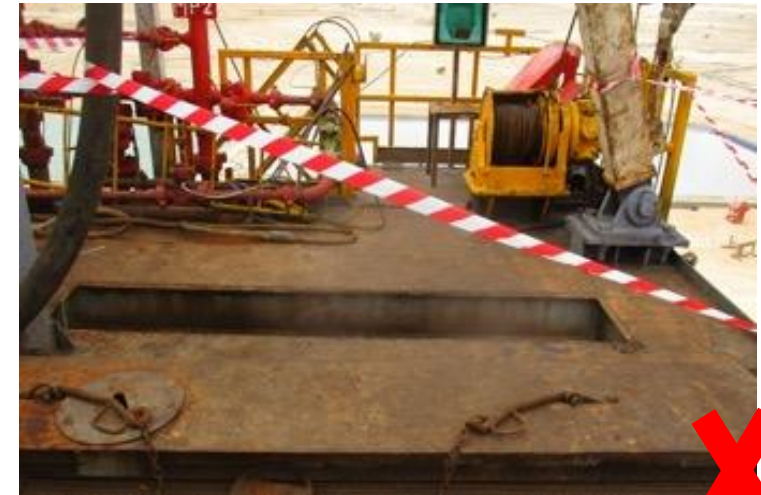
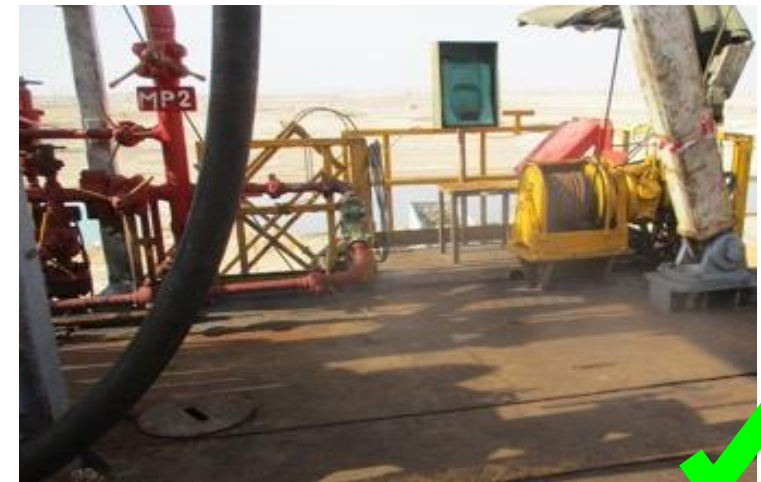
Always ensure to barricade immediately any opening/gaps or shifted handrails

- Ensure that step by step activity, risk, control and responsibilities are discussed with all involved personnel.
- Always ensure to intervene and apply the stop-work authority when deemed necessary.
- Always ensure to always supervise the task physically. Never leave the work site unattended
- Always ensure to maintain good housekeeping at the work area.
- Always stick with the plan otherwise inform your supervisor.
- Apply dynamic risk assessment review for any changes in the activity.

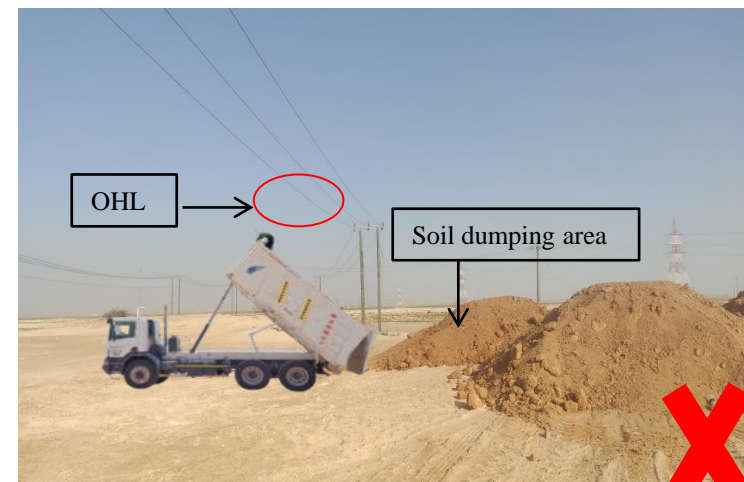
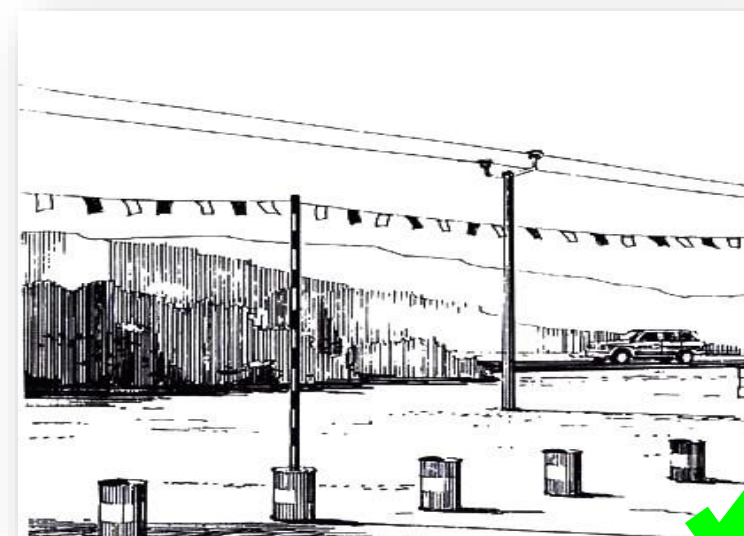
Always maintain safe clearance from Over Headlines

- Always ensure availability of Banksman with vehicles while loading/unloading and reversing activity.
- Always maintain safe horizontal and vertical working distance and provide safety barriers for work in the vicinity of OHL.
- No work in the vicinity of OHLs shall be carried out without having an OHL clearance.

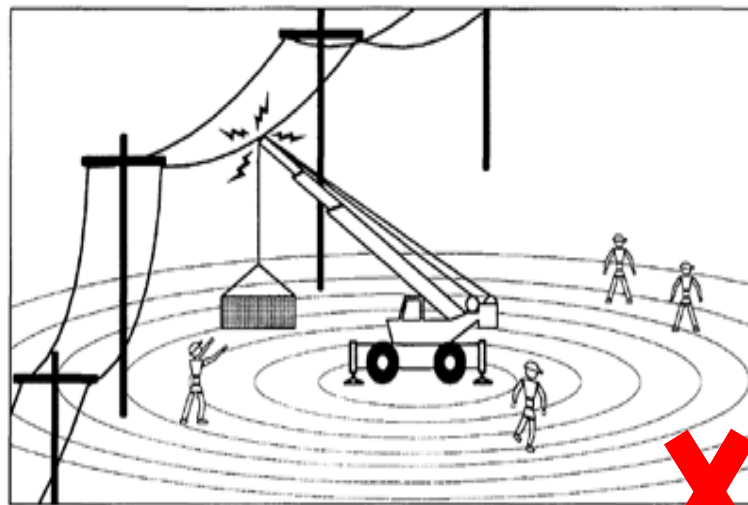
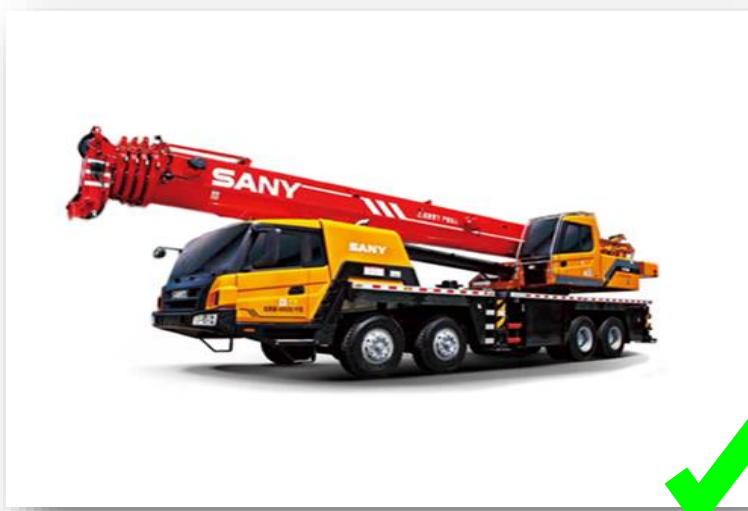
Always be cautious about proximity hazards of overhead lines whilst operating crane

- Always ensure boom of the crane is lowered and slings are removed during moving of the crane.
- Always operate the crane after receiving the signal from banks man.
- Always ensure all rig move team participates in TBT and on-site supervision is provided.
- Always ensure equipment are spotted away from vicinity of overhead powerlines.
- Always ensure out of site register is updated with rig move activities.
- Always maintain safe clearance from Over Headlines

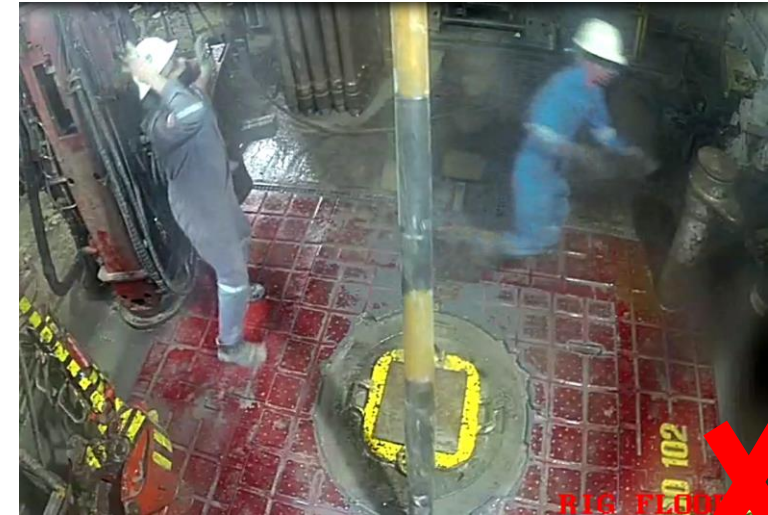
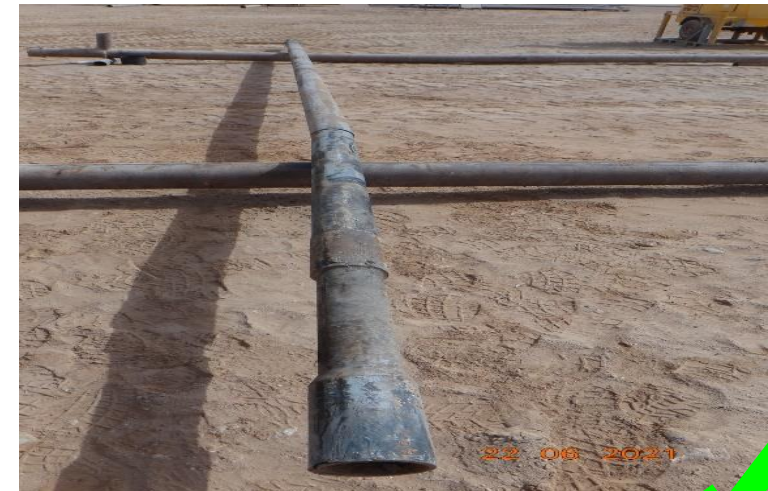
Observe fatigue during crew change-Empower to Stop

- Always ensure the you are fully concentrated during operation and while dealing with equipment.
- Always ensure to keep attention to signs of fatigue during crew changes and manage them.
- Always ensure good communication between Driller & Crew.
- It is safer to keep the elevator door against the inclination of the assembly in case the elevator opens, the assembly will remain in the elevator housing due to tool inclination.
- Keep weight on elevator (don't slack off the full weight) to allow mechanism of locking pin engaged.

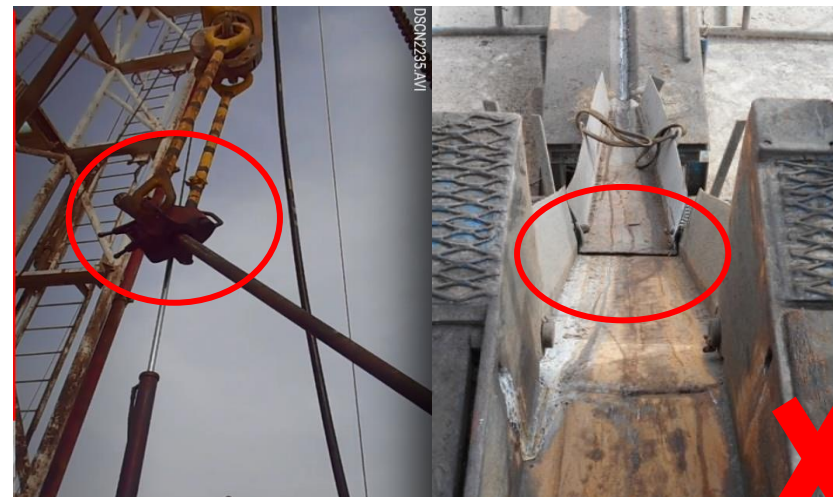
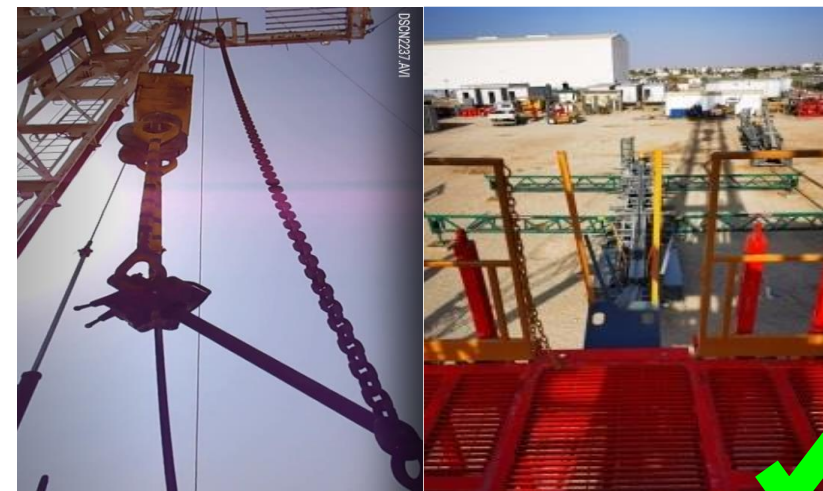
Ensure no objects come in contact with Elevator while in motion.

- Always Comply to Drops zone management, utilize step back safety zone whenever possible
- Always Observe the path of the elevator while tripping and during laying down the Tubular thru the V-Door (Tubular smooth motion)
- Always Ensure the Elevator is properly latched (Floorman to “thumb up” to the driller prior to picking the string)
- Straight line V-Doors is preferred , always inspect the equipment pre use, check the condition of the V-Door and catwalk groove

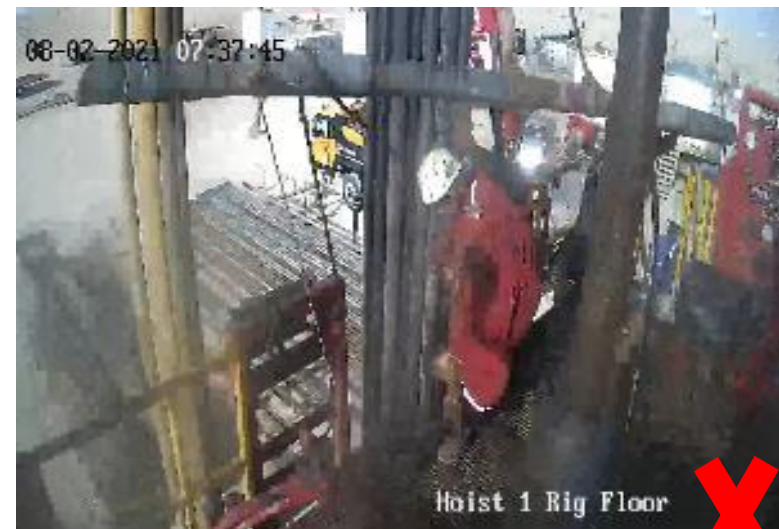
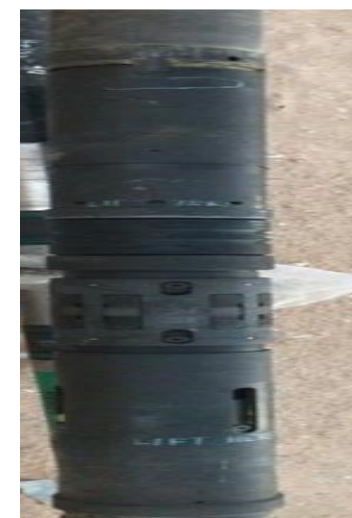
Ensure the running tool is properly connected to quantum packer prior to pick up to floor

- Ensure the running tool is properly prepared before shipping to wellsite.
- Ensure appropriate lifting method is used to lift and run quantum packer.
- Ensure red zone is effectively managed
- Ensure adherence to procedure.

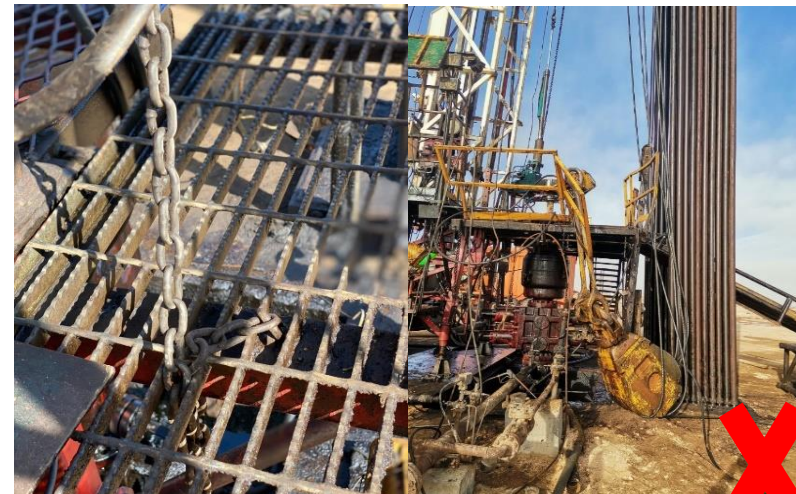
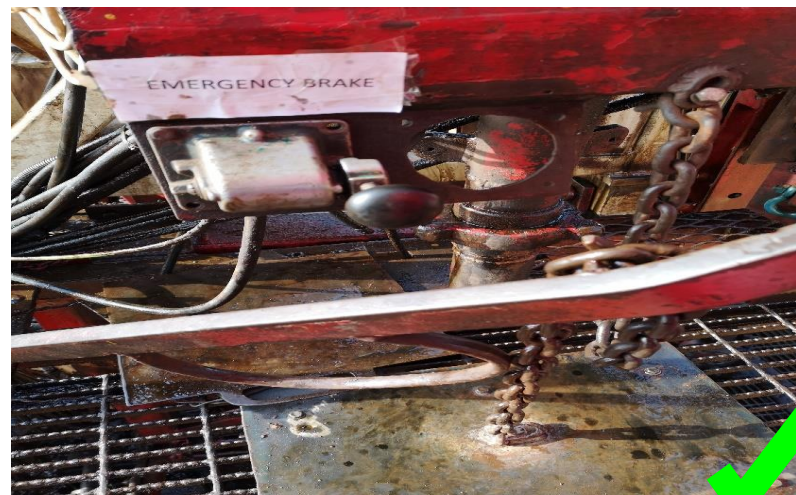
Ensure Emergency brake is engaged, and brake handle is correctly secured when Driller is away

- Ensure the travelling block is correctly secured and brakes are engaged before leaving the Driller console.
- Check and ensure the chain locking mechanism is free from obstructions.
- Always ensure floor activities are performed under supervision.
- Ensure the SOP and HEMP is reviewed and updated to confirm it meets OEM/ Stds.

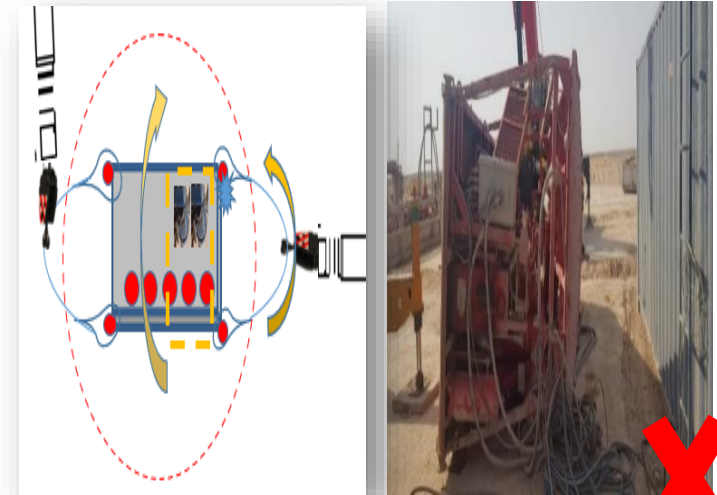
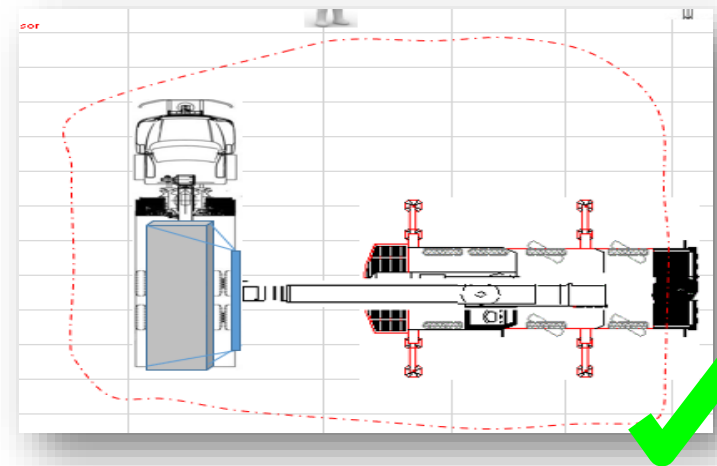
Always ensure critical lifting operation are conducted under competent lifting supervisor

- Ensure Critical lifts must be supervised and led by competent lifting supervisor.
- Ensure the lifting attachments are fit for the task
- Ensure that any critical lifts has an approved lift plan which should be reviewed before the lift.
- Verify that the rigging method and sling selection is done in accordance with the lifting plan.
- Ensure the red zone is fully controlled before starting any lift.
- Do not start any lifting operation without the presence of lifting supervisor and completing the CoW process.
- Ensure that MOC is in place for all changes in accordance with PDO MOC procedure
