#### Gt. Yarmouth Base Pressure Testing Incident, 16/8/01

- Pressure testing 5K choke
  manifold TX 54-10
- Choke tested inside GY base well test pressure test bay
- Workshop Foreman and Technician inside test bay to inspect for leaks
- Thermowell (3/4" NPT) failed
- *Hit Workshop Technician in leg, resulting in serious injury to right knee*

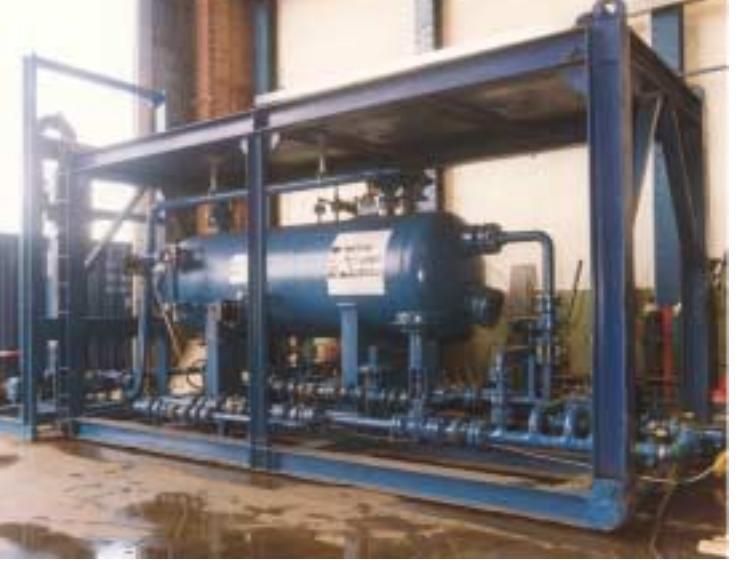
When pressure acts upon an area, a force is generated

The higher the pressure ie 10,000psi

*The larger the area ie 400 barrel tank*

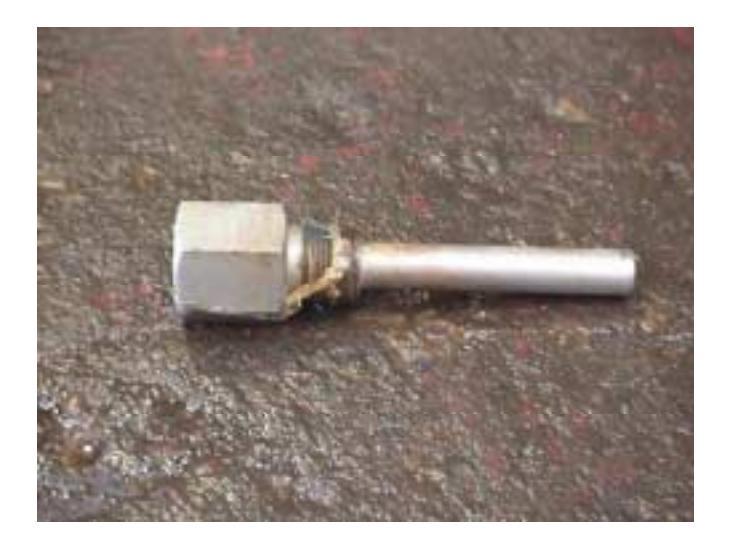
Force	=	Pressure x Area
Test pressure	=	5000 psi
Affected area	_	0 785 sa ins

Force	=	<u>1 3/4 tons</u>
-------	---	-------------------

# When the NPT thread failed....

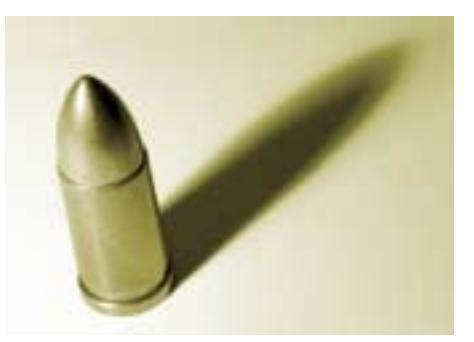
## ... the stored energy was released and propelled...

...the thermowell at a velocity of 42 metres/ sec or
