## SEVERE INJURY WITH HAND AMPUTATION AND SKULL FRACTURE

Lost Time Injury

March, 14<sup>th</sup> 2003

Offshore construction

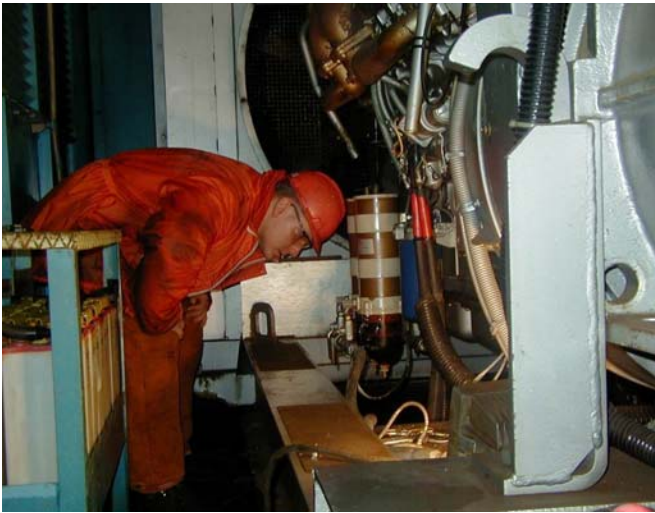
- ⌚ The other motorman, before to go to the store, recalls seeing the Injured Person bending over with his hands on his knees near the filters before he left.

At that moment the Deck electrician was near the control panel.

The Injured Person, being very skilled and confident with this job, most likely did not consider the hazards related to the removal of PPE and the suction of the ventilation system. In fact the jacket was sucked by the ventilation and pulled into the pulley thereby causing the accident.

One of the main causes of the accident can be considered to be the improper guarding of the pulleys and belt used to transfer the rotating motion to the ventilation/cooling system.

All inspection operations beyond the control panel can only be performed with a stand-by person in attendance within the immediate area of the emergency stop and in a condition to easily see the inspection operators.
