SAFETY ALERT

Grinder Injury

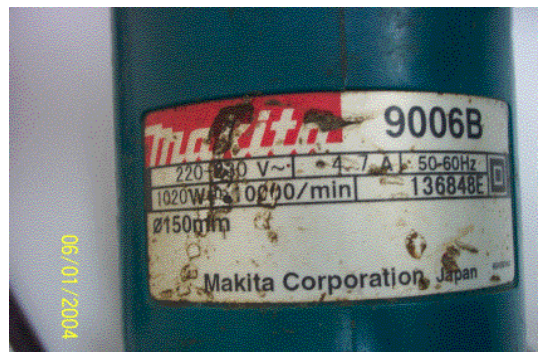
Based on manufacturer specification, Makita grinder model 9006B should use 6" grinding wheel, speed load 10,000 RPM.

9.5" grinding wheel was used instead of using 6" grinding wheel. This wheel was over sized and allowed only to be run at 3400 RPM.

Grinding wheel was running at 10,000 RPM (over rated speed) causing the wheel fly apart and hit the mechanic's face.

- Utilised improper tool.
- No grinder safety guard.
- Not using face shield for PPE.
- Mechanic has been warned but he ignored it.
