Asphyxiation of Welder on LNG Construction Site

23 August, 2009

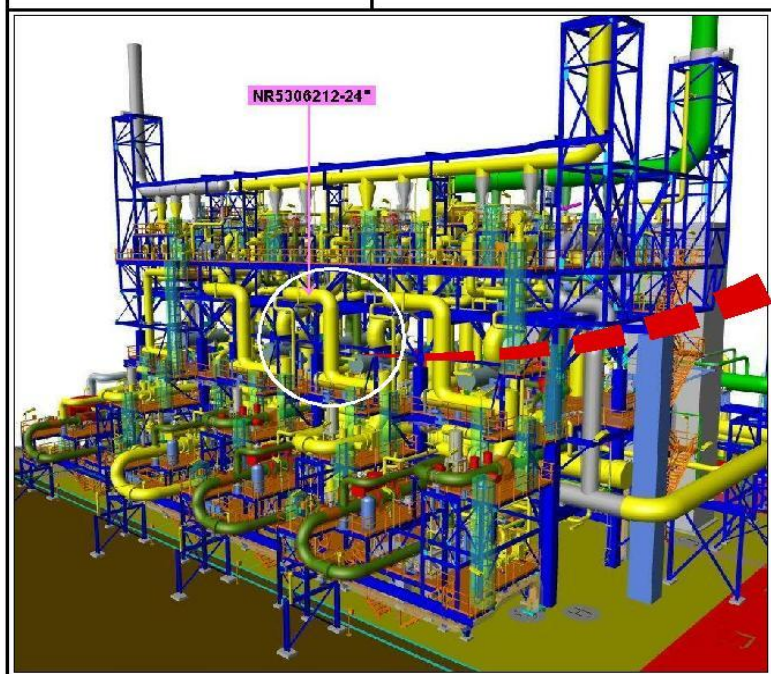
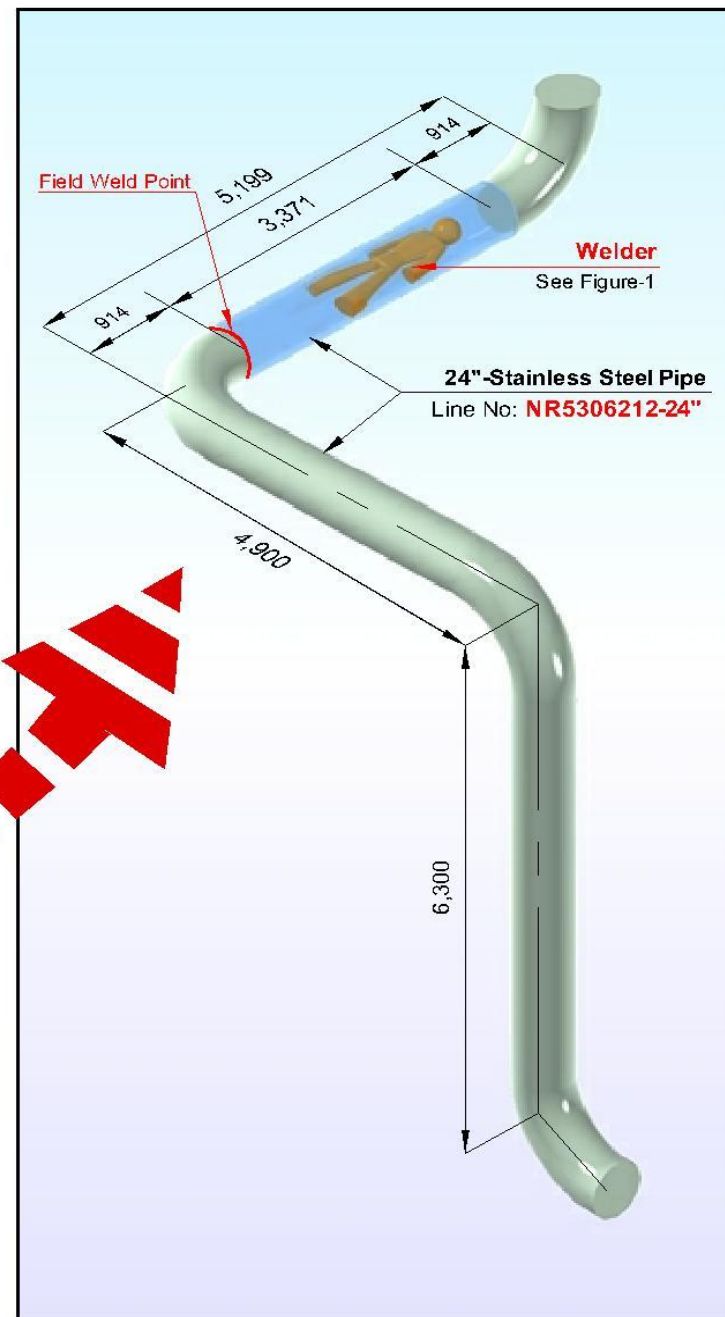
LOCATION OF INCIDENT

53-XH0603 @ 20m Level

53-XH0603

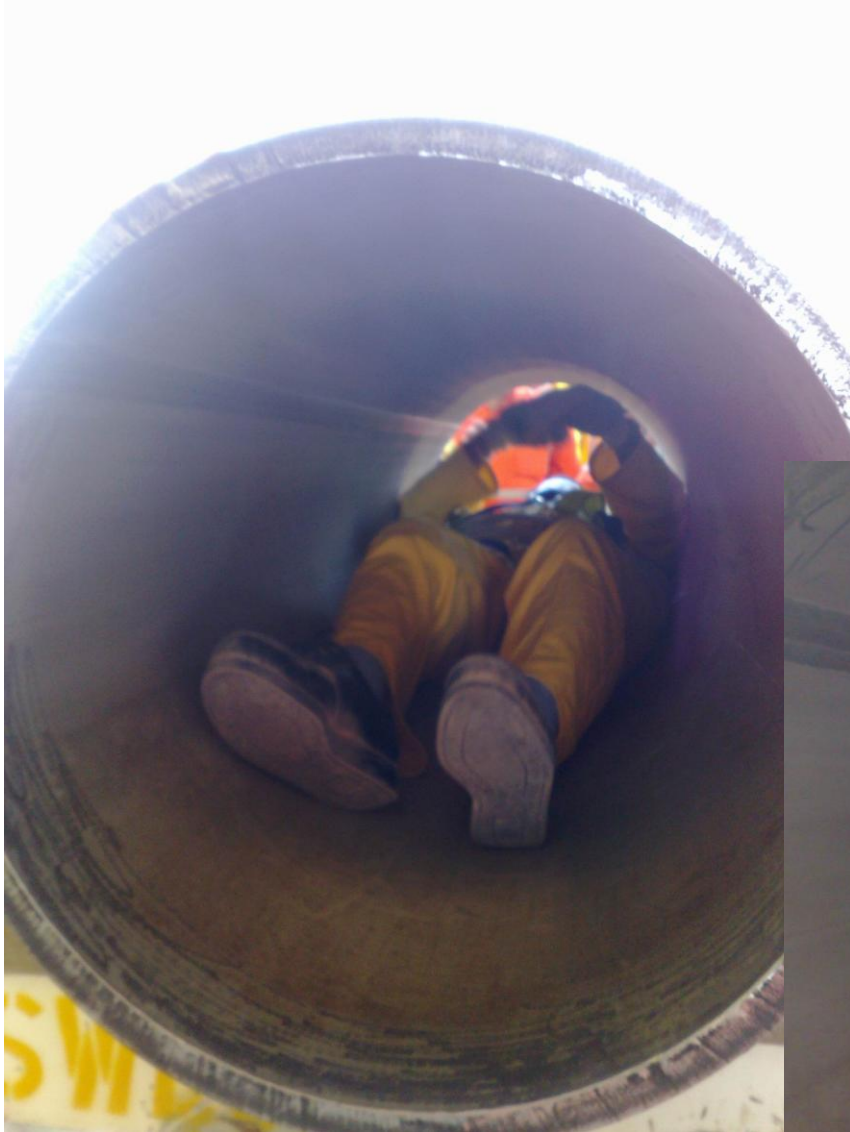
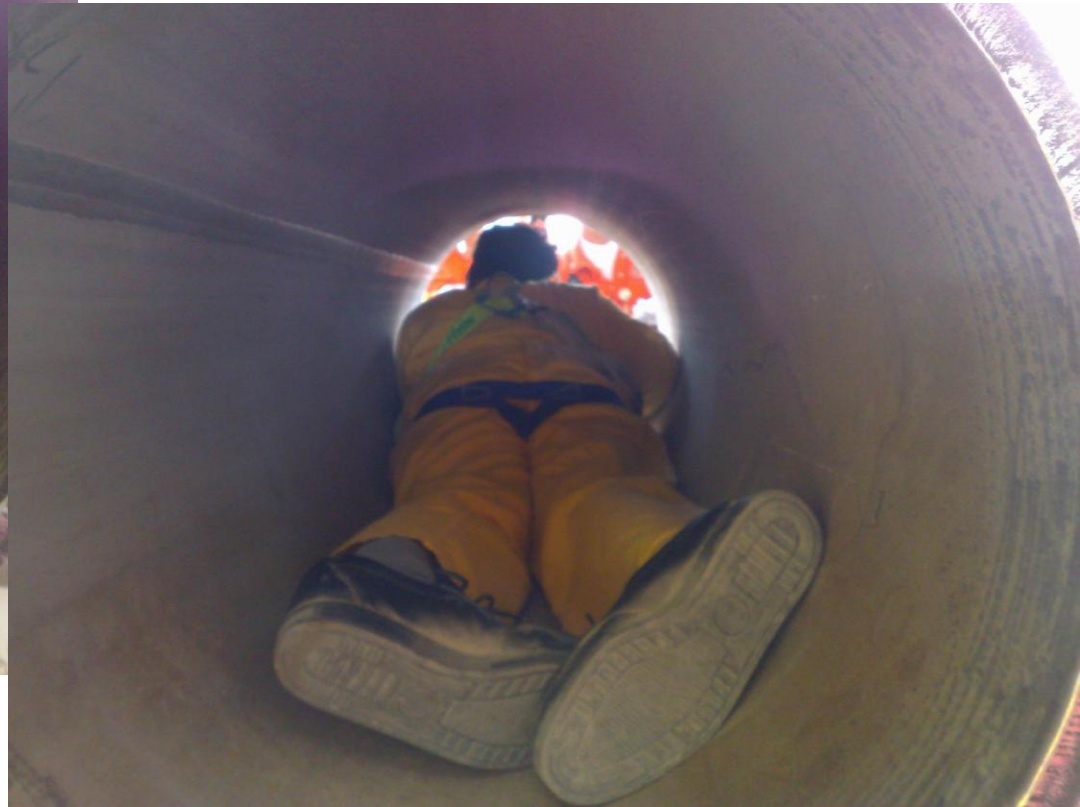
Re-Creation

- No evidence that the victim intended harm to himself
- No evidence that the victim fell into the pipe
- Evidence indicates the victim entered pipe on his own to inspect his weld
- No tools in possession other than cell phone (light)
- Re-creation indicated person of similar size can move relatively easily inside 24" (ID 22") pipe
- Two welders assigned to the task but separated without direction from supervision
