Brake Bands

INCIDENT

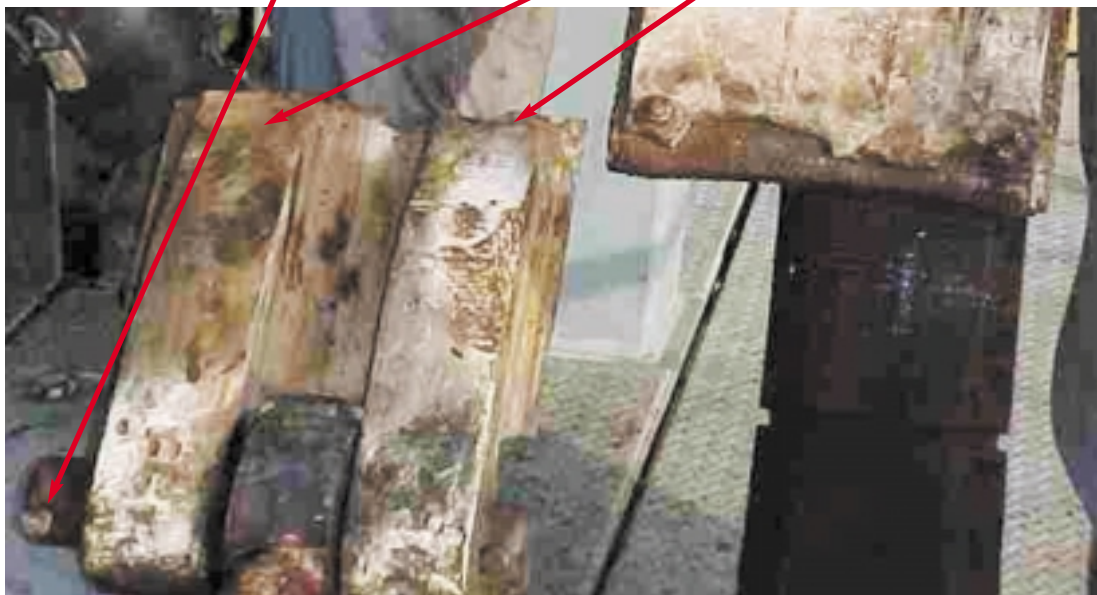
Brake band parted above connecting links when attempting to slack off weight.

- Bands failed due to excessive flex and prior damage.
- The bands were welded instead of being replaced.

By failing to lubricate the pins and keep them lubricated excessive flexing was administered above the welded areas which caused the failure.

- Inspect brake bands every 6 months.
- Do not repair damaged bands but replace them with new ones instead.
- Take the connecting link pins out once per month and clean and re-grease so there is free movement of the band.

Never weld - replace with new bands!
